REPORT OF INVESTIGATION

Fatal Drowning Accident
February 25, 2023

La Havana Pit
Terra Firma Materials LLC
Havana, Hidalgo County, Texas
ID No. 41-04706

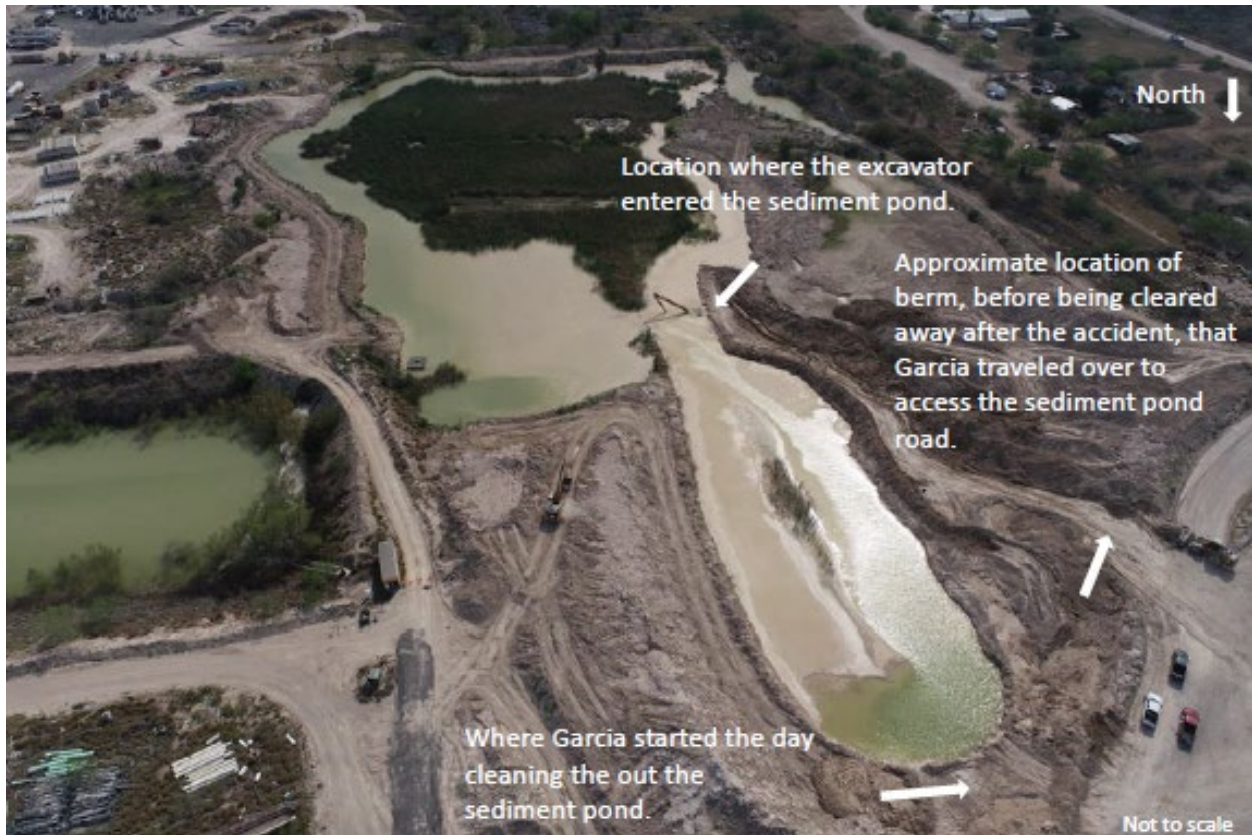
APPENDIX A – Reference Point of Accident
(Photograph Taken after Accident)

On February 25, 2023, at 5:36 a.m., Garcia started his shift. Garcia met with Gonzalez at Gonzalez's pickup truck and inquired about the day's activity. Gonzalez instructed Garcia to clean out the north end of the sediment pond with the excavator since the plant would not be in operation due to maintenance. On a map, Gonzalez showed Garcia where he wanted Garcia to work. At 6:28 a.m., after attending a safety meeting that included safety talks on ladders and berms, Gonzalez observed Garcia removing material from the sediment pond where Gonzalez instructed him to work (see Appendix A).

The accident occurred near the end of the road that ran alongside the sediment pond, approximately 355 feet from the north end of the sediment pond. Garcia had traveled away from the area Gonzalez assigned him to work. The sediment pond was an old pit that the mine operator converted into a recirculating sediment pond for the wash plant. The sediment pond

was approximately 10 to 12 feet deep where the excavator entered the water. The sediment pond was approximately 20 to 25 feet wide, and the berms at the accident site were approximately two feet high.

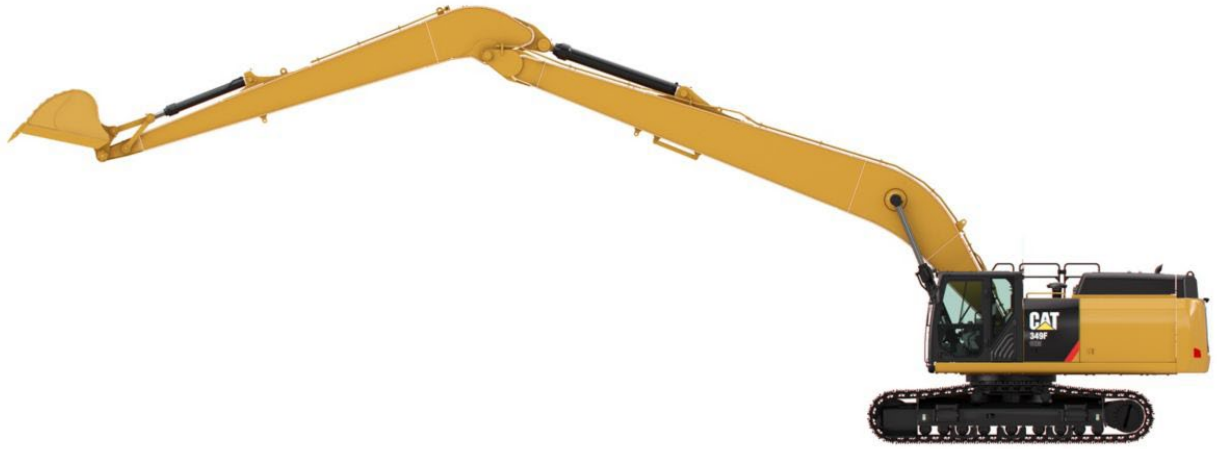
APPENDIX C – Long Reach Excavator

The excavator involved in the accident was a Caterpillar 326FL long reach excavator with a 60-inch ditch cleaning bucket (see Appendix C). The excavator had an operating weight of 58,470 lbs., digging depth of 48 feet, four inches, and a maximum loading height of 46 feet, nine inches. The excavator was on a lease to purchase program. The mine operator had this excavator on site for approximately one year prior to the accident and used it daily to clean out the sediment pond.

When the mine operator recovered the excavator from the sediment pond, the operator's cab was three-quarters full of mud. During the removal of mud from the operator's cab, investigators found the key in the "on" position and the throttle in the "full throttle" position. The investigators found that the excavator's seat belt extended out, which may indicate that Garcia was wearing his seat belt at the time of the accident. Investigators found the seat belt to have visible mud under and over it, preventing it from retracting. Once the debris was removed, the seat belt operated as designed. The front window was pushed inward towards the operator, and the left side window was pushed inside the cab. There were no objects under the travel pedals that would have prevented the pedals from operating normally. The straight travel pedal did not have the locking pin in place indicating that the equipment operator could fully use the travel pedals. The excavator did not have any safety defects that contributed to the accident.
