REPORT OF INVESTIGATION

Fatal Machinery Accident
February 26, 2023

LMS Excavating LLC (A7147)
Freeburn, Pike County, Kentucky

Grapevine South Surface Mine
Appalachian Resource West Virginia, LLC
Matewan, Mingo County, West Virginia
ID No. 46-08930

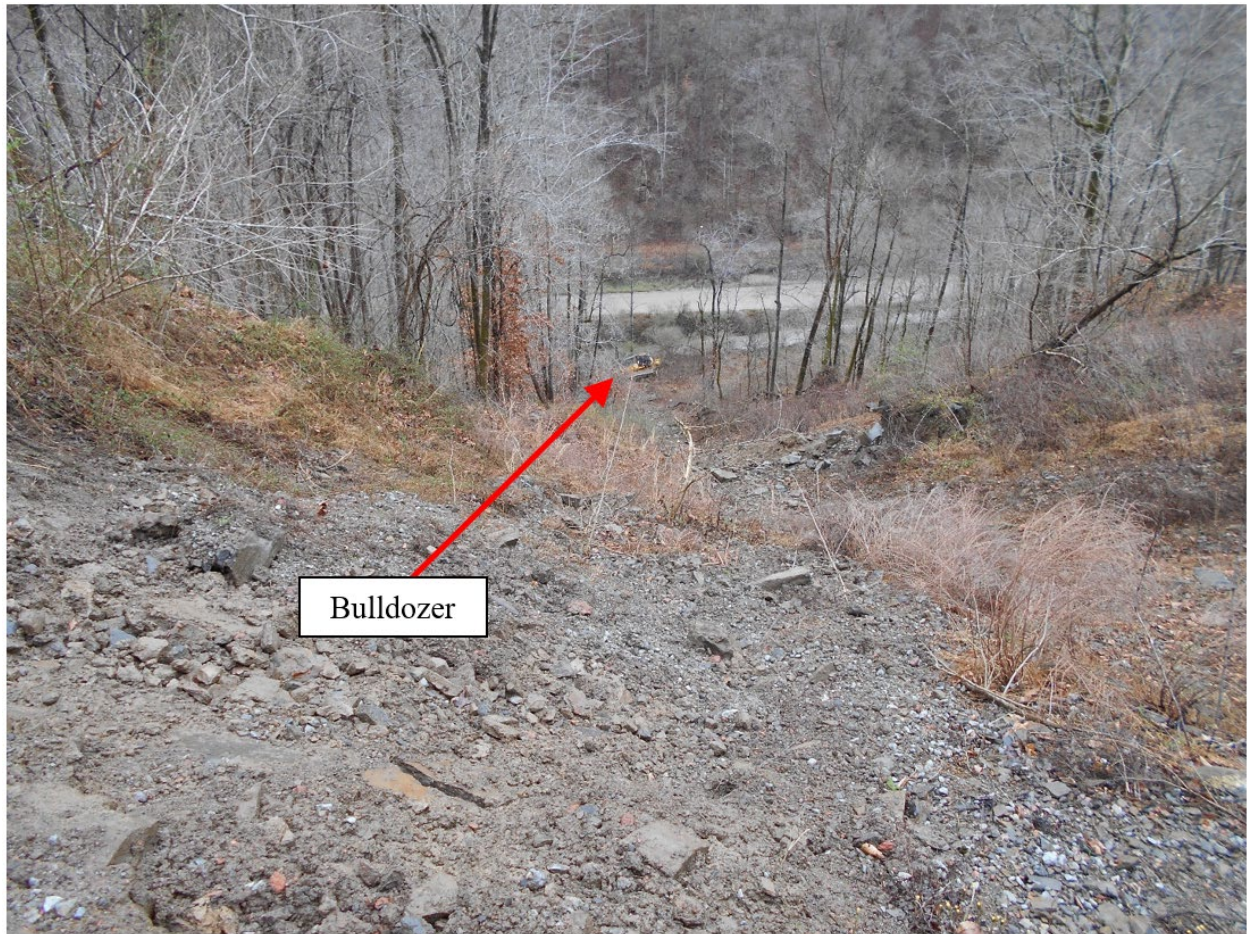
APPENDIX B – Location of Bulldozer After Accident

Based on the examination of the accident scene, investigators determined that B. Mapes used the bulldozer to reposition the large rocks, allowing him to tram the bulldozer into the barricaded area. Once inside the barricaded area, B. Mapes pushed the rocks back into position with the bulldozer and trammed in reverse with blade down to repair the damage to the road. The bulldozer backed over the edge of the road where a previous embankment failure (see page 4) had occurred and rolled down the hill. B. Mapes was ejected and later found 149 feet uphill from where the bulldozer came to rest at the bottom of the hill (see Appendix B).

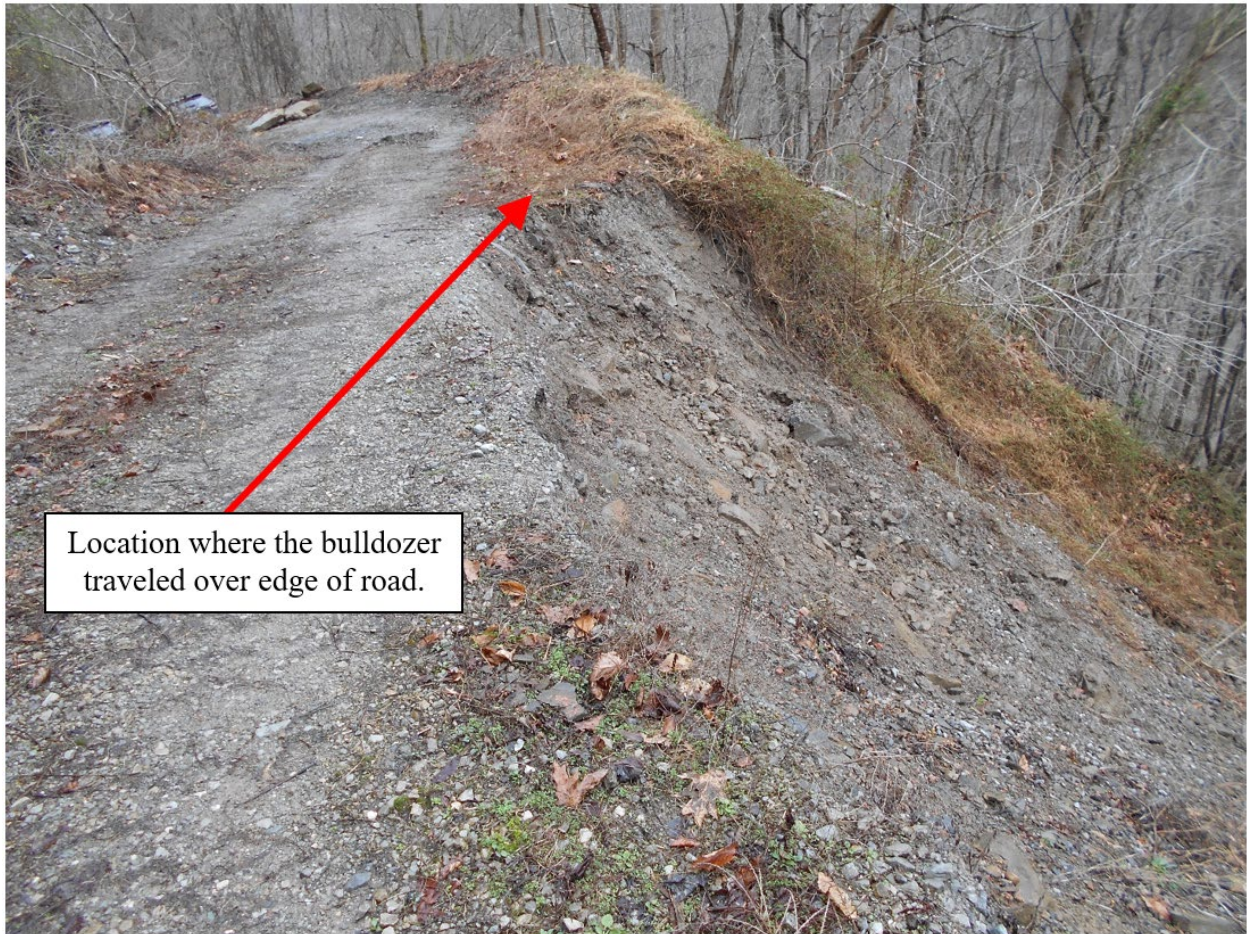
APPENDIX D – Photograph of the Accident Scene

In February 2019, an embankment failure occurred along Haul Road 3 which extended from the outside berm of the road down to the creek below, approximately 400 feet. During the embankment failure, a portion of the original road, including the berm, broke off, resulting in a sharp drop off on the outside edge of the road (see Appendix D). Additionally, the embankment failure reduced the width of the road from approximately 20 feet to as narrow as 11 feet. The mine operator placed large rocks approximately 50 feet before and after the broken section of the road to act as a barricade.

Location where the bulldozer traveled over edge of road.
