REPORT OF INVESTIGATION

Fatal Powered Haulage Accident
January 17, 2023

Mojave Plant & Quarry
Calportland
Mojave, Kern County, California
ID No. 04-00036

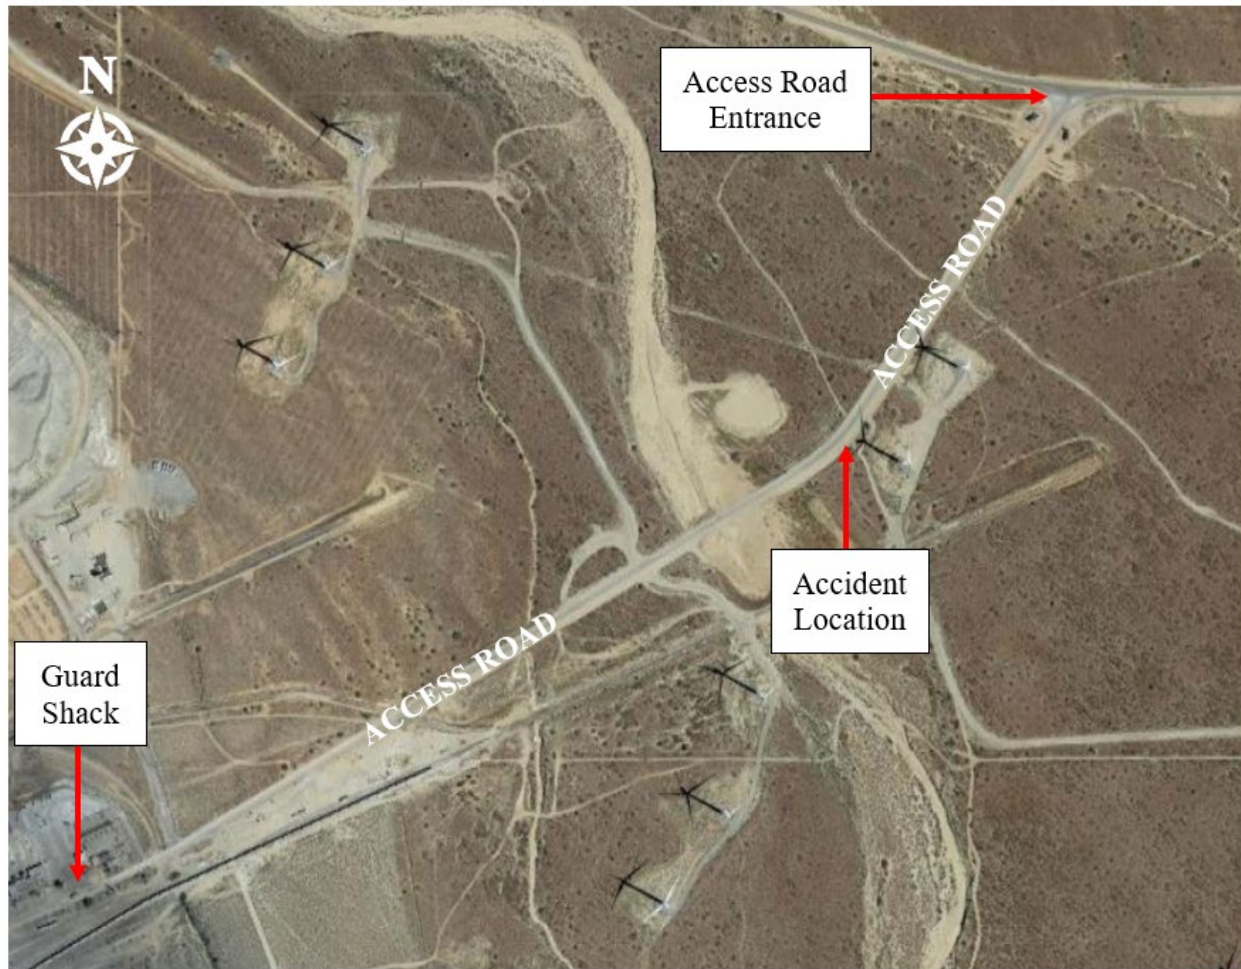
APPENDIX B – Location of the Accident

The accident occurred on the mine access road, 0.63 miles from the guard shack (see Appendix B). The road is comprised of grooved concrete, which is intended to shed water from the road surface when it rains. Grooved concrete reduces the risk of hydroplaning. Overall, the roadway was in good condition prior to the inclement weather. The posted speed limit at the time of the accident was 40 mph (see Appendix C). The mine operator previously installed instant display vehicle speed signs to warn drivers when they exceeded the posted speed limit. According to interviews, the road was icy at the time of the accident. Investigators determined that the icy conditions contributed to the loss of control of the vehicle. The mine operator did not have the material or equipment to treat the road to prevent ice/snow build up and had never previously treated the road for these conditions. Neither the mine, nor the local police had any records of previous accidents reported on this road.

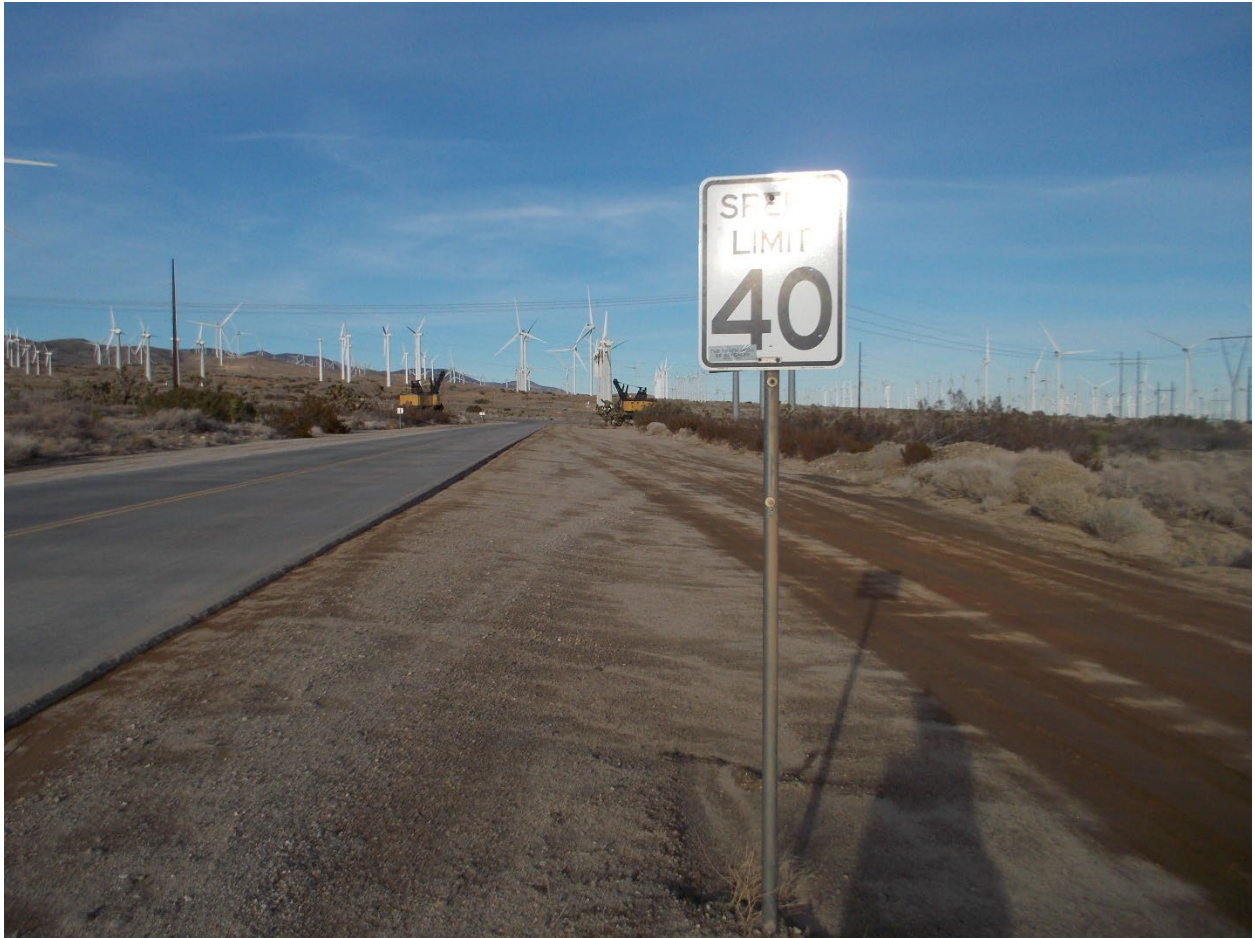
APPENDIX C – Posted Speed Limit Sign

The investigator determined that Argueta had not received adequate site-specific hazard awareness training from the mine operator. However, this did not contribute to the accident. The over-the-road haul truck's dash cam video shows he was operating below the posted speed limit and was in the appropriate lane of traffic when the accident occurred.

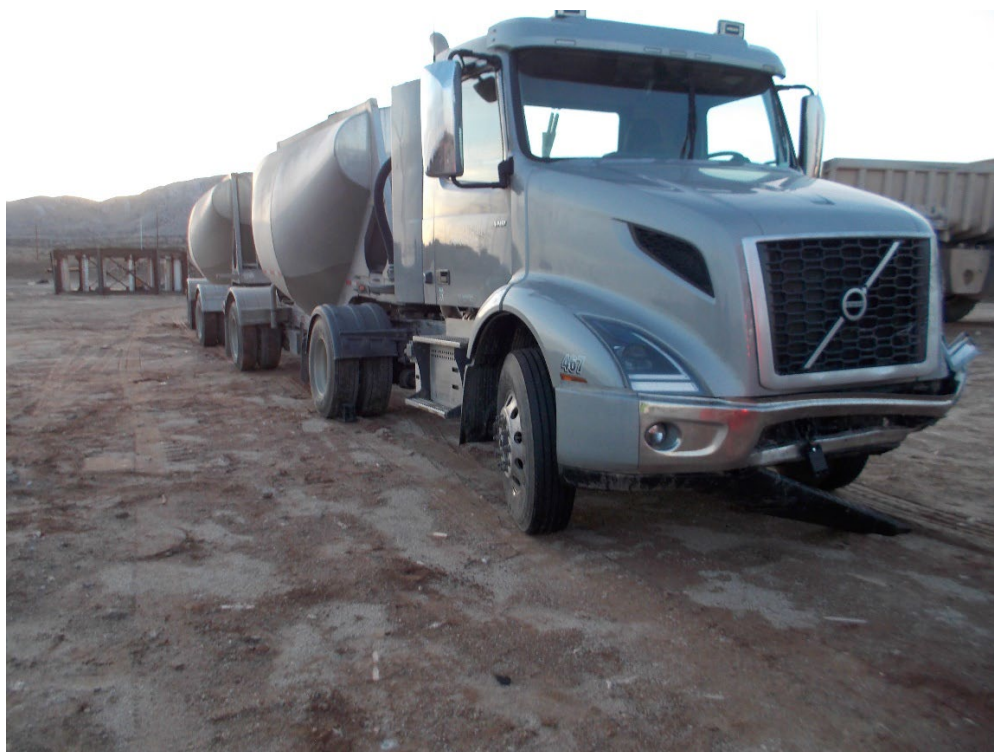
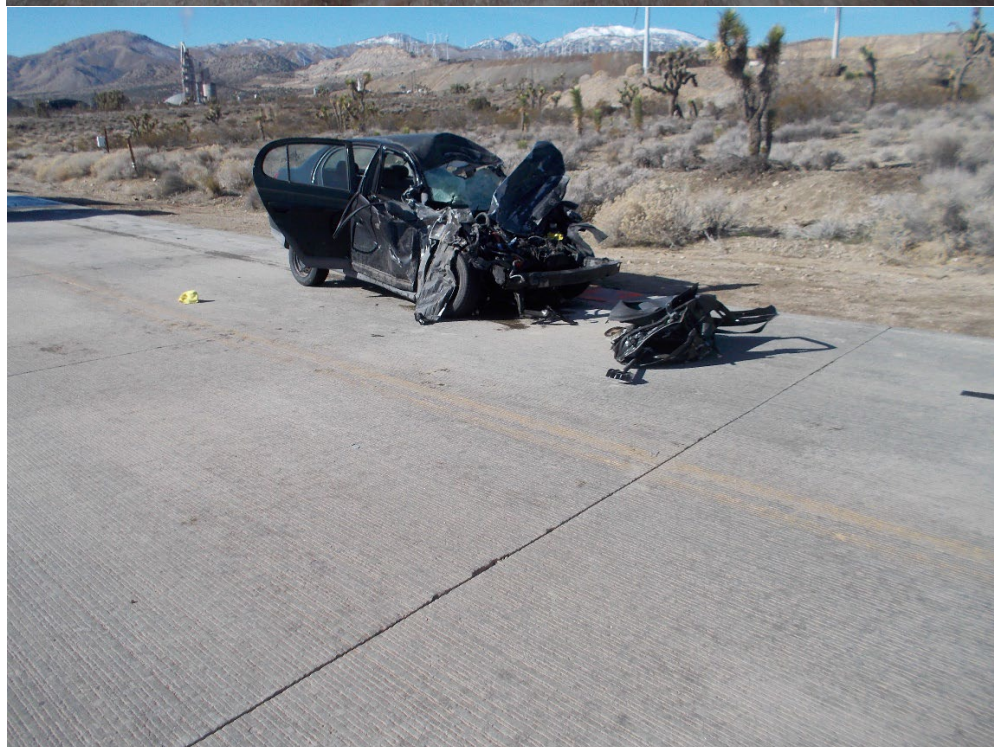
APPENDIX D – Photographs of the Vehicles Involved

The over-the-road haul truck involved in the accident was a 2022 Volvo VNR, equipped with two closed product trailers (see Appendix D). Examination of the over-the-road haul truck did not reveal mechanical deficiencies or defects that contributed to the accident. The investigator found the service brakes and parking brakes on the haul truck functioned properly when tested and did not contribute to the accident.

Colindres' vehicle was a 1999 Toyota Echo. Investigators examined the tires on the vehicle and found them to be nearly new and the brake pads were not badly worn. Due to the amount of damage, the investigator was unable to test the systems on the vehicle. Because the vehicle could not be tested, the investigator could not determine if any mechanical deficiencies or defects contributed to the accident.
