REPORT OF INVESTIGATION

Fatal Electrical Accident
January 27, 2023

Piedmont Mining, LLC (B2884)
McIntyre, Georgia

Wrens Plant
KaMin LLC
Wrens, Jefferson County, Georgia
ID No. 09-00143

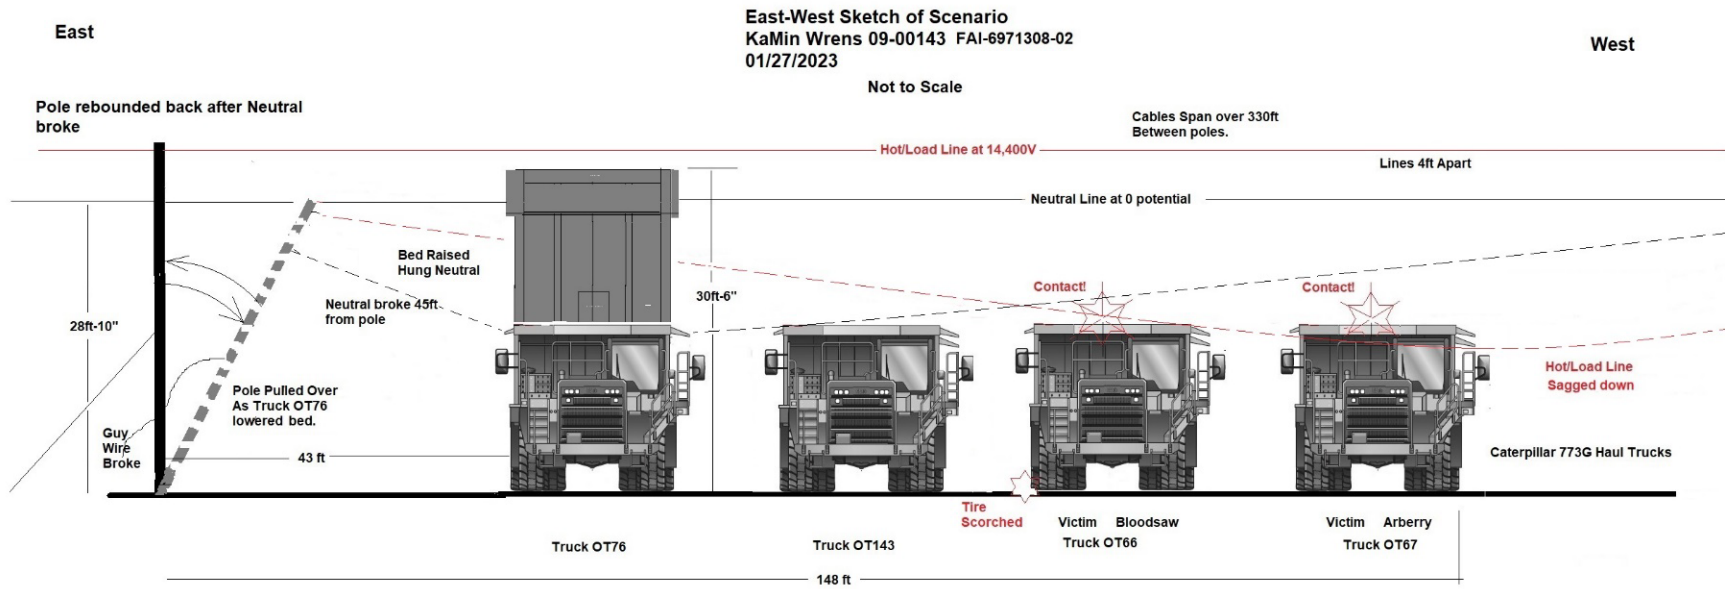
APPENDIX A – Accident Sequence

While still in the staging area, Jordan raised the bed of haul truck No. 76 to drain water that had accumulated from rain on the previous day. As the truck bed lowered, it caught the neutral power line (the lower, un-energized wire of the two running above the staging area). As Jordan

lowered the truck bed and began to pull away, the neutral line pulled the power poles together breaking one of the guy wires (wires that assist in stabilizing utility poles in the ground and keep them upright). This caused the energized line of the power lines to sag down below its normal position. The energized 14,400-volt power line contacted and came to rest across the top of the bed of haul truck No. 66 and across the handrails and catwalk of haul truck No. 67.

The energized power line's contact with the haul trucks created sparks and arcing (visible discharge of electrical current) as the electrical energy ran through the trucks to the ground. Seeing this, Bloodsaw exited the cab of haul truck No. 66 and received a fatal electric shock when he contacted the ground and the truck. Asbury exited the cab of haul truck No. 67 and received a fatal electric shock when he contacted the 14,400-volt power line spanning across the front of the haul truck. After Jordan pulled away in haul truck No. 76 to drive to the pit, the neutral line, previously hung by his raised truck bed, broke. This allowed the poles to relax back to their previous vertical orientation and the energized power line to lift back up to its previous position above the haul trucks. After witnessing the accident, Engram drove haul truck No. 143 to the pit to park it and ran back to the North staging area on foot. Engram saw Bloodsaw and Asberry motionless on the ground and the front passenger side tire of haul truck No. 66 on fire.

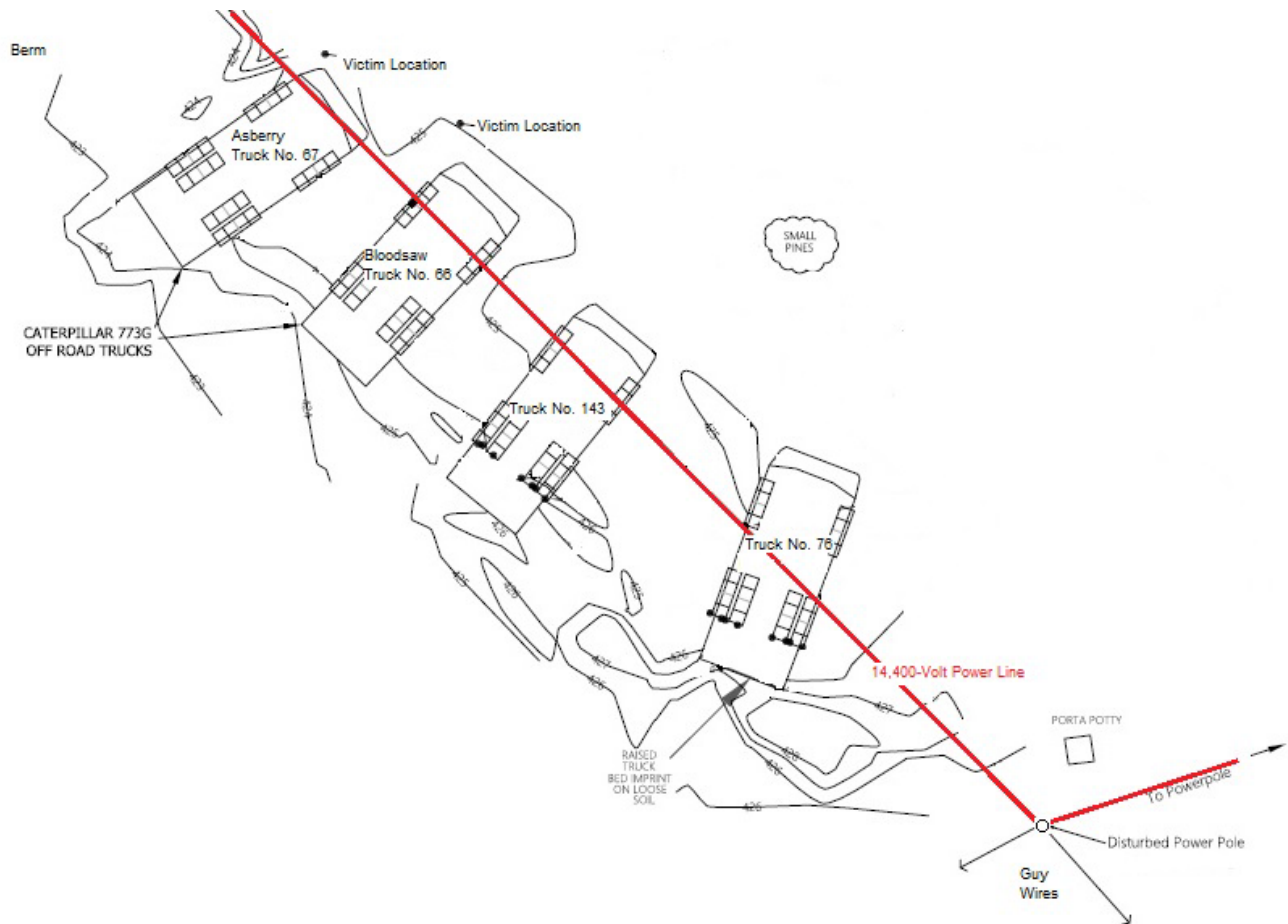
APPENDIX C – Overhead Illustration of the Accident Scene

The accident occurred in the North staging area for the Hunnicutt Pit. The staging area was approximately 140 feet long and 45 feet wide and served as a parking area for four haul trucks and a bulldozer (see Appendix C).

Since 2017, the contractor allowed contractor miners to operate equipment and park in this area daily during pit operations. Contractor management and members of the mine operator's management and safety department visit this area on a regular basis and were aware of the overhead high-voltage power lines. The power lines existed before the mining of the Hunnicutt Pit began and were in place to provide power to adjacent properties. There were other areas away from overhead high-voltage power line that could have been used as a staging area. The neutral line of the power line was located such that when the truck bed was raised, the bed was higher than the neutral line, making it subject to contact. The truck bed height when raised was over 30 feet in height, but the neutral line was located approximately 27 feet above ground and within approximately one foot of the energized power line.

The hazard of contacting the overhead power lines was not immediately obvious to the contractor miners because the lines could not be seen from inside the cab of the haul trucks due to the orientation of the haul trucks and the power lines. The power lines were less than ten feet away from contact with the haul truck when the bed was raised. The mine operator and contractor did not install warning signs or barricades to warn miners of the hazard of the overhead high-voltage power lines where the hazard presented was not immediately obvious to miners working in the area. The mine operator and contractor also did not ensure that equipment was not operated within ten feet of energized high-voltage power lines. Investigators determined that these factors contributed to the accident.

Corrective Action: The mine operator developed and implemented a new written procedure to prevent work from occurring within a prescribed distance of energized overhead power lines. The mine operator trained all affected miners in the new procedure. The contractor relocated the staging area to where there are no overhead power lines. The contractor also built berm barricades to prevent parking and operation of equipment and machinery beneath the power lines.
