REPORT OF INVESTIGATION

Fatal Slip or Fall of Person Accident
January 30, 2023

Randolph Deep Mine
Martin Marietta Kansas City, LLC
Randolph, Clay County, Kansas
ID No. 23-02308

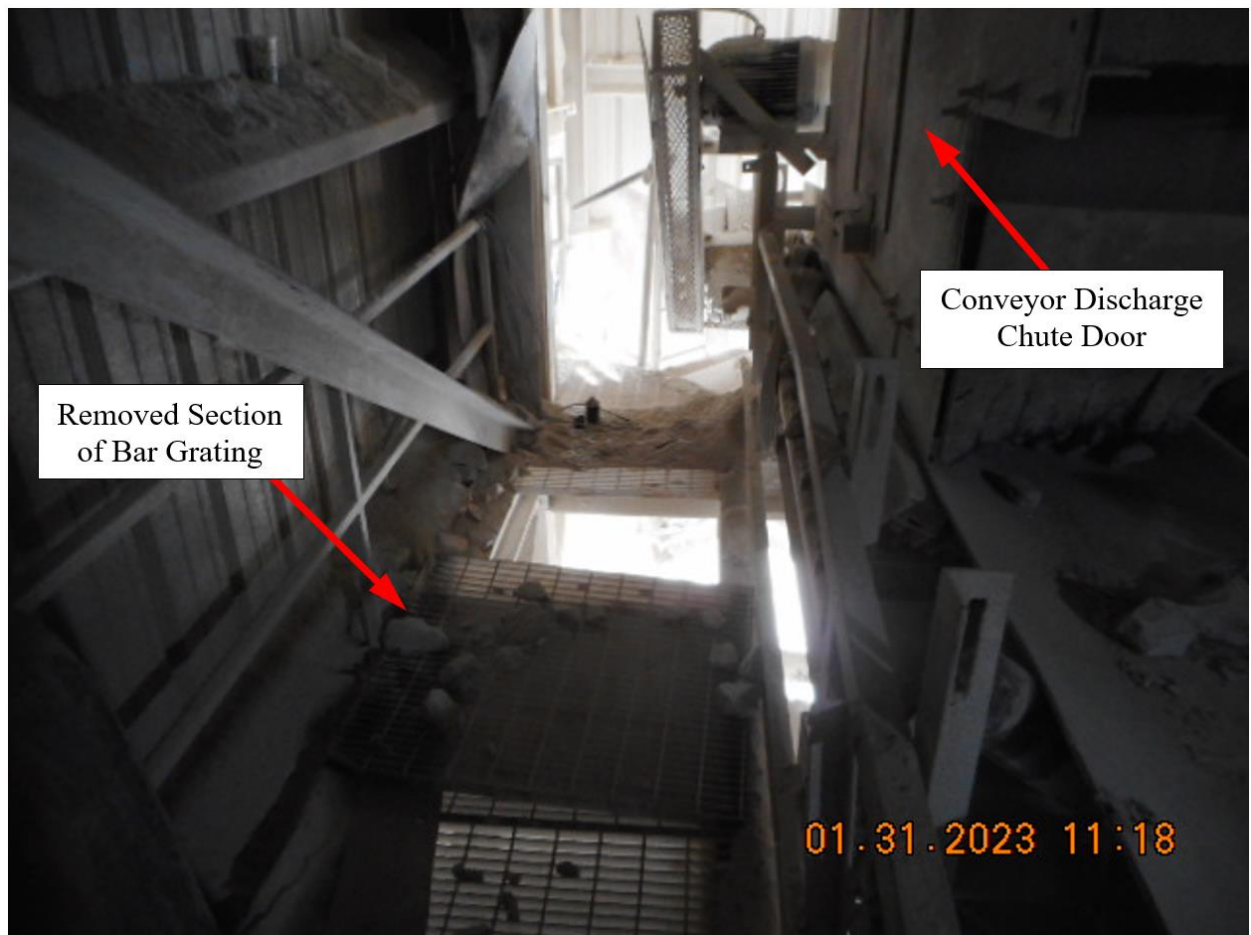
The No. 12 belt conveyor has two chutes that are fed from overhead sizing screens. One chute is located at the tail roller and one chute is located at the head roller. Miners removed a 35.5-inch by 41-inch section of bar grating, leaving a 34-inch by 37-inch opening in the catwalk at the head roller end. This bar grating used to be hinged on the side farthest from the belt, but the hinge broke at some point and the investigators were unable to determine when that happened. The bar grating at the tail roller end was permanently hinged to the catwalk and was propped open during the cleanup. After removing or opening these sections of bar grating, miners were able to shovel the rock from the conveyor discharge chute through the opening to the ground below. According to interviews, miners clean the chute once or twice per year as part of their regular duties to keep the plant running. The mine operator did not assign this task to the miners and was not aware of the procedure of lifting the floor grate as part of the procedure for cleaning out the chute. When the miners completed the cleanup, the hinged bar grating at the tail roller end was replaced, but the bar grating at the head roller end was not. Investigators observed Allen's boot print on the conveyor side support beam, indicating that at some point Allen had walked around the opening in the catwalk at the head roller end. Based on the examination of the accident scene, Allen apparently stepped through the opening while walking on the catwalk. The mine operator did

not barricade or post warning signs to prevent miners from falling through the opening in the catwalk, which contributed to the accident.

APPENDIX A – Removed Section of Bar Grating on the Head Roller End of the Catwalk

Corrective Action: The mine operator hired a contractor to conduct a training session on fall protection while working on elevated surfaces or near areas that create a fall hazard. The training included installation of protective devices or adequate warning signals in accordance with Title 30 Code of Federal Regulations (30 CFR) Part 57.11012.

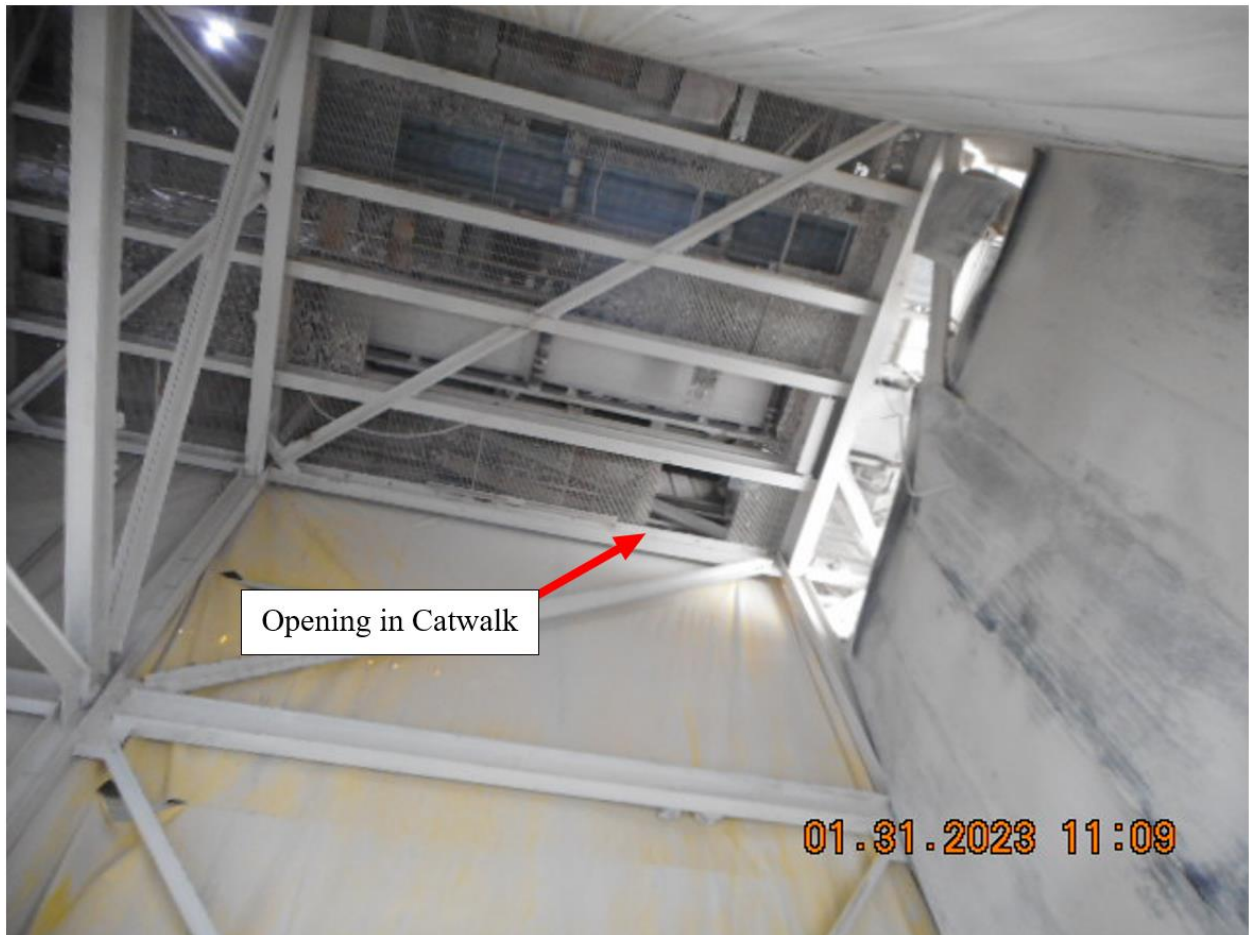
The accident occurred on the catwalk along the No. 12 belt conveyor in the East end building of the plant. The catwalk is approximately 40 feet long and is elevated 35 feet above the ground.

APPENDIX B – View of the Catwalk Opening from the Ground
