REPORT OF INVESTIGATION

Fatal Machinery Accident
January 4, 2023

Sevierville Quarry
Vulcan Construction Materials, LLC
Sevierville, Sevier County, Tennessee
ID No. 40-00115

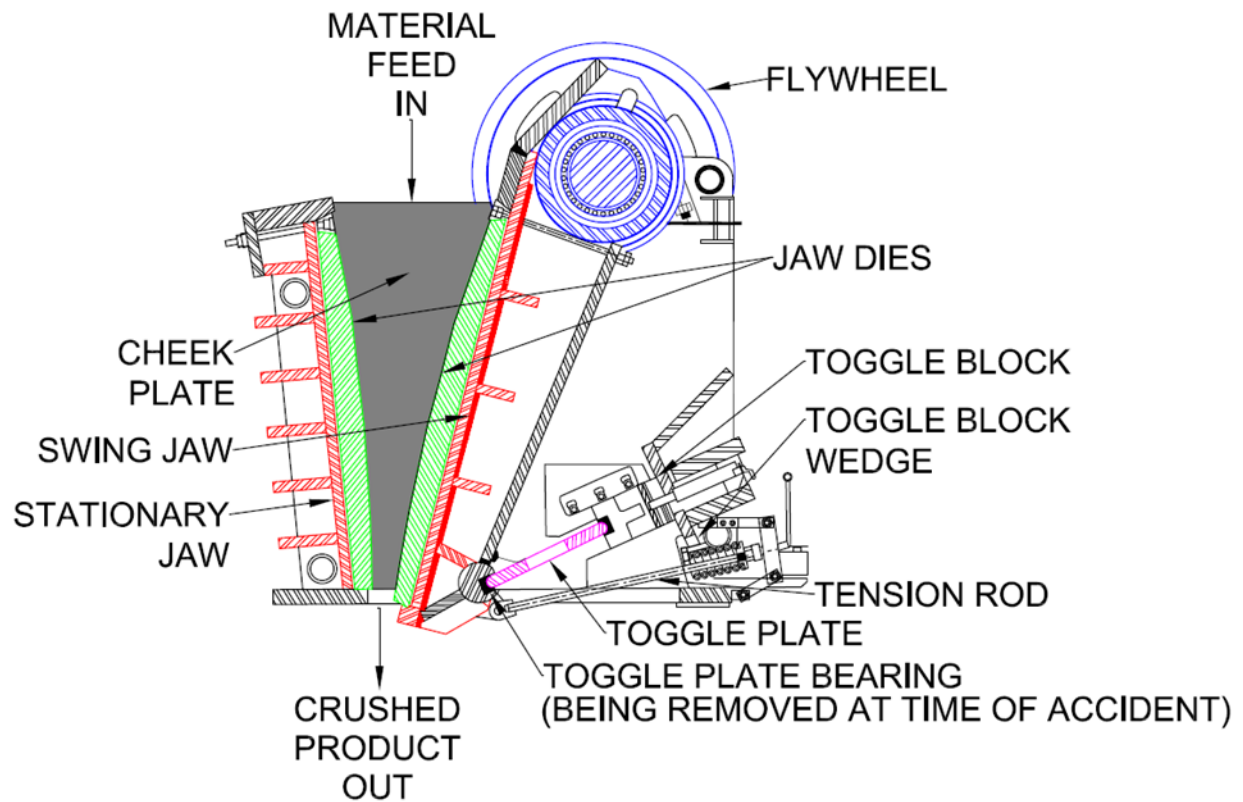
APPENDIX A – Schematic of Crusher (Assembled)

**FULLY ASSEMBLED CRUSHER
PRIOR TO ACCIDENT**

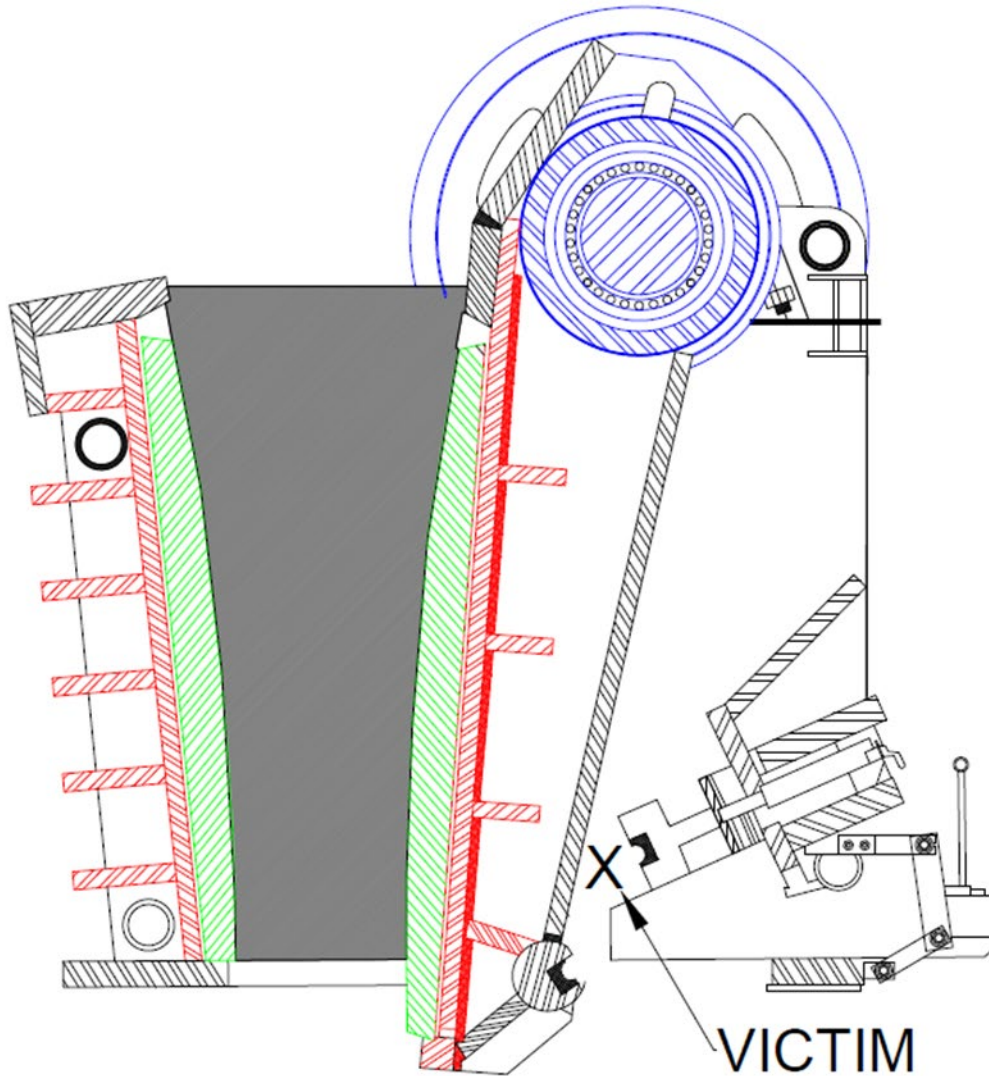
APPENDIX B – Schematic of Crusher (Disassembled)

On January 3, 2023, Rhea assigned Ogle; Lane Carr, Leadman; Brandon Carr, Plant Operator; and Kendall Carr, Plant Fixed Maintenance, to replace worn parts on the crusher (see Appendix A). The crew used a chain hoist attached to the bottom of the swing jaw and crusher frame to pull the swing jaw in the direction of the stationary jaw and block it against hazardous motion. When the swing jaw moved, the swing jaw die contacted the left side cheek plate. According to interviews, B. Carr and K. Carr heard a loud metal on metal popping sound as the two metal plates slid past one another. When the crew finished work for the day, K. Carr slowly released pressure off the chain hoist, allowing the swing jaw to come to rest in a nearly vertical position (see Appendix B). The crew did not notice the swing jaw's motion was impeded due to binding against the left side cheek plate (see Appendix C), and the toggle bearing was wedged in the bottom of the swing jaw.

POSITION OF SWING JAW AT TIME OF ACCIDENT

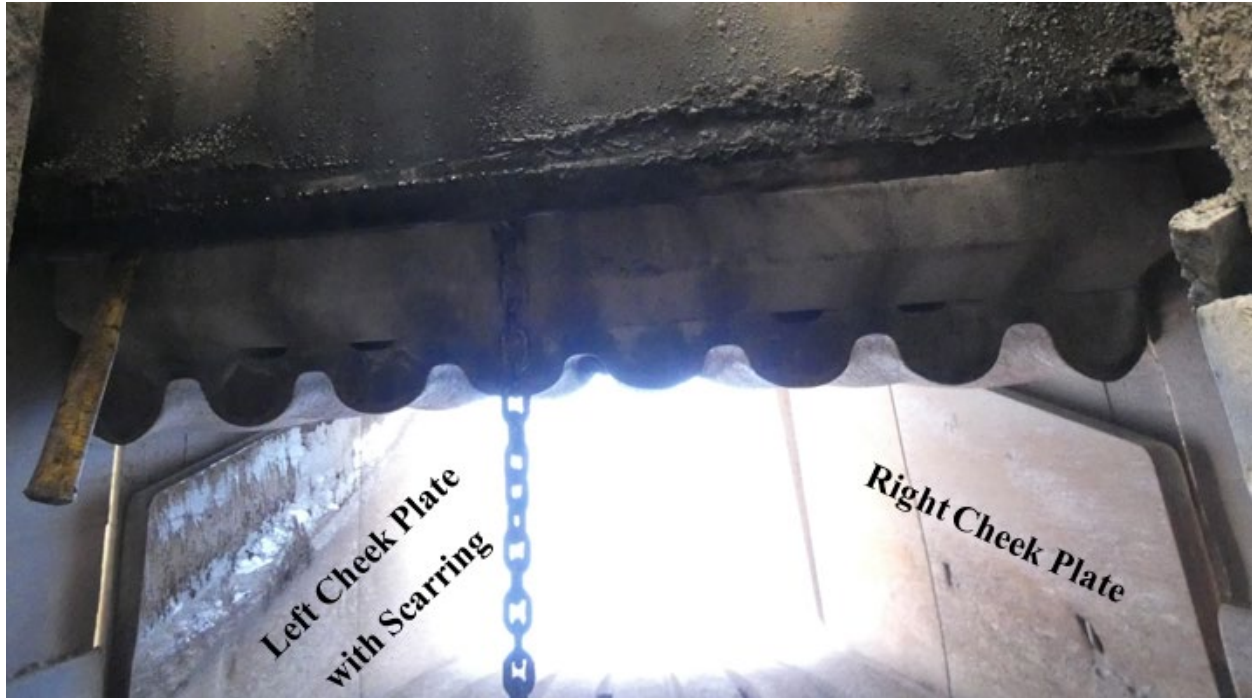
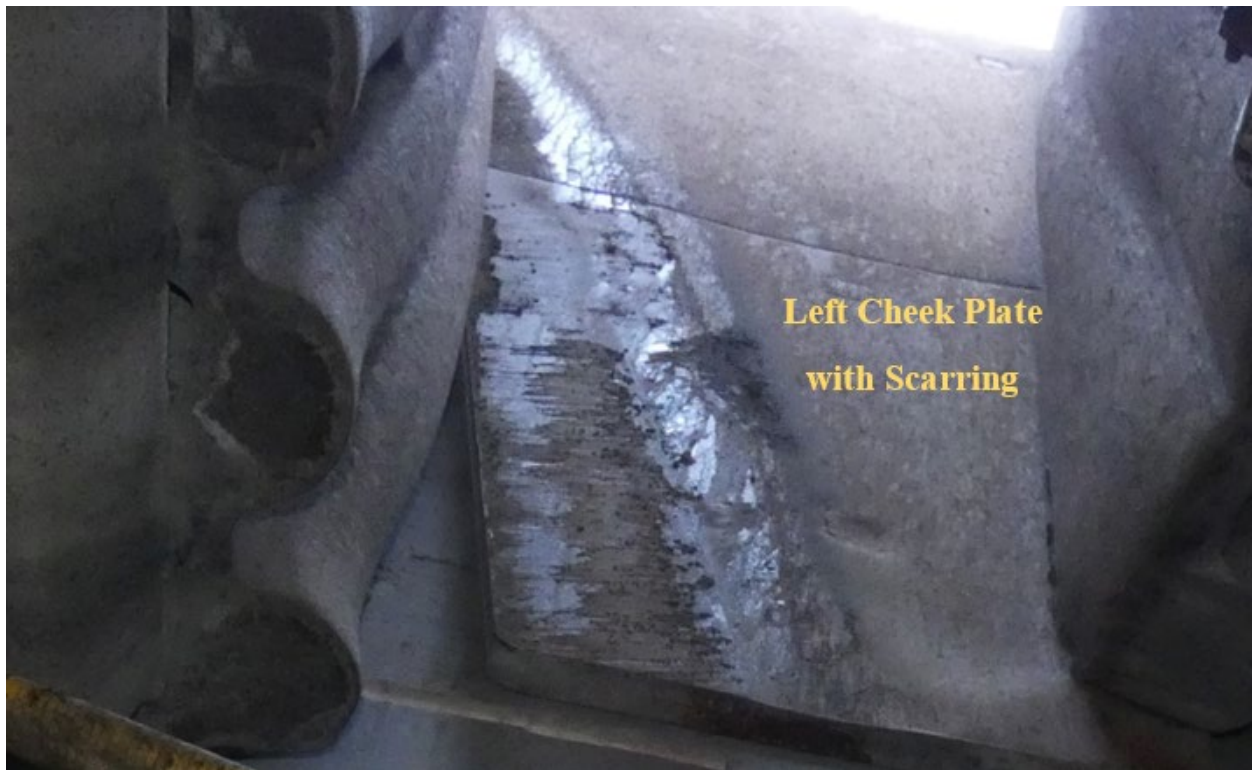
APPENDIX C – Evidence of Swing Jaw Contacting Left Cheek Plate

The crusher is a Hewitt-Robins 42 x 48-inch Grizzly-King Extra Heavy-Duty Jaw Crusher, manufactured in 2000. The crusher has a frame assembly weight of 62,000 pounds and a jaw assembly weight, including flywheels, of 58,000 pounds for a combined weight of 120,000 pounds. The investigators observed scarring on the left side cheek plate created by the swing jaw binding against it.

New task training records for maintenance work on the crusher for B. Carr, L. Carr, and K. Carr were provided by the mine operator, but the actions taken on the day of the accident indicate that the task training was inadequate. The mine operator did not provide adequate task training when changes occurred during the maintenance work that created conditions that affected the safety risks to miners. The changes were the swing jaw binding against the left cheek plate and the toggle bearing that was wedged in the bottom of the swing jaw.

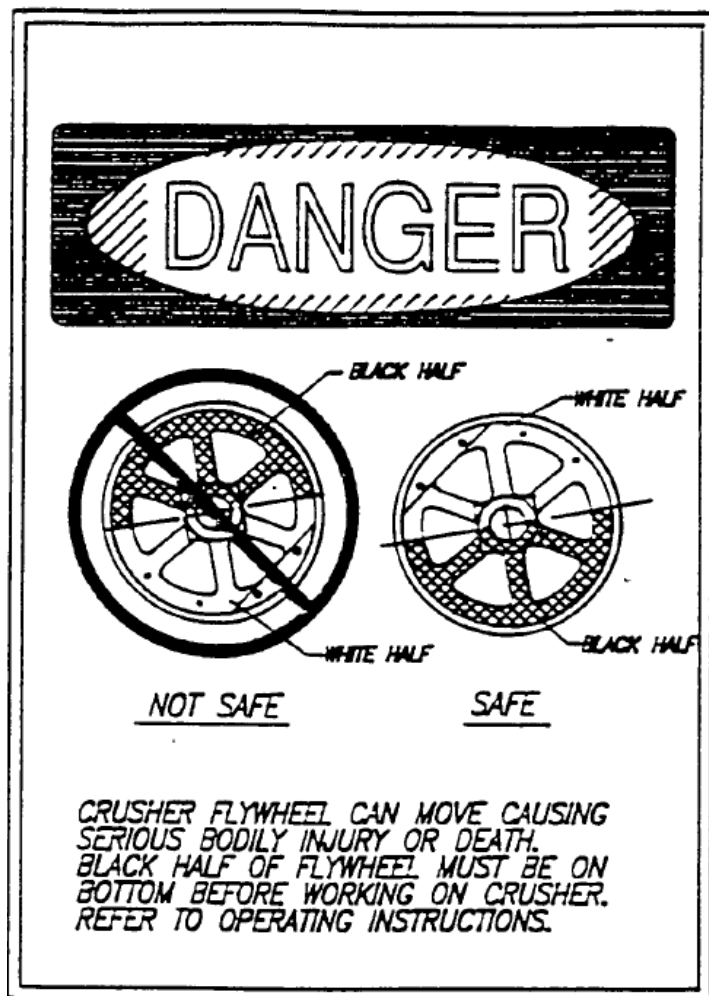
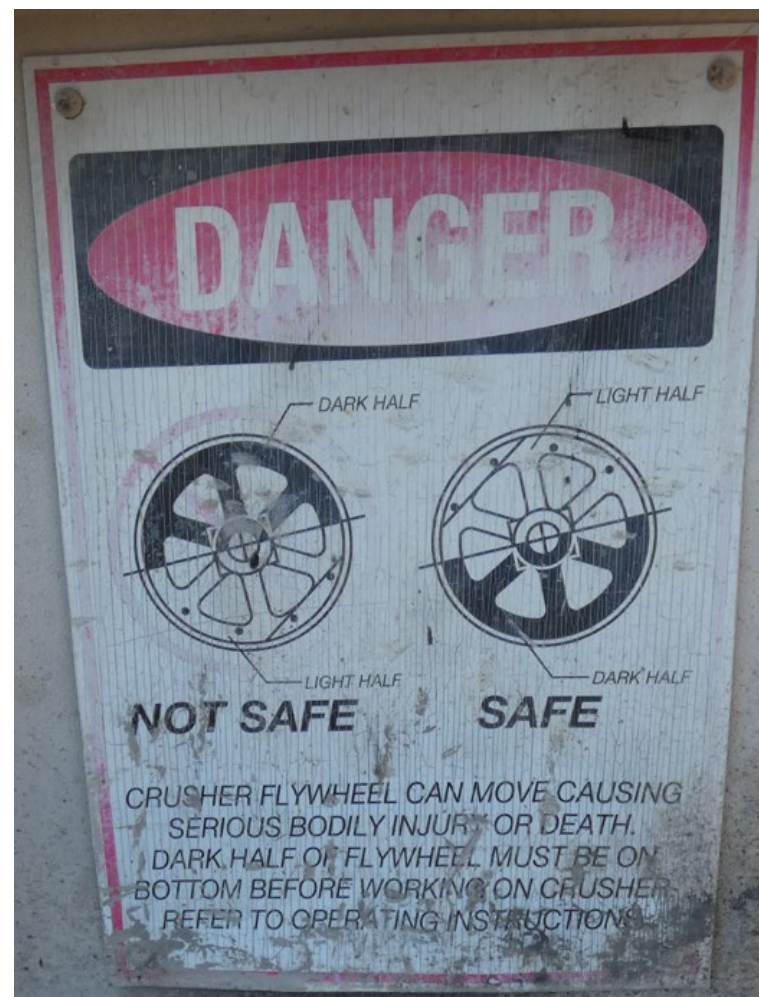
APPENDIX E – Danger Sign

After releasing the chain hoist, L. Carr and K. Carr stated that the crusher was in a stable “safe” position due to the flywheel counterweight on the bottom, as indicated by the black markings on the lower half of the flywheel. The crew was referring to a manufacturer’s danger sign on the side of the crusher that depicts when the crusher chamber was safe or not safe for conducting non-maintenance work on the crusher, such as clearing stuck rocks, without entering the chamber (see Appendix E). The danger sign states, “Crusher flywheel can move causing serious bodily injury or death. The black half of flywheel must be on bottom before working on crusher. Refer to operating instructions.” The manufacturer’s operating instructions explain that in the event the crusher stops or becomes jammed during normal operations, the flywheel must be placed in a stable “safe” position, as depicted by the danger sign. The maintenance crew had not reviewed the operating instructions. They also did not recognize that when the toggle assembly is removed, the lower end of the swing jaw is no longer constrained. The entire swing jaw must be secured from hazardous motion regardless of the flywheel position. L. Carr was present during the maintenance work and allowed miners to position themselves within a confined space and the unblocked swing jaw. The investigators determined that the mine operator did not block moveable parts of the crusher against hazardous motion, which contributed to the accident.

Corrective Action: The mine operator revised and implemented a written procedure for blocking machinery against hazardous motion to comprehensively address stored energy. The mine operator trained all miners on the procedure.
