REPORT OF INVESTIGATION

Fatal Machinery Accident  
July 17, 2023

Holcim – NER, Inc.  
Swampscott Quarry  
Swampscott, Essex County, Massachusetts  
ID No. 19-00020

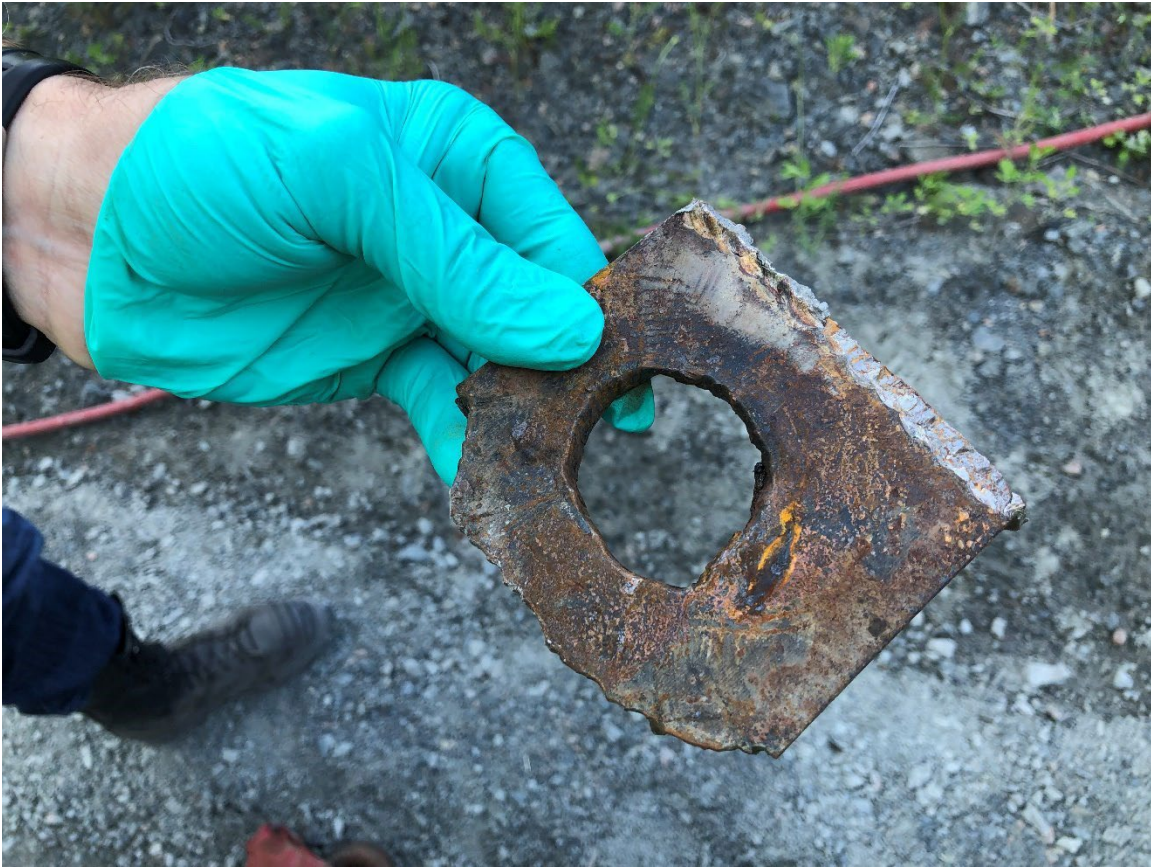
APPENDIX A – Lifting Lug Welded to Narrow Arm Guard No. 3

On July 17, 2023, Matthew Carrier, Second Shift Foreman, and John Kontarasis, First Shift Foreman, were performing repair work on the gyratory crusher which involved the removal and replacement of the arm guards. Carrier welded one 4-inch by 4-inch by ½-inch steel lifting lug on each of the arm guards so they could be lifted with a crane. Miners were going to lift the arm guards to clean and prepare the area before replacing the arm guards. An irregular-shaped hole of approximately 1.75-inch diameter was burned through the center of the lifting lugs so the rigging could be attached (see Appendix A).

To attach the lug to narrow arm guard No. 3, Carrier used a stainless-steel welding rod to make a single-pass weld on each side and across the front of the 4-inch-wide lug. There was no weld along the back 0.5-inch-thick edge because the position of the concave lining plates made it inaccessible. Based on interviews and observation of the weld, investigators determined Carrier used a stainless-steel welding electrode to ensure proper adhesion of the lug to the narrow arm guard.

Industrial Testing Laboratory Services (ITLS) examined the fracture surfaces of the welded connection between the lifting lug and narrow arm guard. ITLS determined that the weld filler was a good match for the narrow arm guard metal. ITLS concluded that the weld size far exceeded what was needed to suspend the 320-pound arm guard.

Based on these measured fracture areas and the strength of the weld metal and base metal, MSHA investigators determined that the welded connection was of sufficient strength to lift the narrow arm guard. Depending on the angle of inclination between the lifting sling and the longitudinal axis of the weld, the connection strength was calculated to vary between 26,000 pounds (longitudinal) and 59,700 pounds (perpendicular).

Based on interviews and testing, investigators determined the narrow arm guard was suspended, but then became caught on the underside of the concave lining plates, or wedged against the crusher, eccentric bushing, and support arm. The force applied by the crane to the rigging was much greater than the weight of the arm guard and rigging. Investigators determined that the crane boom or load line controls were engaged. This caused the arm guard to move and become hung up, allowing the load magnitude to rapidly increase beyond the strength of the weld. Investigators determined that this caused the accident.

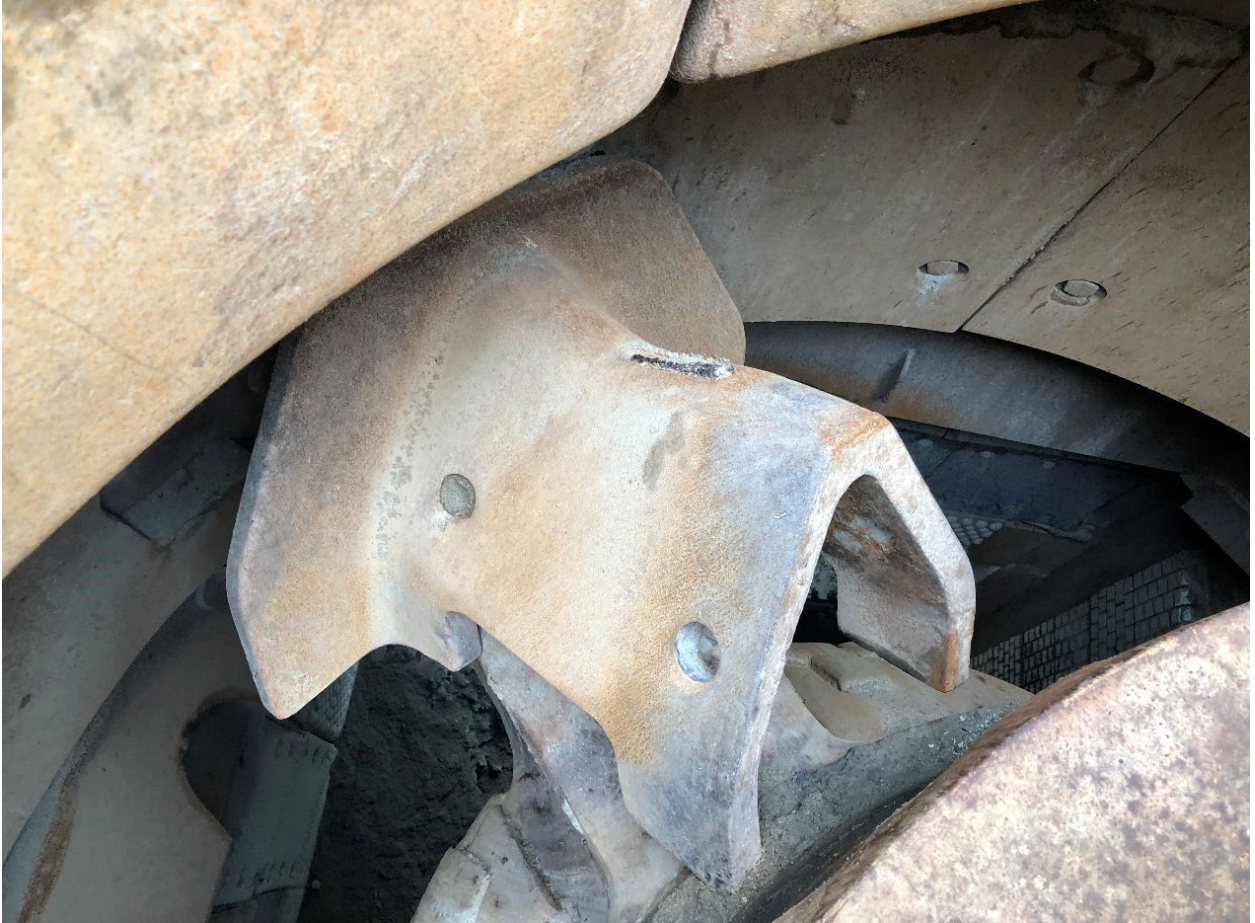
APPENDIX B – Narrow Arm Guard No. 3

The arm guard liners protect two support arms and a pinion shaft arm from rock abrasion and wear during crushing operations. The narrow arm guard liner being lifted at the time of the accident weighed approximately 320 pounds. The clearance between the edge of the work platform and the surface of the concave wear plates lining the crushing chamber above the arm guard was 14.5 inches. Because of the narrow clearance, miners decided to lift the arm guards up and clean under them, rather than completely remove them during cleaning. Hemenway, Kontarasis, and Morency all stated that narrow arm guard No. 3 was lifted and was unrestrained as Kontarasis cleaned beneath it with a compressed air wand and pry bar.
