REPORT OF INVESTIGATION

Fatal Machinery Accident
March 1, 2023

Bizzack Construction LLC (V409)
Lexington, Kentucky

Elkhorn Stone
Mountain Aggregates Inc
Elkhorn City, Pike County, Kentucky
ID No. 15-00213

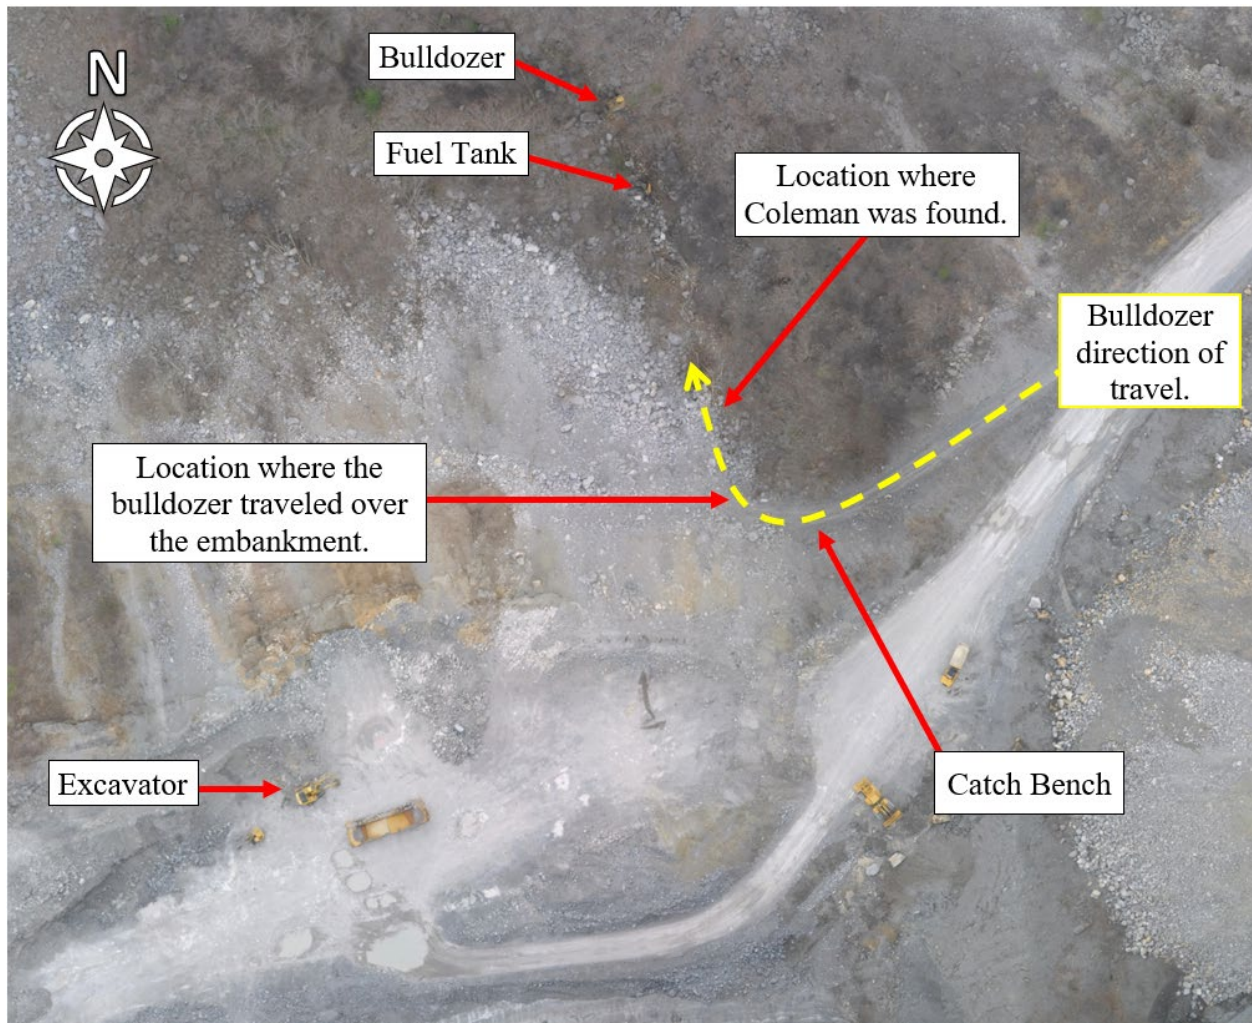
APPENDIX B – Aerial View of Accident Location

The accident occurred on a catch bench that was under construction (see Appendix B). The mine operator barricaded off this area, which was directly below the active pit. The catch bench measured 24 feet wide. Coleman trammed the bulldozer approximately 295 feet down the catch bench where the bulldozer traveled over the embankment (see Appendix C).

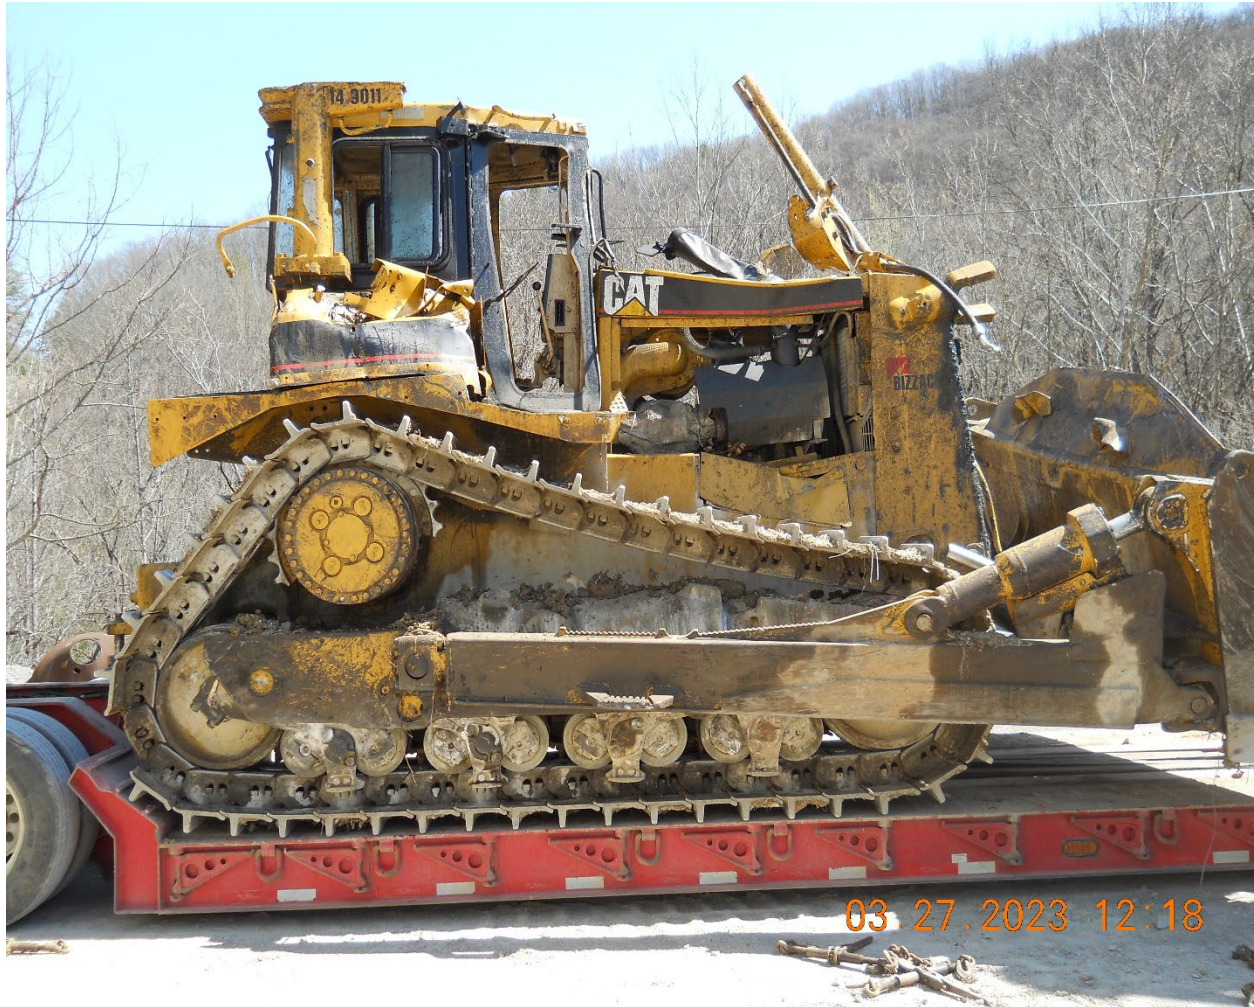
APPENDIX D – Photograph of the Equipment Involved

The bulldozer involved in the accident was a 1998 Caterpillar D8R track-type bulldozer with a Rollover Protective Structure (ROPS) and an enclosed operator's compartment (see Appendix

D). Mark Kvitkovich and Davin Sweeney, Mechanical Engineers from MSHA Technical Support, examined and tested the bulldozer at the mine. As a result of the accident, the bulldozer sustained significant damage to the doors, rear window glass, steering and implement circuit, undercarriage, and fuel and hydraulic tanks. The damage prevented Kvitkovich and Sweeney from testing the steering and implement circuits. The bulldozer operator's compartment and ROPS were intact. The ROPS sustained visible denting; however, there was no damage to the inside of the operator's compartment. Mechanical and hydraulic examinations of the braking system revealed that it was fully functioning. All in-cab controls moved freely without binding and produced the intended movement to their associated linkages and valves. Investigators found the seat belt in the unlatched position. Inspection of the seat belt did not reveal any defects and the seat belt restraint system functioned as intended. Investigators did not identify any mechanical or hydraulic defects that contributed to the accident.
