REPORT OF INVESTIGATION

Surface  
(Crushed and Broken Limestone)

Fatal Machinery Accident  
March 15, 2023

Fort Pierce Mine  
Florida Rock Industries Inc  
Port Saint Lucie, Saint Lucie County, Florida  
ID No. 08-00899

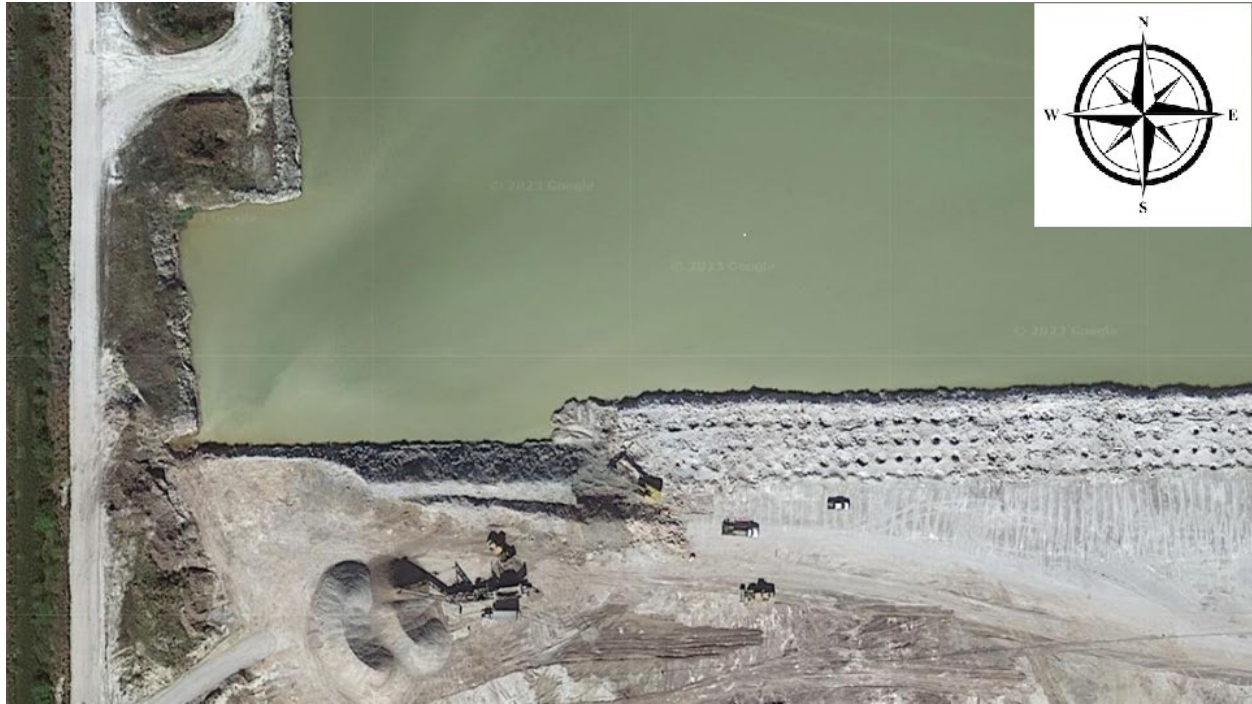
## APPENDIX B – Aerial View of Mine

The accident occurred in the south quarry pit area at the edge of the water (see Appendix B). Wright was operating the excavator on top of previously blasted, unconsolidated material on the water's edge. Wright had the excavator positioned at an approximate, 45-degree angle to the bank as had been company policy since a previous incident at the site involving sloughing material at the edge.

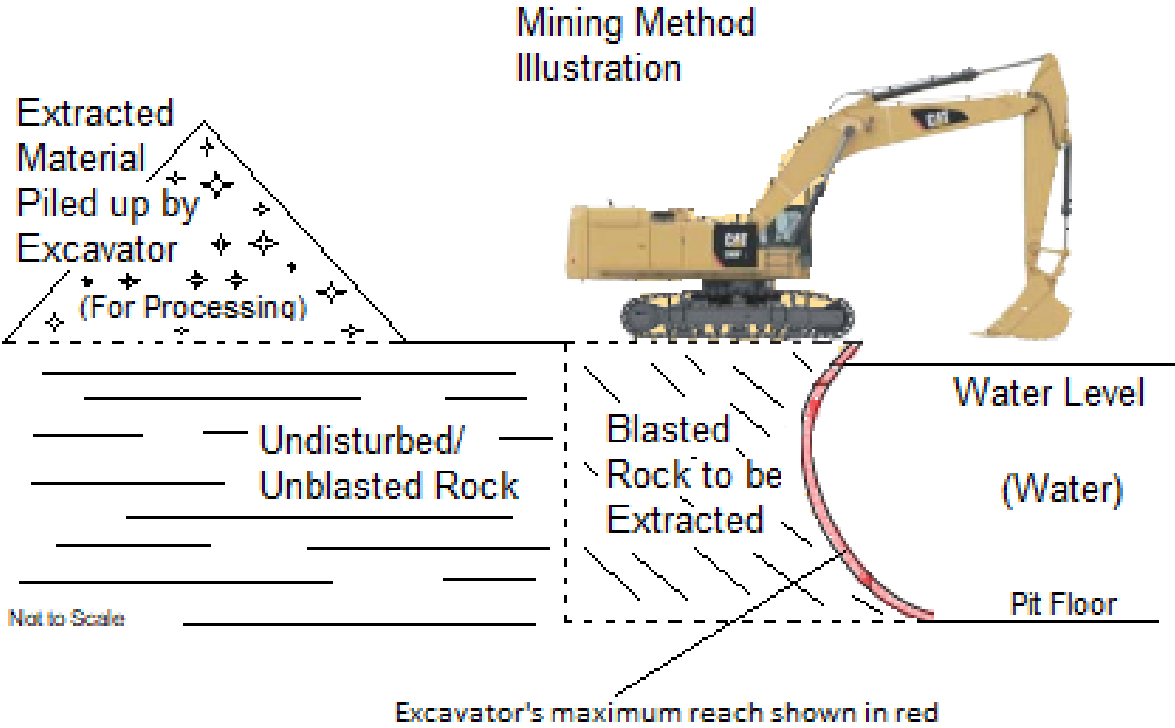
APPENDIX C – Mining Method Illustration

The mining at the Fort Pierce Mine is done by drilling, and blasting adjacent to the water-filled pit. The last blasting event before the accident occurred on February 28, 2023. The blasting fractures over 24 feet of rock, approximately three feet of which remains above the water's surface. The excavator is operated on top the loose blasted material to extract it from the water. The excavator operator mines material to a depth of 24 feet, which is the bottom of the preferred ore body. According to interviews, the excavator does not reach the bottom of the pit floor but extracts as much material as it can reach. The visibility through the water in the pit is extremely low and the excavator operator cannot see the material below the water's surface to observe the conditions of the pit bank beneath the excavator (see Appendix C).

This general mining method was consistent at the mine, including at the time of an incident approximately a year ago, when too much material was removed from the pit bank. This caused the pit bank to slough, and the excavator to fall into the water. The mine operator had to remove the excavator from the water. The mining method did not ensure the material the excavator operated on top of was stable. This previous event should have been sufficient to put the mine operator on notice of the potential ground failure because of the mining method used; however, the mine operator did not implement adequate changes to prevent a recurrence. Investigators determined this contributed to the accident.

Corrective Action: The mine operator has developed and implemented new policies and procedures, and has changed their mining methods by replacing the excavator with a dragline which places the miner back from the hazard of the edge of the pit. The mine operator has trained all miners on the new policies and procedures.

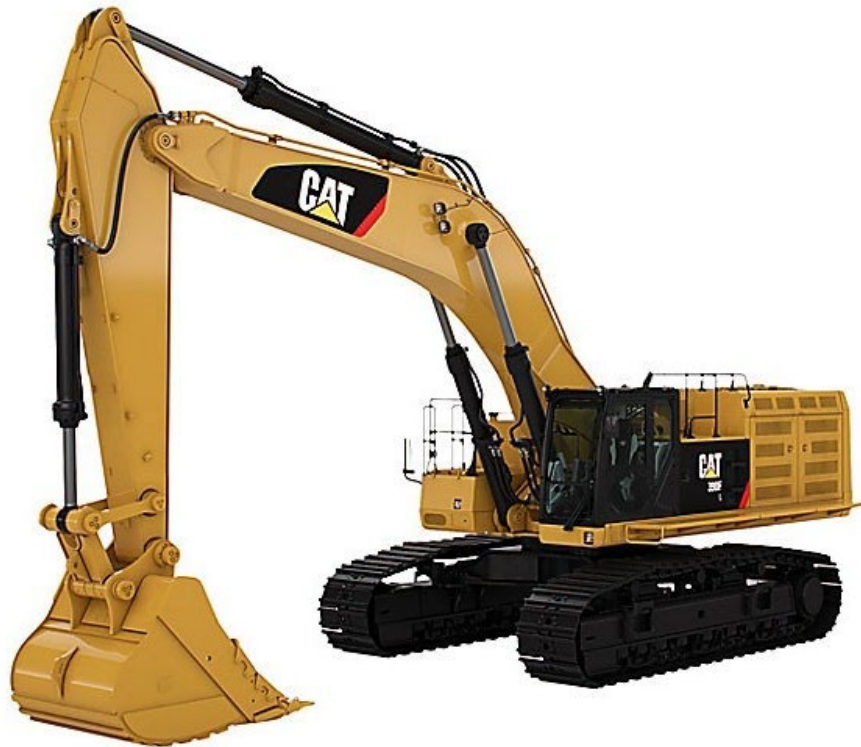
APPENDIX D – Caterpillar Model 390F L Hydraulic Excavator

The excavator involved in the accident was a 2017 Caterpillar Model 390F L Hydraulic Excavator (see Appendix D). As of the date of this report, the excavator remains in the water-filled pit and is not able to be viewed or physically inspected. From the statements provided by the divers, the excavator is lying on its side with the door of the cab on the downward side of the machine. This could not be visually confirmed as the water is very murky, providing less than 1 foot of visibility. According to interviews of the mine operator and miners, the excavator was equipped with a functional seat belt and a window breaking device. Wright also wore a CO2-inflated flotation device around his waist. When Wright was recovered from the excavator, the device was still around his waist and not inflated. Investigators were unable to determine if any safety defects existed that may have contributed to the accident.

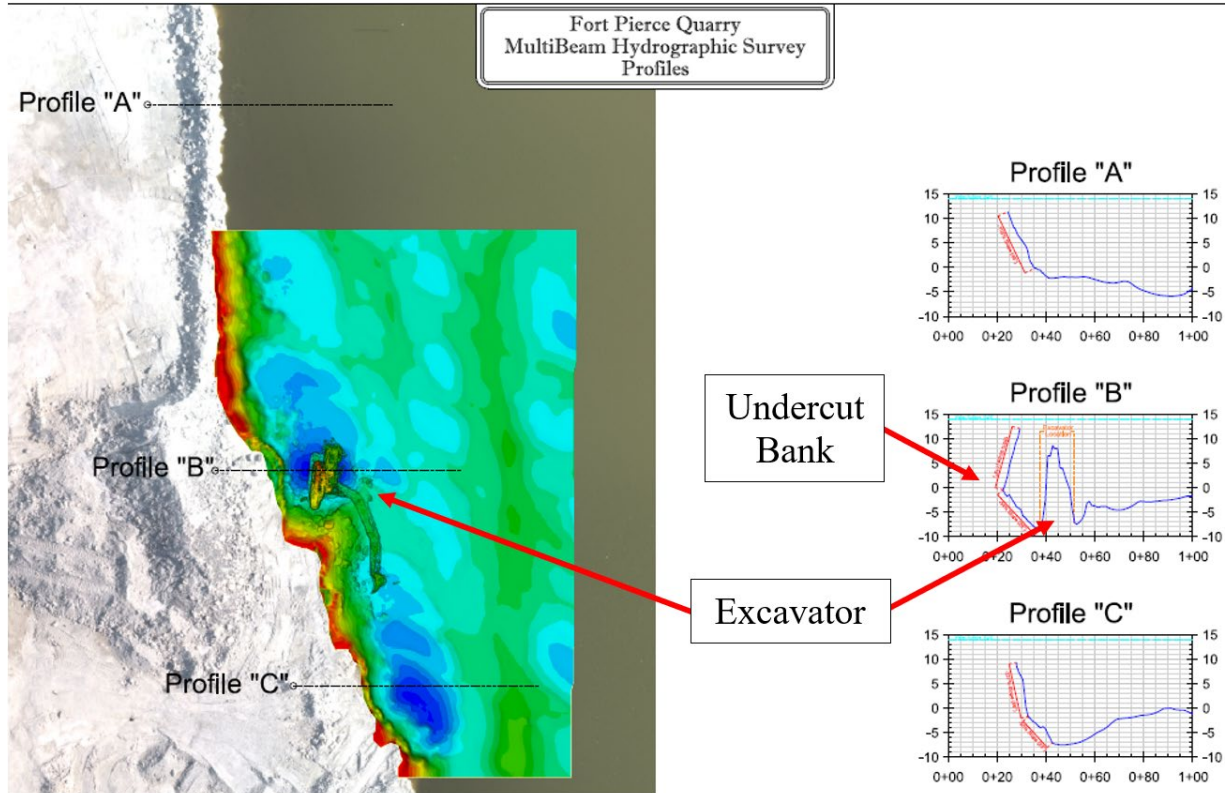
## APPENDIX E – MultiBeam Hydrographic Survey

Wakelee conducted a workplace examination and ground condition examination in the south quarry area on the day of the accident at approximately 6:30 a.m. Wakelee did not report any adverse safety conditions. According to a MultiBeam Hydrographic Survey taken during the investigation, the bank where Wright was operating the excavator was undercut at some point during Wright's shift (see Appendix E). An adequate ground condition examination as the conditions changed during the shift would have identified the undercut bank that created the unstable ground. Investigators determined that the mine operator did not examine, and where applicable test, ground conditions as warranted during the work shift, which contributed to the accident.

Corrective Action: The mine operator's new mining method reduces exposure to hazardous ground conditions at the edge of the bank while draglines excavate material. The mine operator developed and implemented a new written procedure for conducting ground condition examinations as conditions warrant for the new mining method. The mine operator trained all miners on the new procedure.
