REPORT OF INVESTIGATION

Fatal Fall of Roof Accident  
March 18, 2023

Mine No. 1  
Hamilton County Coal, LLC  
Dahlgren, Hamilton County, Illinois  
ID No. 11-03203

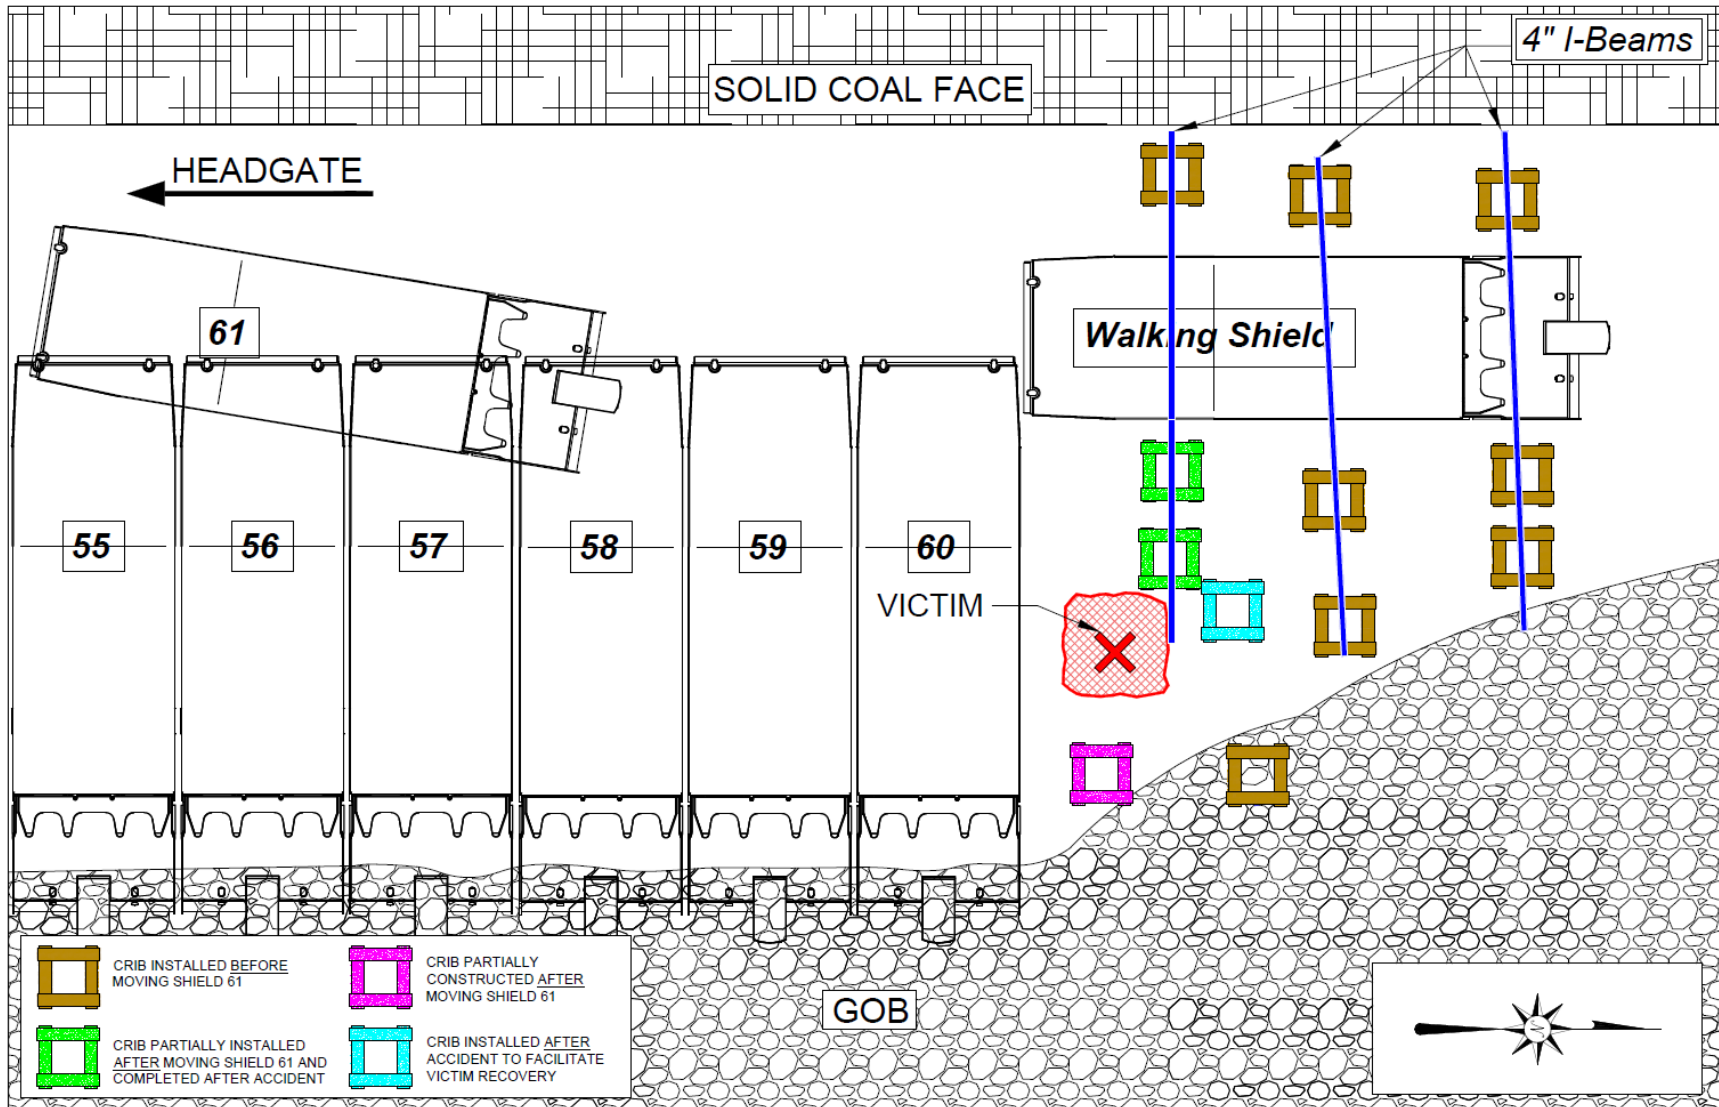
# APPENDIX B – Drawing of Accident Scene

The accident occurred at crosscut ten of the headgate entries, on the 6 Right District 3 Panel 10 teardown face of the longwall (see Appendix B). Miners were working adjacent to shield 60, between the walking shield, and the gob. The hole in the roof mesh was located where shield 61 had been located (see Appendix C). The rock fall was located approximately 21 feet from the face, three and a half feet from shield 60, and nine feet from the walking shield.

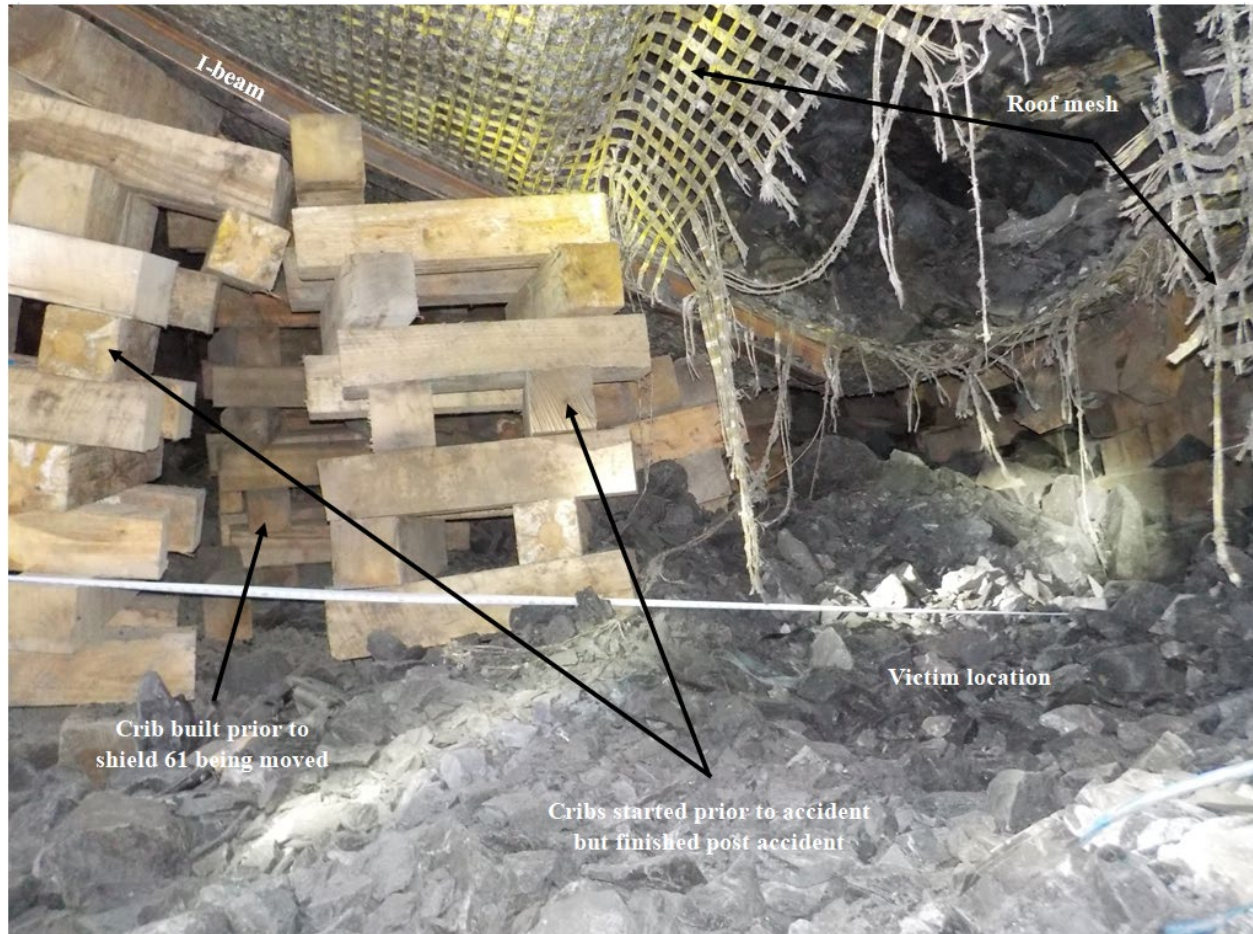
## APPENDIX C – Photo of Accident Scene

The rock that fell through the mesh created a void in the mine roof that was measured to be approximately four feet in diameter and four feet high. Investigators calculated the fallen rock to weigh approximately five tons.

Huesker Minegrid 400/300 – 3/4S roof mesh was installed to cover the mine roof prior to the accident occurring to prevent rock intrusion. The mesh has a minimum ultimate tensile strength of 23,365 pound/foot, which exceeded the requirements of the Roof Control Plan. The hole in the roof mesh was near the end of an I-beam that had been pressed against the mine roof by shield 61 prior to the removal of that shield. Miners stated the roof mesh can be damaged when installing the I-beam.
