UNITED STATES  
DEPARTMENT OF LABOR  
MINE SAFETY AND HEALTH ADMINISTRATION

REPORT OF INVESTIGATION

Fatal Powered Haulage Accident  
March 22, 2023

Longview Mine  
Century Mining LLC  
Volga, Barbour County, West Virginia  
ID No. 46-09447

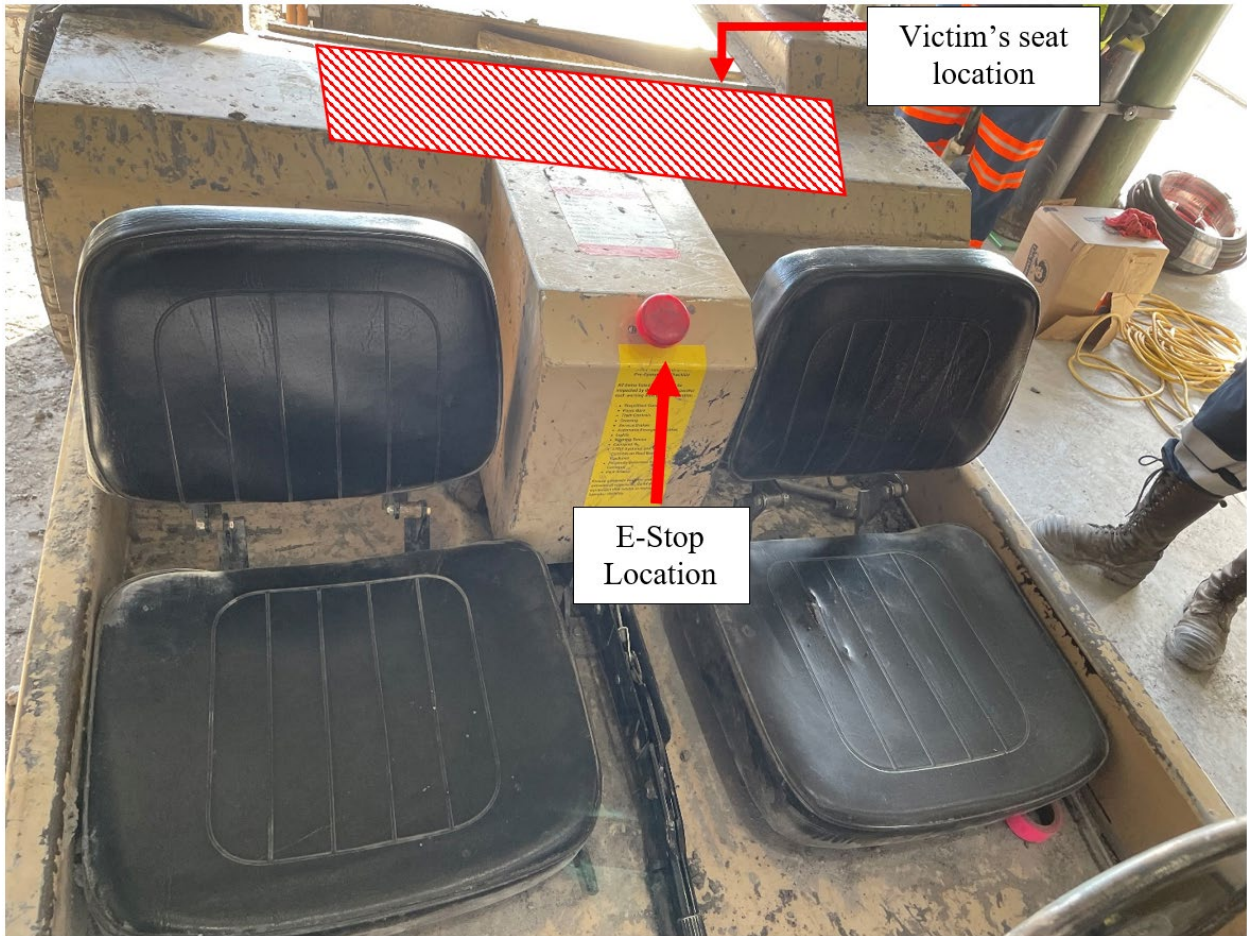
APPENDIX B – Stryker Seating Arrangement

According to interviews, Allen continued to drive the Stryker outby and started up a grade. See Appendix A for a map of the accident scene. At approximately 15½-block, Elkins accidentally depressed the emergency stop button (E-stop) located between the seats on the center console (see Appendix B). The E-stop shut the power off to the Stryker, which came to a stop and began drifting backwards downhill. Elkins pulled the E-stop button back out, restoring power to the Stryker. The lights came back on, but the tram control, including the regenerative braking did not work. Allen applied the foot brake and the hand activated parking brake but neither functioned. The Stryker began to pick up speed and Allen attempted to keep it in the center of the entry as it rolled backwards so the Stryker would not contact the entry ribs and overturn. The Stryker travelled approximately 210 feet and entered the 17-block intersection and veered toward the passenger side rib.

Investigators examined the Stryker at the accident scene and found the main power switch in the “on” position, the tram switch in the “forward” position, and the light switch in the “front” position. Additionally, the E-stop button was depressed, and the parking brake was not engaged. James Paynter, Mine Maintenance Chief, stated during the investigation that the E-stop was depressed, and the batteries were unplugged after the accident to prevent the batteries from catching on fire.

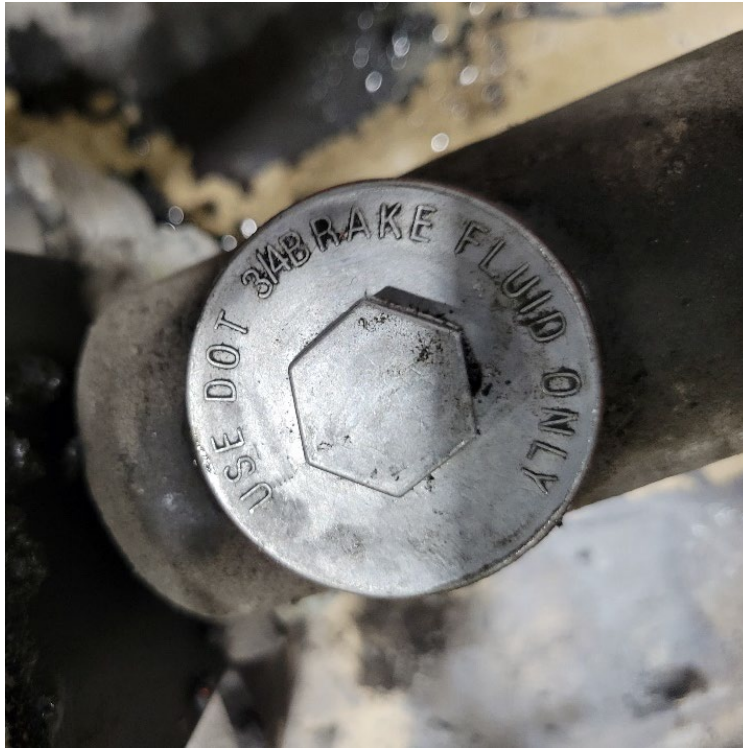
APPENDIX D – Brake Master Cylinders

The service brake is activated through a foot brake master cylinder that pushes hydraulic oil to the brake packs. The investigators applied the service brake foot pedal and manually rotated the rear wheel. The application of the service brake foot pedal did not create any hydraulic pressure and did not prevent the rear wheels from rotating. Additionally, when the service brake foot pedal was released, there was no pressure that returned it to the fully released position as designed. Maintenance records obtained during the investigation show the foot brake master cylinder was replaced on January 17, 2023. The master cylinder that was replaced on the Stryker was not the designed master cylinder for the wet brake system. The wet brake system was designed to work with a foot brake master cylinder compatible with mineral based hydraulic oil. The replacement master cylinder is designed to operate with DOT 3/4 brake fluid according to the reservoir cap (see Appendix D).

MSHA Technical Support's lab analysis determined that mineral based hydraulic oil was inside of the recently installed master cylinder reservoir at the time of the accident. The piston spring cup inside the brake master cylinder was found to be damaged when inspecting the internal components (see Appendix E). An analysis conducted by the RJ Lee Group, an independent laboratory contracted by Technical Support, determined the piston spring cup to be made of Ethylene-Propylene (EP), which is not compatible with mineral based hydraulic oil. The mineral based hydraulic oil inside the brake master cylinder caused the piston spring cup to swell and eventually fail over time. This failure of the piston spring cup would not allow the brake master cylinder to build pressure to engage the service brake. Investigators determined this condition contributed to the accident but were unable to determine how long the condition existed.

1. The brake master cylinder recently installed on the personnel carrier was filled with mineral based hydraulic oil. The installed master cylinder is only compatible with DOT 3/4 brake fluid. The mineral based hydraulic oil deteriorated the internal components of the master cylinder rendering it defective and preventing the foot brake from activating the wet brake system.
2. The manually activated parking brake was out of adjustment and did not operate when activated.

*Figure 1: Brake Master Cylinder on Stryker at the time of the accident*

Corrective Action: The mine operator examined all personnel carriers to ensure they were maintained properly, particularly the braking systems. The mine operator also conducted task training with all miners on the pre-operational examinations of all personnel carriers in the mine. This training included procedures for removing equipment from service when identifying safety defects. The mine operator also installed a second independent front brake system and brass tags that identify the type of oil required for each master cylinder on all rubber-tired personnel carriers in the mine and trained miners on the proper oil required for each master cylinder.

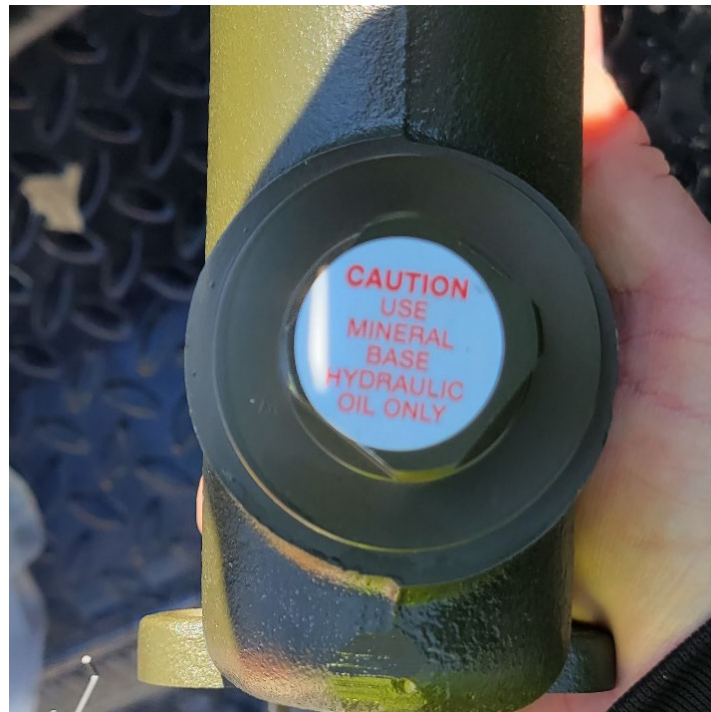
*Figure 2: Brake Master Cylinder designed for Stryker service brake system*
