REPORT OF INVESTIGATION

Surface
(Limestone)

Fatal Powered Haulage Accident
March 9, 2023

Plant & Quarry
Texas Lime Company
Cleburne, Johnson County, Texas
ID No. 41-00072

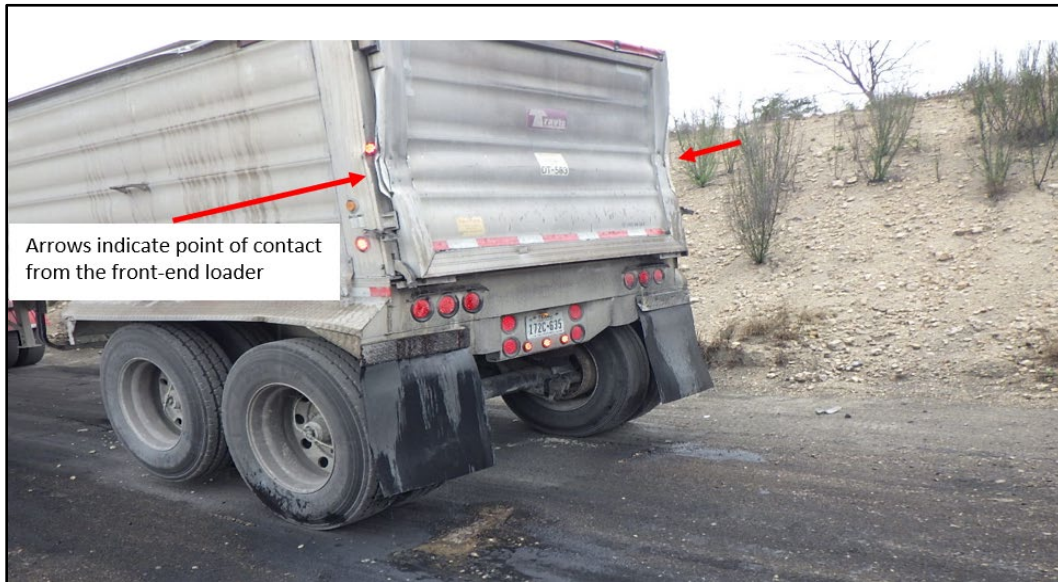
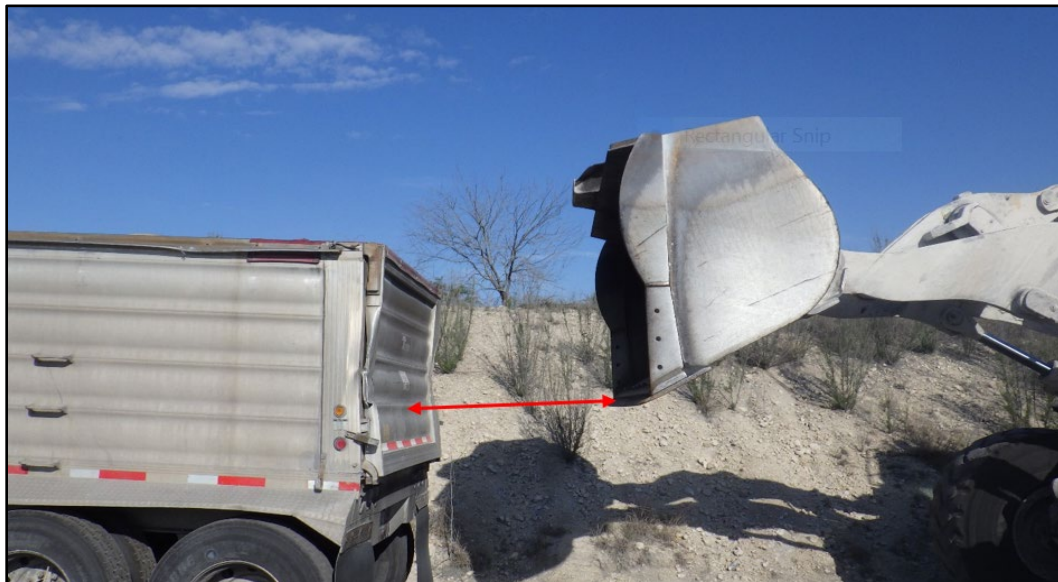
APPENDIX B – Staged Photos Indicating Impact Point to Trailer

The front-end loader was a 2019 Komatsu WA480-8. Investigators examined the front-end loader and did not find any defects that contributed to the accident. According to interviews, Turner was operating the front-end loader with the bucket raised so that it restricted visibility while the front-end loader was in motion. The operator's manual states, "When driving the machine or performing operations, always keep a safe distance from people, structures, or other machines to avoid coming into contact with them." Additionally, it states to keep the bottom of the bucket 16 to 20 inches above the ground when traveling on level ground. A warning label on the front-end loader states, "Improper operation can cause serious injury or death. Read manual and labels before operation." Turner could not maintain line of sight with the bucket raised to the height of the operator's cab, which is greater than 20 inches above the ground. The mine operator did not ensure Turner maintained control of the front-end loader, which contributed to the accident.

Root Cause: The mine operator did not ensure that the front-end loader operator maintained control of the front-end loader.

Corrective Action: The mine operator retrained all mobile equipment operators on maintaining line of sight while operating equipment.
