REPORT OF INVESTIGATION

Fatal Handling Material Accident  
November 17, 2023

Eden Facility  
Eden Stone Co., LLC  
Eden, Fond Du Lac County, Wisconsin  
ID No. 47-00044

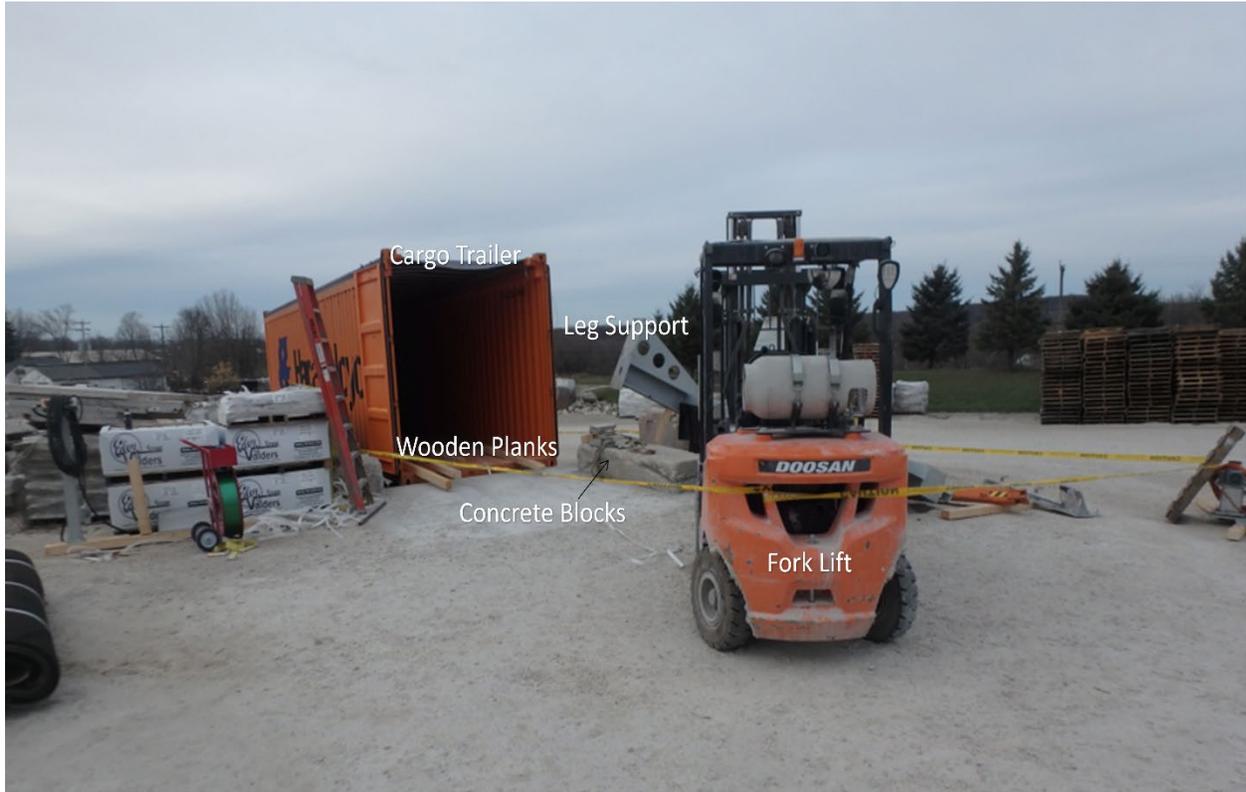
APPENDIX B – Loading Dock at Splitter Shop

The accident occurred at the loading dock at the Splitter Shop (see Appendix B).

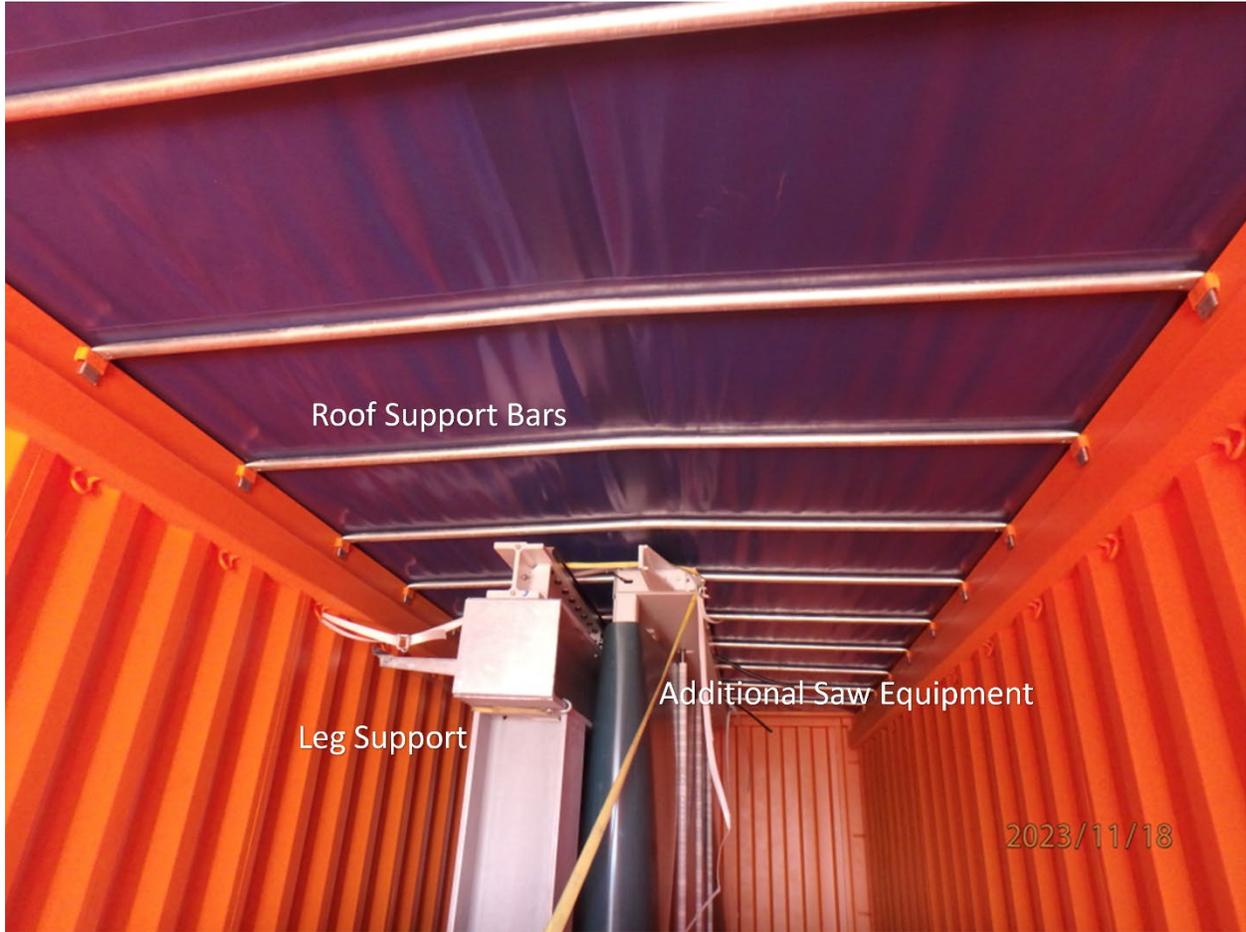
APPENDIX C – Canvas Top of Cargo Trailer

The cargo trailer had a canvas top with support bars running across its width. The canvas top allowed for the removal of the cargo trailer's contents from the top using a crane (see Appendix C). There was no crane on-site at the time of the accident.

According to interviews with the crew involved in unloading the cargo trailer, this was the first time that the mine received a delivery of large equipment in a cargo trailer. Therefore, they had never unloaded equipment delivered in this manner. Normally, the mine received equipment deliveries on a flatbed trailer and miners unloaded them using a forklift. The mine operator did not provide new task training for unloading the leg support structures from a nontypical delivery method. Investigators determined that this contributed to the accident. The safe way to unload this delivery would have been to use a crane.

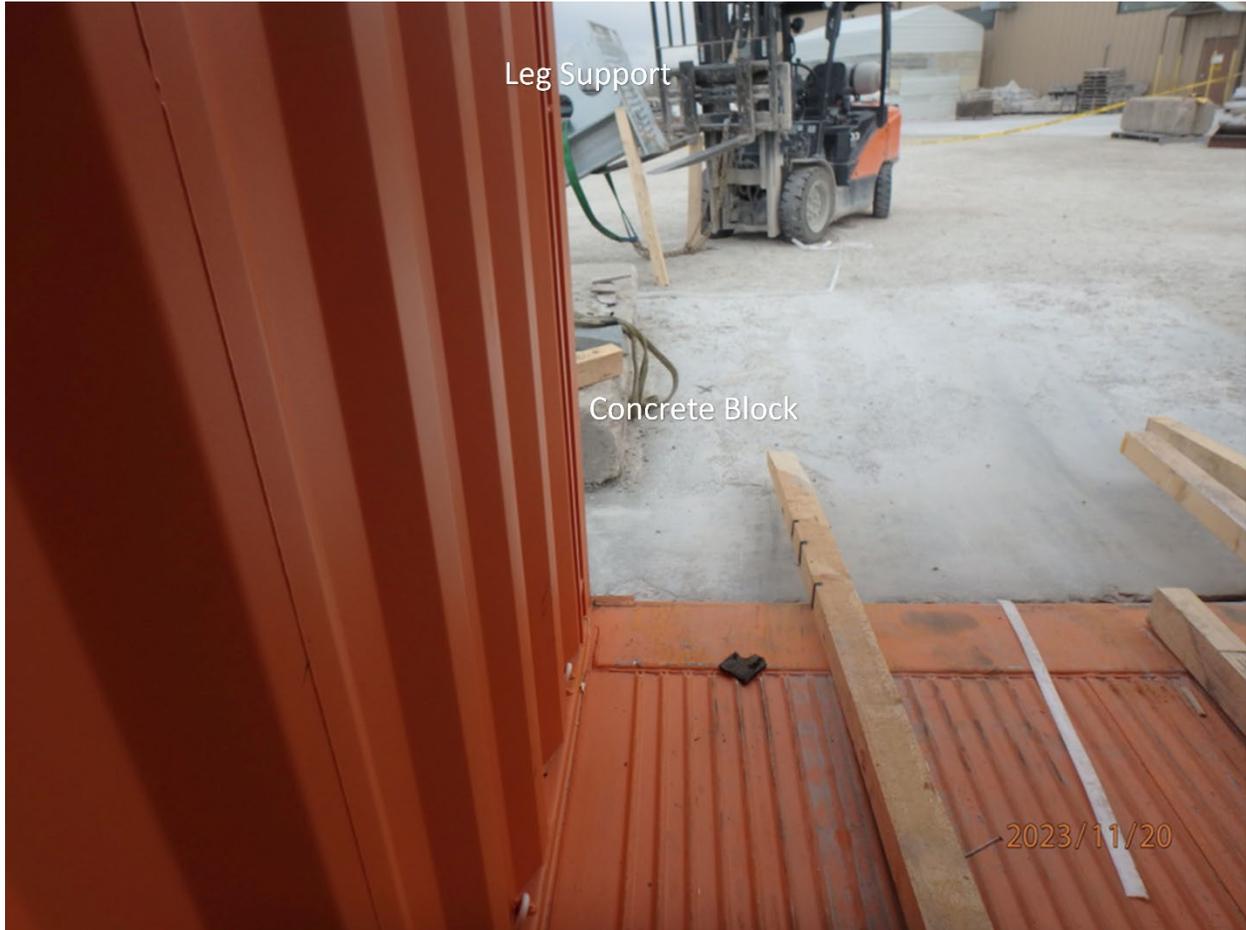
APPENDIX D – Concrete Block at Loading Dock in the Way of the Leg Support

There was a concrete block on the north side of the loading dock. To avoid hitting the block, M. Hernandez continued to pull the leg support structure out of the cargo trailer at an angle instead of straight (see Appendix D). Montes, Freund, and Cepeda were in the fall zone (fall radius) of the leg support as M. Hernandez pulled it out with a forklift. There was nothing to support the leg support structure from falling as it came out of the cargo trailer. The mine operator did not ensure that the leg support structure was unloaded in a manner that did not create a hazard to miners from falling or shifting. Investigators determined this contributed to the accident.
