UNITED STATES  
DEPARTMENT OF LABOR  
MINE SAFETY AND HEALTH ADMINISTRATION

REPORT OF INVESTIGATION

Fatal Powered Haulage Accident  
October 2, 2023

Maple Springs Mine  
LCT Energy, LP  
Hollsopple, Somerset County, Pennsylvania  
ID No. 36-09973

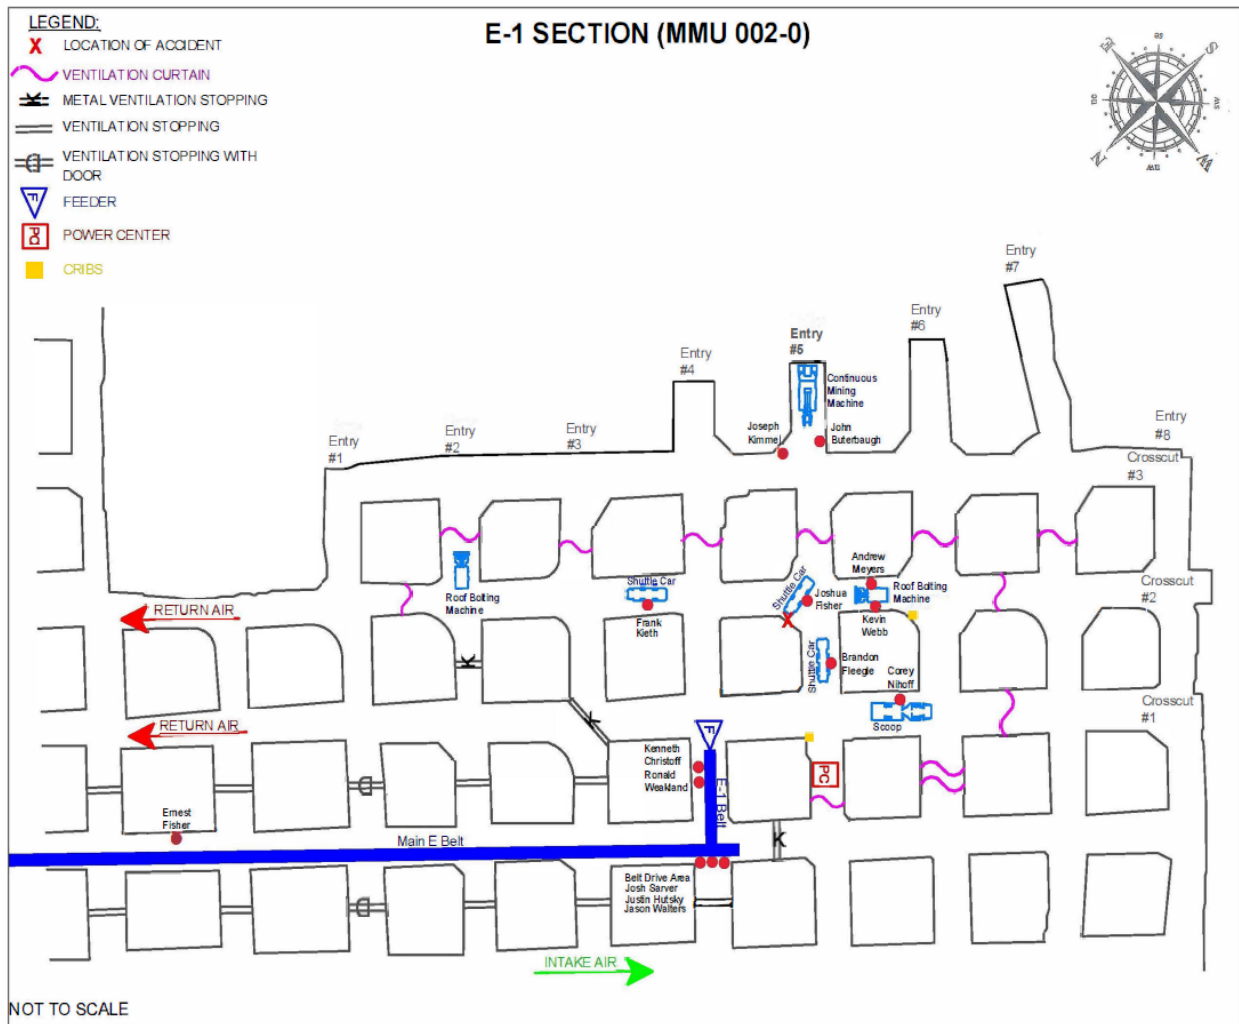
# APPENDIX A – Map of E-1 Section

The accident occurred in the E-1 Section, in the No. 5 entry, approximately 140 feet outby from the working face, on the outby corner of the second outby No. 4 to 5 crosscut (see Appendices B and C). The mine operator mines entries approximately 18 feet wide and four feet high. The area was dry and rock dusted.

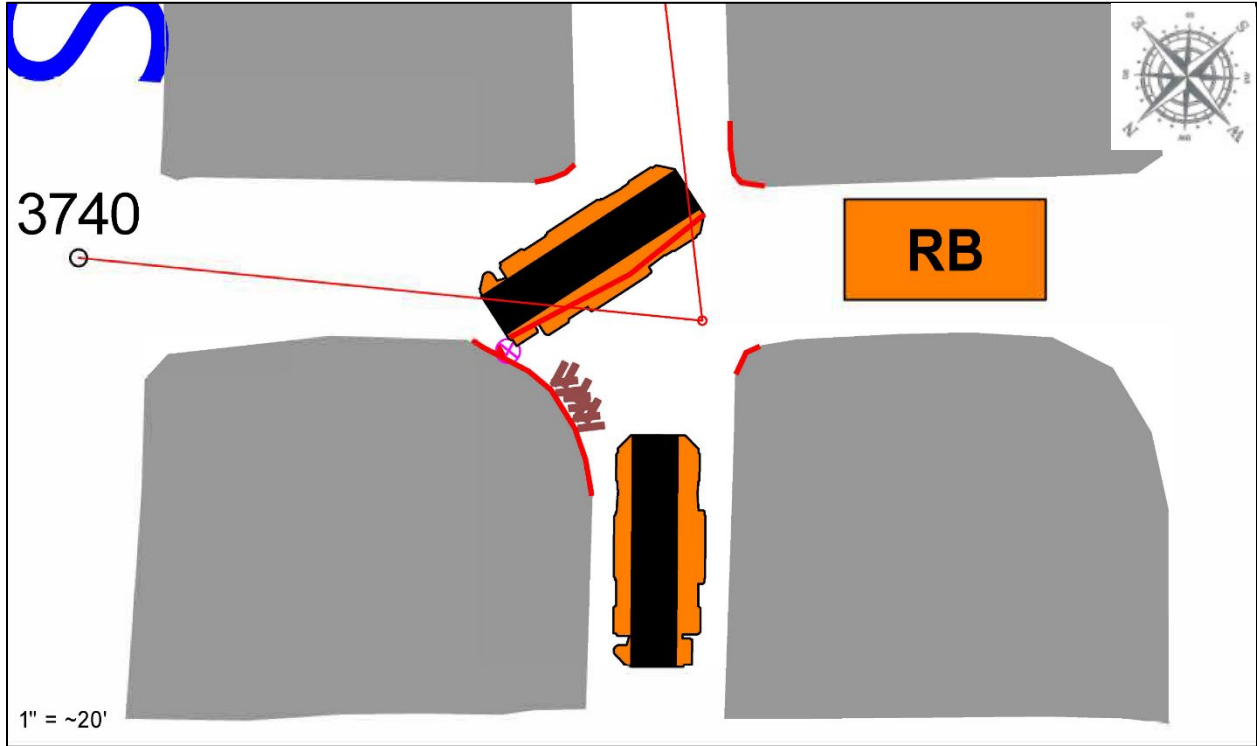
APPENDIX C – Map of the Accident Scene

Frederick, Nihoff, and Webb unloaded the crib blocks along the coal rib adjacent to the outby corner of the No. 4 to 5 crosscut intersection, the second open crosscut outby the face. Once they unloaded the wooden crib blocks, Webb traveled to the roof bolting machine located in the second outby No. 5 to 6 crosscut. Nihoff drove the scoop outby and waited on the shuttle cars to leave the area so the cribs could be built. Frederick stayed near the outby corner of the No. 4 to 5 crosscut in the No. 5 entry. Frank Keith, Shuttle Car Operator, positioned his shuttle car in the second outby No. 3 to 4 crosscut at the intersection of the No. 4 entry. Fleegeer finished unloading and positioned his shuttle car in the No. 5 entry, just outby the second crosscut from the working face. Based on interviews, neither Keith nor Fleegeer saw Frederick still standing on the outby corner of the second outby No. 4 to 5 crosscut in the No. 5 entry.

shuttle car to the feeder. The operator's cab was on the left side facing the dumping end of the shuttle car. When Fisher approached the back check curtain in the No. 5 entry, he sounded his audible warning device. Fisher then proceeded through the back check curtain and turned right from the No. 5 entry into the second outby No. 4 to 5 crosscut. While turning to the right, Fisher struck the outby coal rib in the intersection with his shuttle car. The canopy and the coal on the shuttle car obstructed Fisher's ability to see across the dumping end of the shuttle car. When Fisher struck the coal rib, he saw a light and realized his shuttle car contacted Frederick. Fisher then backed his shuttle car up approximately three feet, exited the shuttle car, and called for Buterbaugh, who is an emergency medical technician. Webb, upon hearing Fisher, traveled from the roof bolting machine in the second outby No. 5 to 6 crosscut to notify Buterbaugh. Buterbaugh stopped the CMM and traveled with Webb to the location of the accident.

The shuttle car involved in the accident was a Highland Machine Shuttle Car Model 10/21KLA264. Investigators tested and determined the brakes, steering, and sounding device were all functioning properly. The load of coal on the shuttle car obstructed the shuttle car operator's view of the off-operator side of the machine at the time of the accident.

**Corrective Action:** The mine operator developed written procedures to prevent a reoccurrence. The procedures are as follows:

1. A sign will be posted outby the section load center requiring notification to the section foreman prior to anyone entering inby the loading point. Once notified, the foreman will make clear where and what haulageways are being used and which shuttle cars they are operating.

2. When work in any shuttle car haulageway is to be conducted, operation of the shuttle car in said haulageway shall cease until the work is complete. When work is completed and all are clear of the haulageway, the shuttle car operator will be notified that he can continue. Examples of work include but are not limited to: installation of supplemental support, shoveling, moving cables, etc.
