REPORT OF INVESTIGATION

Fatal Powered Haulage Accident  
April 15, 2024

Riverbend Sand and Gravel  
Martin Marietta Materials Inc  
Brighton, Weld County, CO  
ID No. 05-04841

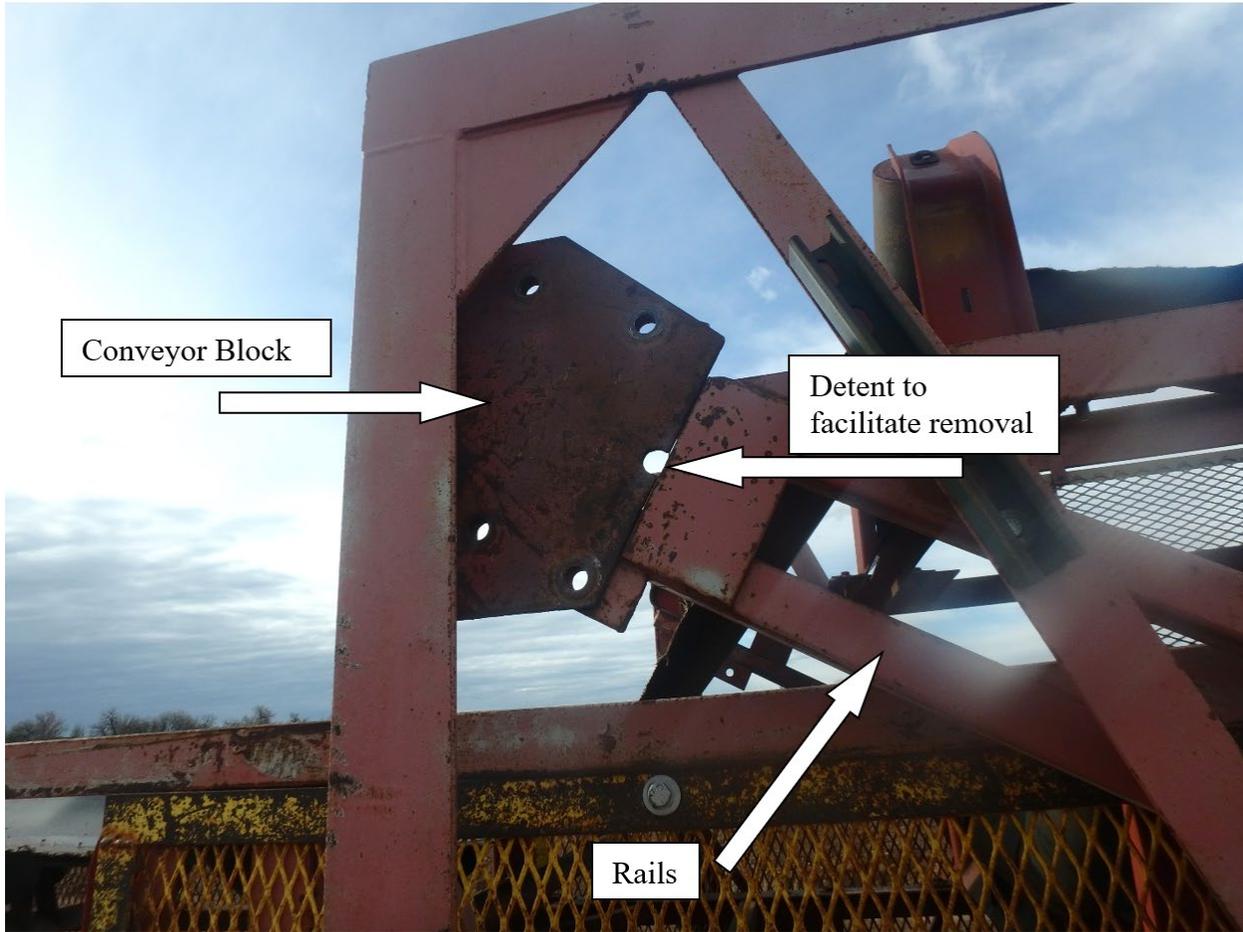
APPENDIX B – Conveyor Blocks Installed

The collapsible belt conveyor involved in the accident is a Fisher Industries 225-foot Overland Conveyor, Company Number FC-2. When set up, the tail section slides into place along rails in the middle section and is held in place by two blocks that are bolted in place (see Appendices B, C, and D). The blocks have a notch to facilitate removal with a pry bar from outside the conveyor assembly. Investigators determined that there were no defects on the conveyor that contributed to the accident.

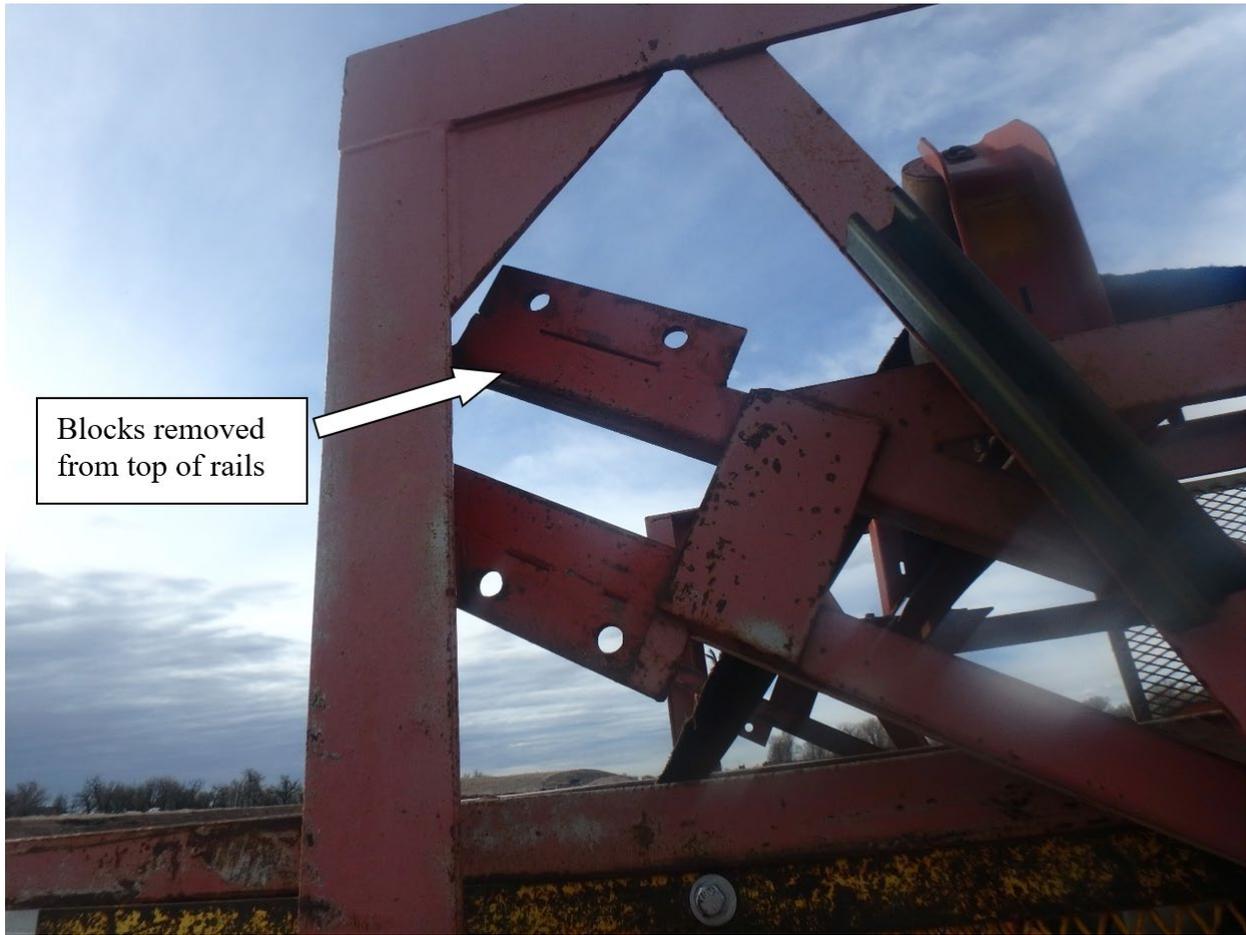
APPENDIX C – Rails with Blocks Removed

On the day of the accident, investigators determined that a different procedure was used. While the tail section of the conveyor was being raised by the excavator, the tail section was not pulled with sufficient force to keep it from lowering. Also, no support, blocking, or equipment was used to prevent the tail section from sliding on the rails and lowering while Gore was positioned between the conveyor sections (see Appendix E). Investigators also determined that the blocks were knocked out with a hammer from inside the conveyor rails instead of being removed with a pry bar or similar tool from a safe location outside the conveyor rails. Additionally, the belt tensioner was still engaged, leaving tension on the belt.

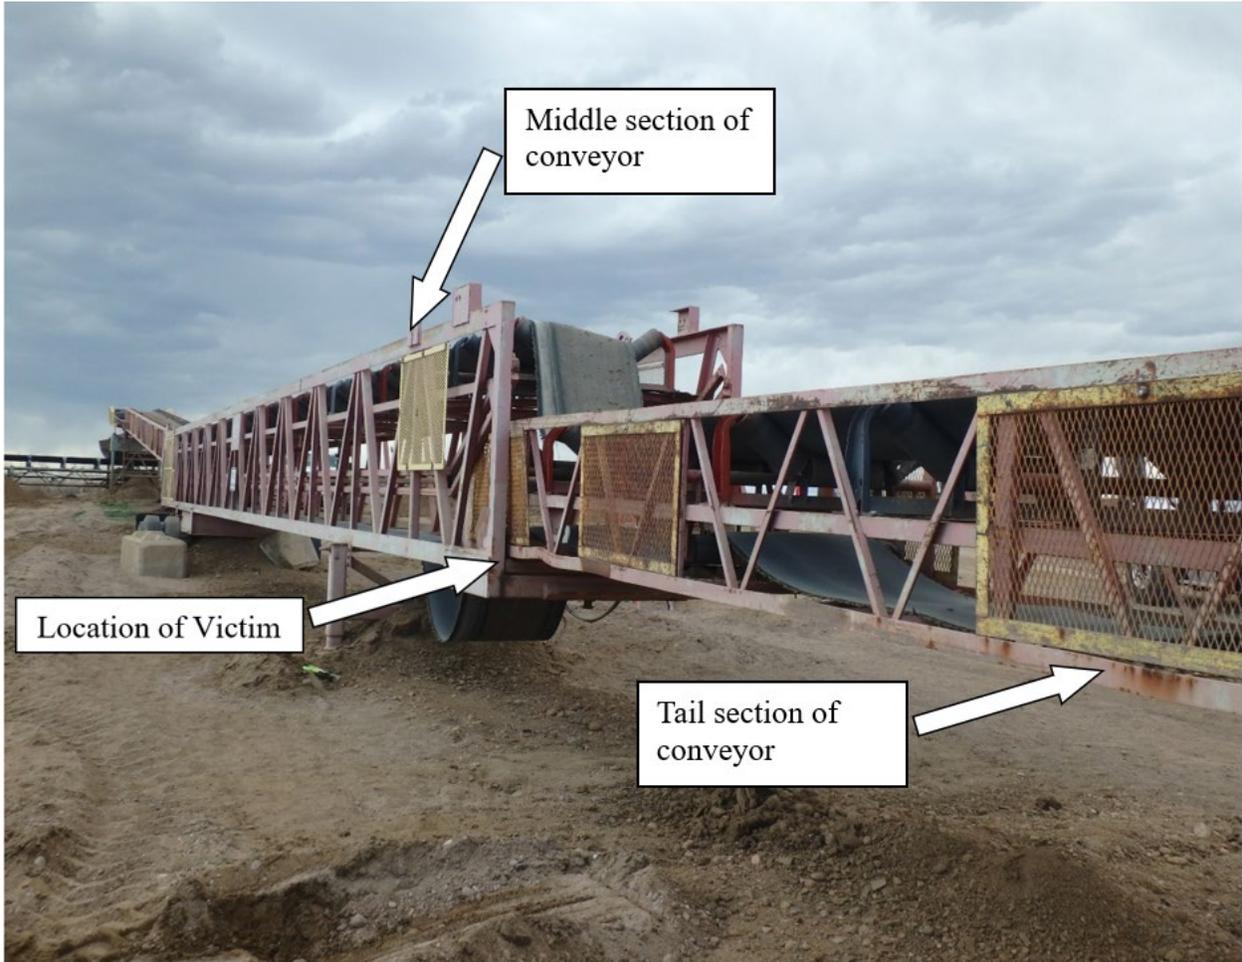
APPENDIX E – Location of Victim

According to interviews and video surveillance footage, at 10:55 a.m., Segelke reviewed the SLAM'D form with Cvetic and Gore and proceeded to get the excavator. Gore and Cvetic started by removing the transfer box and the return rollers from the middle section. At 11:24 a.m., Segelke returned with the excavator, attached a lifting chain to the tail section of the conveyor, and began operating the excavator. Gore and Cvetic removed the bolts for the blocks that prevented the tail section from collapsing into the middle section, but the blocks remained in place due to the weight of the conveyor. Cvetic attached the lifting chain from the tail section to the bucket of the excavator and then walked back towards Gore. At 11:47 a.m., Segelke raised the excavator bucket upward. Gore positioned himself between the tail section and the middle section of the conveyor and removed the blocks with a hammer from inside the conveyor rails. The tail section rapidly slid down the rails, pinning and crushing Gore between the tail and middle sections of the conveyor.

The procedure that Segelke wrote on the SLAM'D form was, "Gather tools and equipment, fold up 225' conveyor, move conveyor out of E-2 and into G-1, set up both 225' conveyors in G-1." The rest of the form, including a question about the task involving pinch/crush and suspended load hazards, was not filled out. Investigators determined that the mine operator did not secure the tail section to prevent accidental lowering and did not ensure Gore stayed clear of the suspended load, which contributed to the accident.

Corrective Action: The mine operator developed new written procedures for collapsing the conveyor that addresses removing belt tension, blocking the sections against the motion while removing blocks, and safe positioning of miners during the task. The mine operator trained all miners in the procedures.

Corrective Action: The mine operator developed new written procedures for collapsing the conveyor that addresses removing belt tension, blocking the sections against motion while removing blocks, and safe positioning of miners during the task. The mine operator trained all miners in the procedures.
