REPORT OF INVESTIGATION

Fatal Powered Haulage Accident
August 11, 2024

West Elk Mine
Mountain Coal Company, L.L.C.
Somerset, Gunnison County, Colorado
ID No. 05-03672

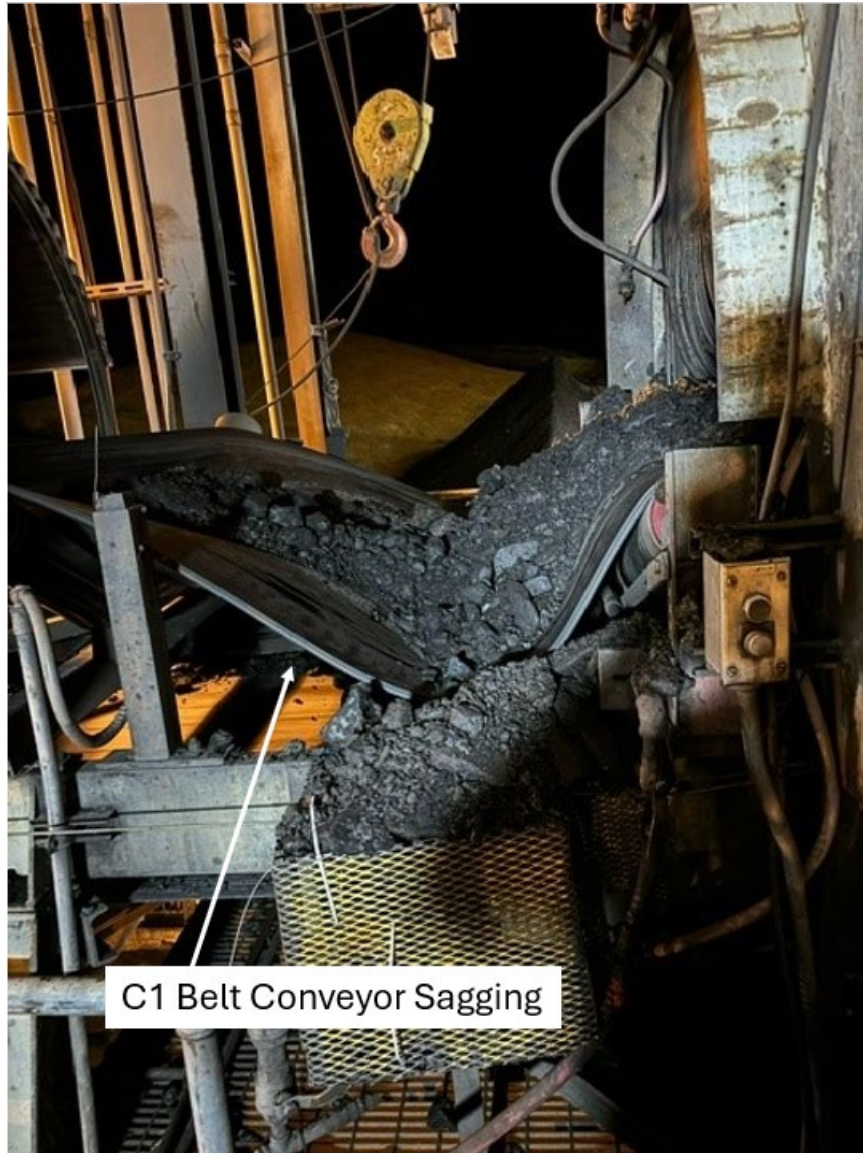
APPENDIX B – C1 Belt Conveyor Sagging Before Accident

On August 10, 2024, at 7:00 p.m., Barnes started his routine shift. According to the electronic data from the belt conveyor, at 11:34 p.m., the C1 conveyor alarm activated in the control room, which indicated that a pull cord had been tripped. According to interviews, Ed Pitt, Surface Foreman, told Joshua Murphy, Surface Miner, to go to the C1 tower and check what had tripped the pull cord. Pitt went to the portal to check the rib switch. Murphy traveled to the top of the C1 belt conveyor tower. Barnes arrived to assist. A large coal spill surrounded the C1 Housing. Murphy and Barnes opened the smaller observation door and saw that the chute was not obstructed. They opened the two large access doors on both sides of the C1 Housing and noted a build-up of coal and rock (see Appendix A). Pitt arrived and assessed the situation. Murphy and Barnes started shoveling the material, and Barnes entered the inside of the C1 Housing to move the material off the edge of the head roller. Pitt told Murphy to get on top of the belt inside the C1 Housing to shovel. Murphy entered and started pushing the material. Pitt told Murphy and Barnes to be cautious because the top belt was sagging (see Appendix B), the counterweight was up, and he did not know which way the belt might move.

During normal operation, the counterweight hangs down below the belt to maintain tension and prevent sagging in the top and bottom of the belt. The initial coal spill caused the C1 belt

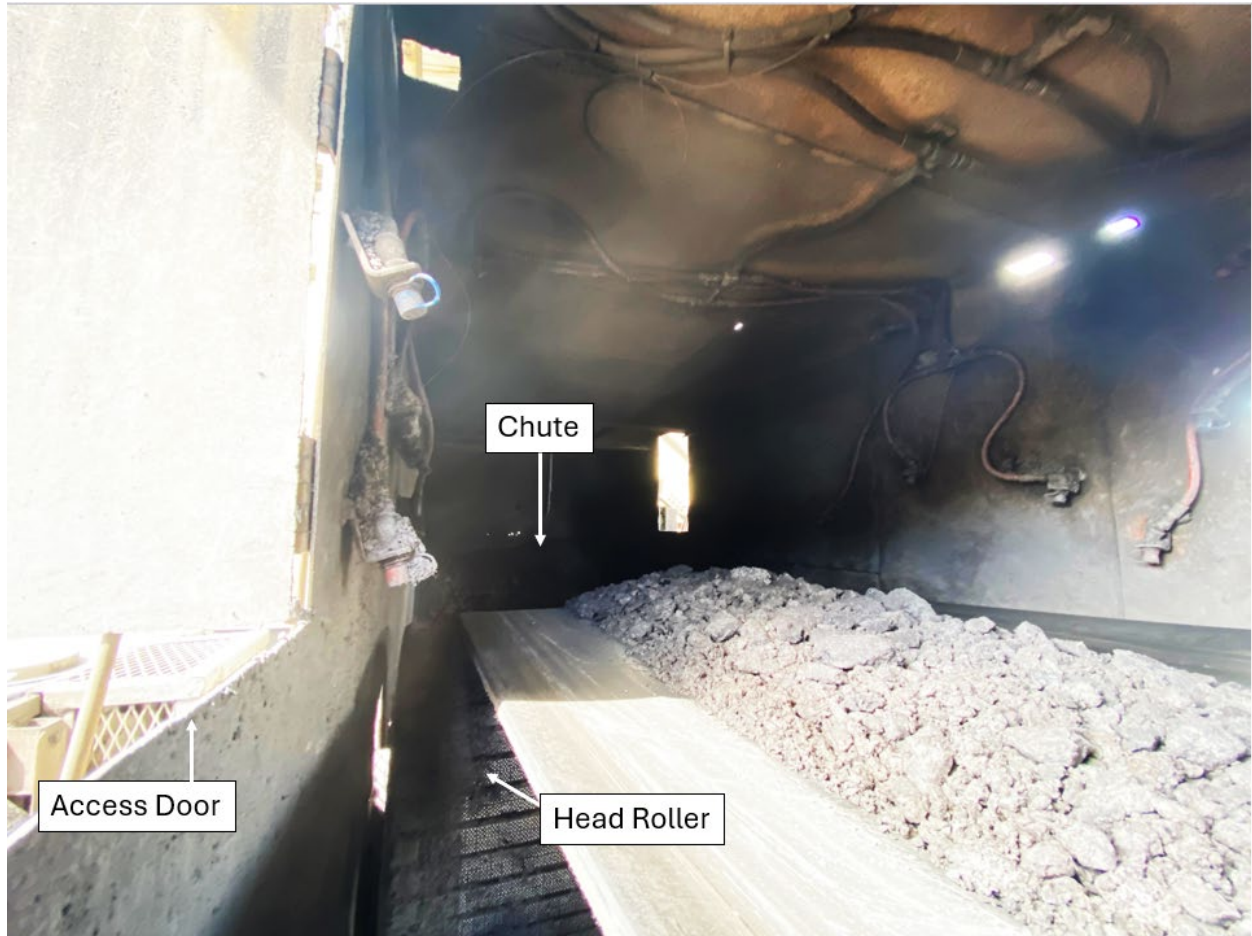
APPENDIX D – Inside C1 Head Roller Housing

The accident occurred on the top floor of the C1 Housing, on the transfer tower platform located on the surface coal handling facility (see Appendix D).

Corrective Action: The mine operator designed new guards and reduced the access to the belt conveyor doors surrounding the C1 Housing with a welded bar to reduce the opening

size. Warning signs have been posted on the C1 Housing, and on the guards, warning miners of the potential hazards associated with cleaning the belt conveyor system. Additionally, the mine operator retrained mine management and miners on their belt conveyor inspection, cleaning, and lockout procedure plan. The mine operator will conduct periodic audits and inspections to ensure compliance with their procedural plan.

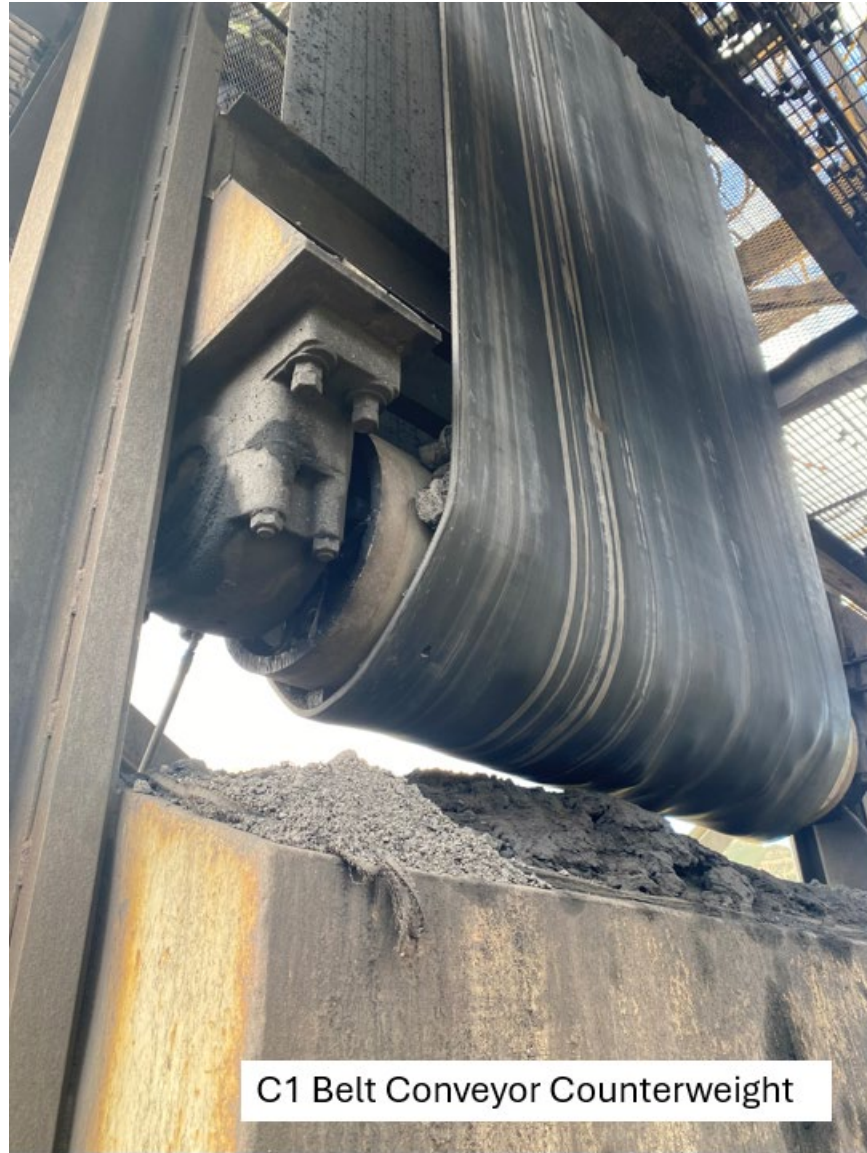
APPENDIX E – C1 Belt Conveyor Counterweight

conveyor pull cord to trip, stopping the belt, and raising the counterweight. The top of the belt sagged due to the coal spill but there was tension on the bottom of the belt. When the counterweight fell, it put tension on the top of the belt, causing it to move forward (see Appendix E). The mine operator did not block the C1 belt conveyor against motion by securing the counterweight in the raised position. Investigators determined this contributed to the accident. Additionally, the mine operator did not lock and suitably tag out the C1 belt conveyor. After the accident and without MSHA's knowledge, Robert Munz, Surface Superintendent, directed miners to lock out and tag out the C1 belt conveyor.
