REPORT OF INVESTIGATION

Fall of Face, Rib, Slide or Highwall Accident
August 22, 2024

Onyx Sterling Pit
Onyx Corporation
Sterling, Worcester County, Massachusetts
ID No. 19-01284

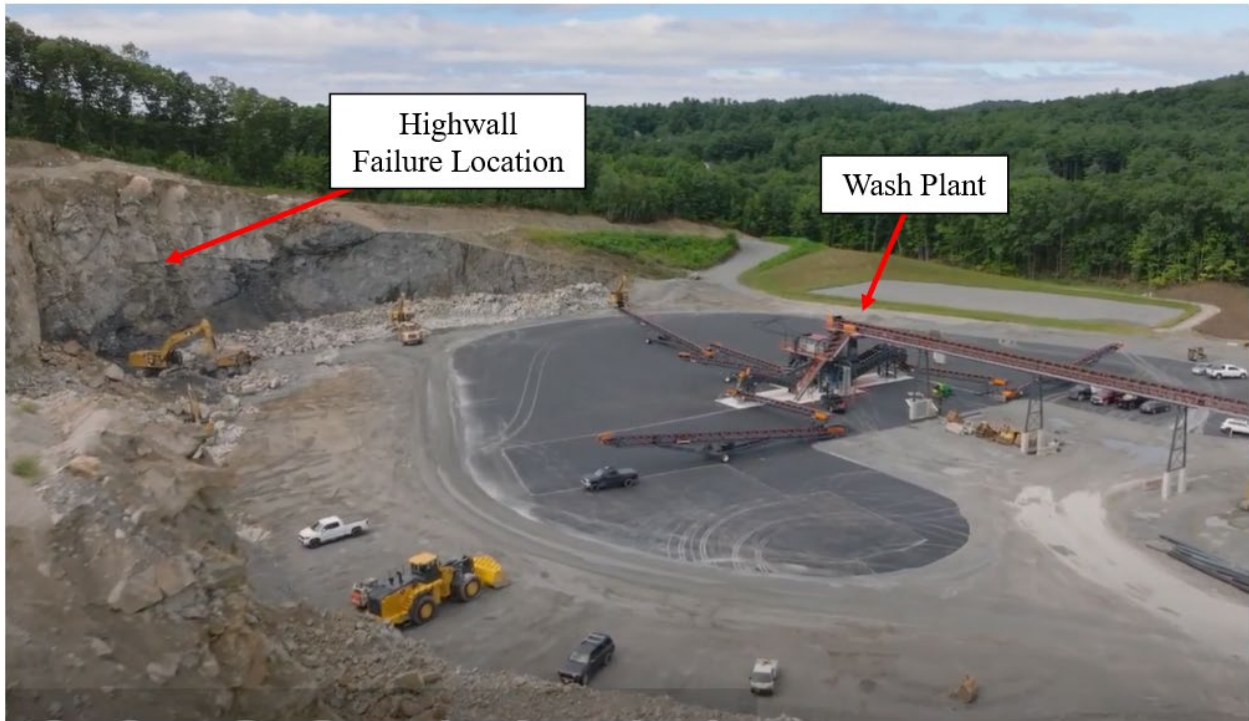
APPENDIX B – Wash Plant and Highwall Prior to the Accident

The accident occurred below the western facing highwall that made up the boundary for the new wash plant (See Appendix B).

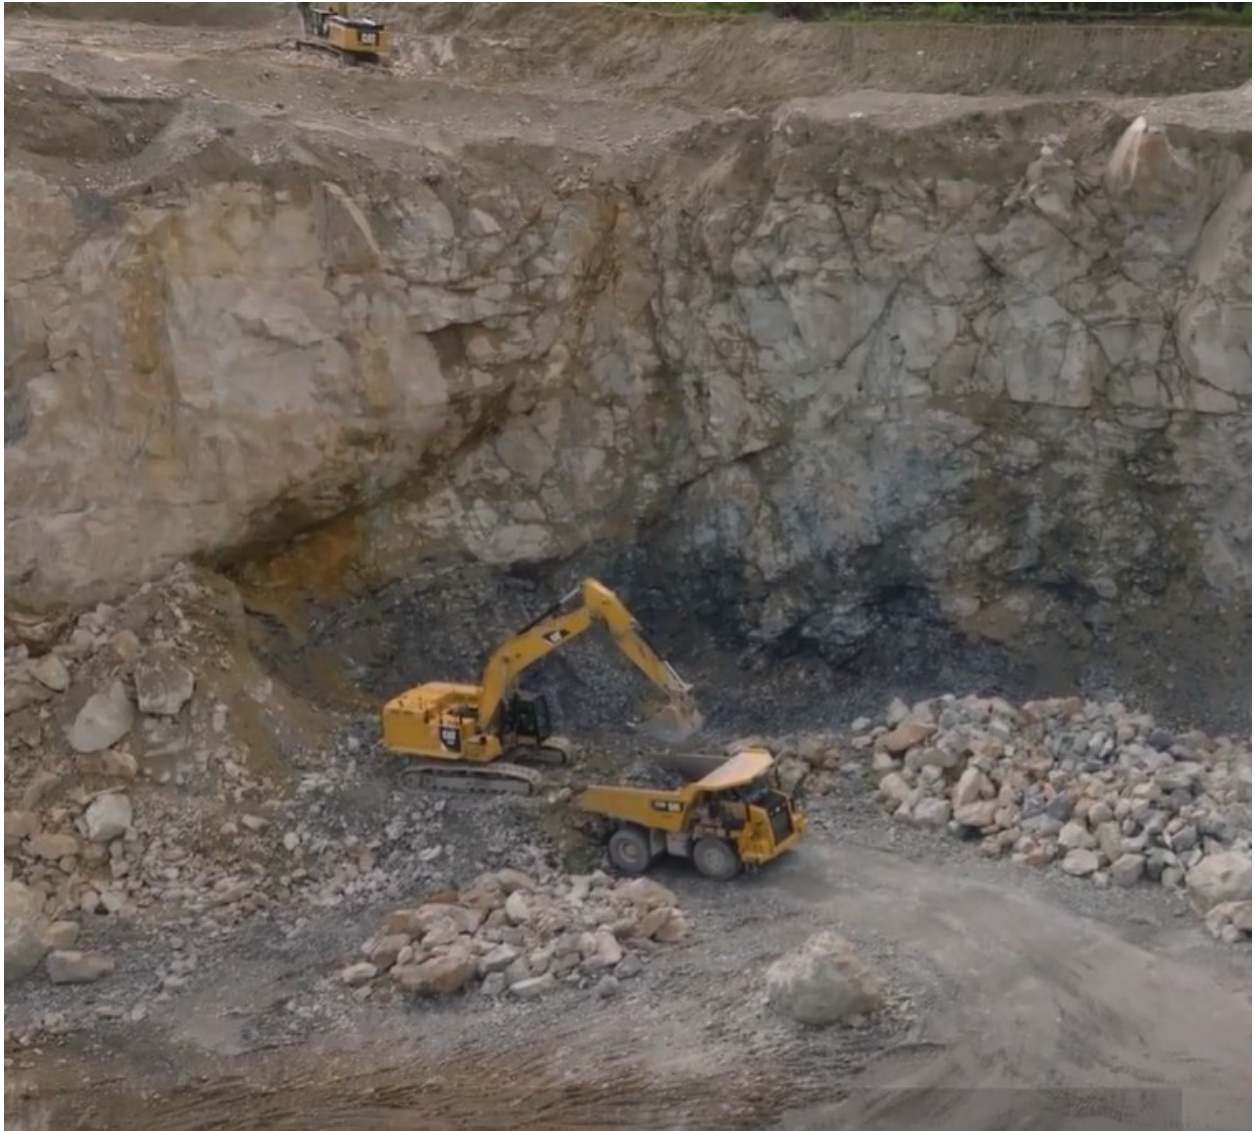
APPENDIX C – Highwall Prior to the Accident

Derby was below the 97-foot western facing highwall at the time of the accident. A1 Drilling and Blasting blasted the highwall face, including the section of the highwall failure, on July 27, 2024. The mine operator's intended purpose of the highwall was to be the perimeter wall around the new wash plant. The highwall had been shaped into an arc resembling two 45-degree bends adjoining it to the northern facing wall along the new perimeter road. At the point where the western facing wall and this arc met, a large mud seam and multiple hazards within the rock strata were present, including but not limited to: bedding planes; joints; piping; fractures; and seepage (see Appendix C). Water had been seeping over the edge of the highwall along the large mud seam. As the material was removed from the bottom of the high wall, the bottom portion of the mud seam was exposed. Investigators determined that work on top of the highwall created

The 97-foot highwall did not have any benches. Loose rock, over hangs, and disjointed material were present. There was no equipment at the mine capable of either maintaining a highwall this size or correcting hazards created by the adverse conditions. The mine operator did not take down or support hazardous ground conditions, which contributed to the accident.

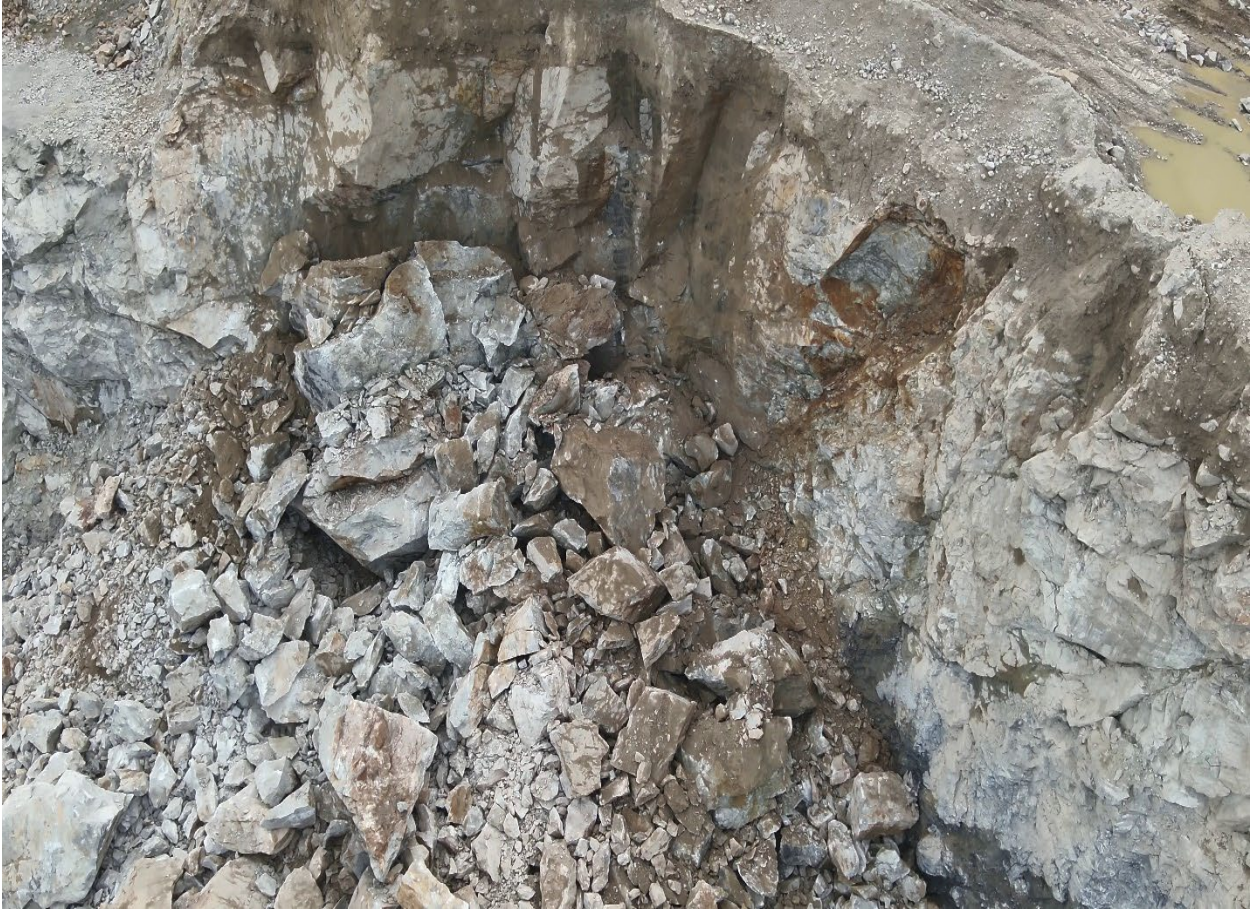
APPENDIX D – Highwall After the Accident

vibrations throughout the rock structure. The flow of water over and through the high wall weakened joints. These adverse ground conditions, and the mining method, caused the highwall failure (see Appendix D). The mine operator did not use mining methods to maintain highwall stability, which contributed to the accident.

Corrective Action: The mine operator developed and implemented a new mining plan that establishes benches of a safe height and width. This plan requires continuous maintenance of benching for all future mining development and preparation. The stripping of overburden and implementation of berms along each bench must be designed to allow inspections of the top of each bench. Additionally, the mine operator will evaluate and implement mining methods in future site developments to ensure highwall stability.
