REPORT OF INVESTIGATION

Fatal Slip or Fall of Person Accident
August 22, 2024

Crisp Industries, LLC (Z3F)
Bridgeport, Texas

East Quarry
APAC-Central, Inc
Tulsa, Tulsa County, Oklahoma
ID No. 34-00050

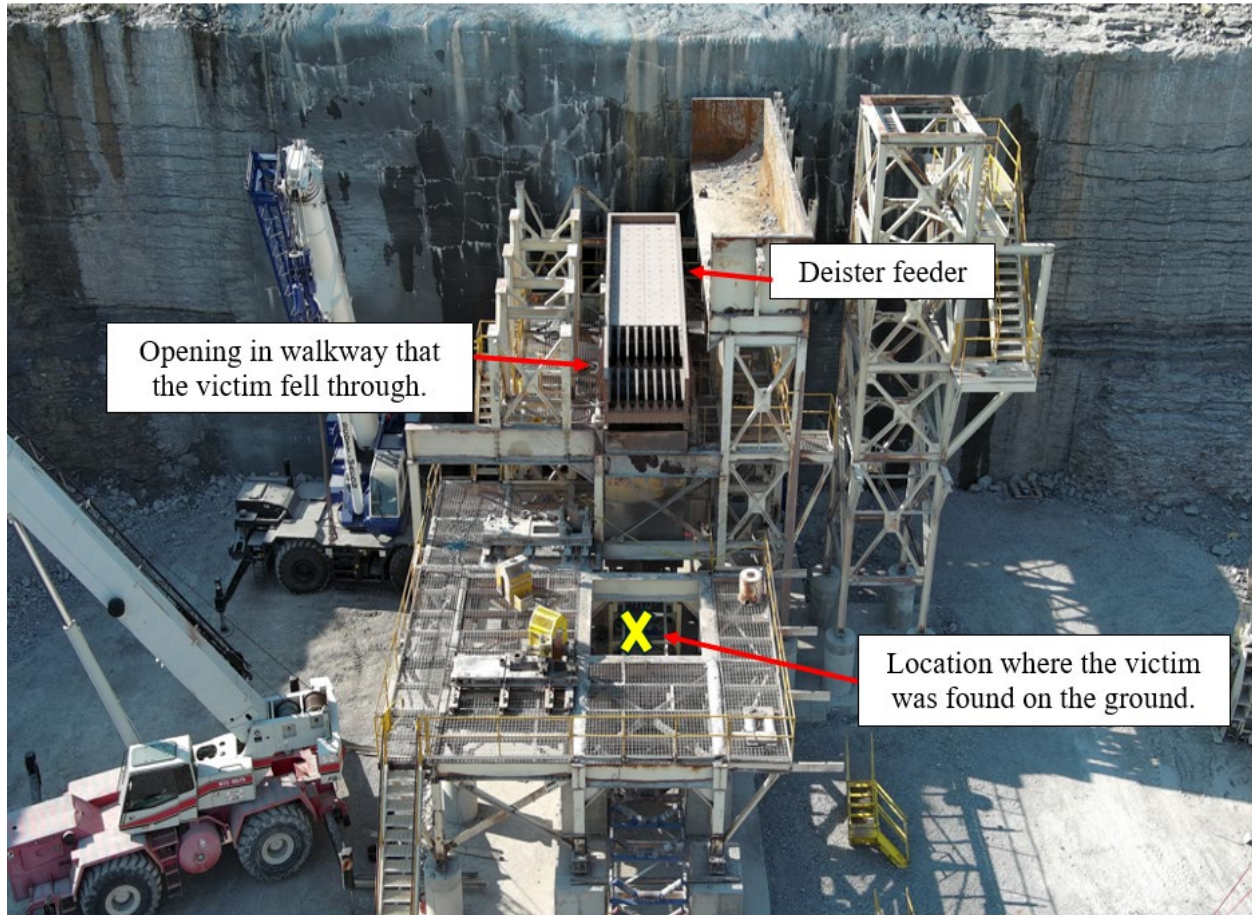
APPENDIX A – 36th Street Primary Plant

At approximately 3:00 p.m., North operated the Tadano GR-1200XL Crane, and Shannon Bean, Crane Operator for Crisp, operated the Link Belt 8075 Crane to lift the new feeder into place from ground level (see Appendix A). Delgadillo progressed to the top of the steps of the third-level feeder platform once the feeder had cleared the second-level hopper structure to begin signaling the crane operators as they lowered the feeder onto the spring basins. Estrada was on the east side of the third-level platform and Rodriguez was on the south side of the platform as the crane lowered the feeder. Once the feeder was low enough on the south side, Estrada and Rodriguez moved toward the south side of the feeder and started tapping (seating) the springs into the basin saddles on the feeder. Once the springs were positioned on the south side, Estrada and Rodriguez moved to the middle spring basin area. Rodriguez was between the chute and the middle basin framework and Estrada was on the south side of the middle basin framework near

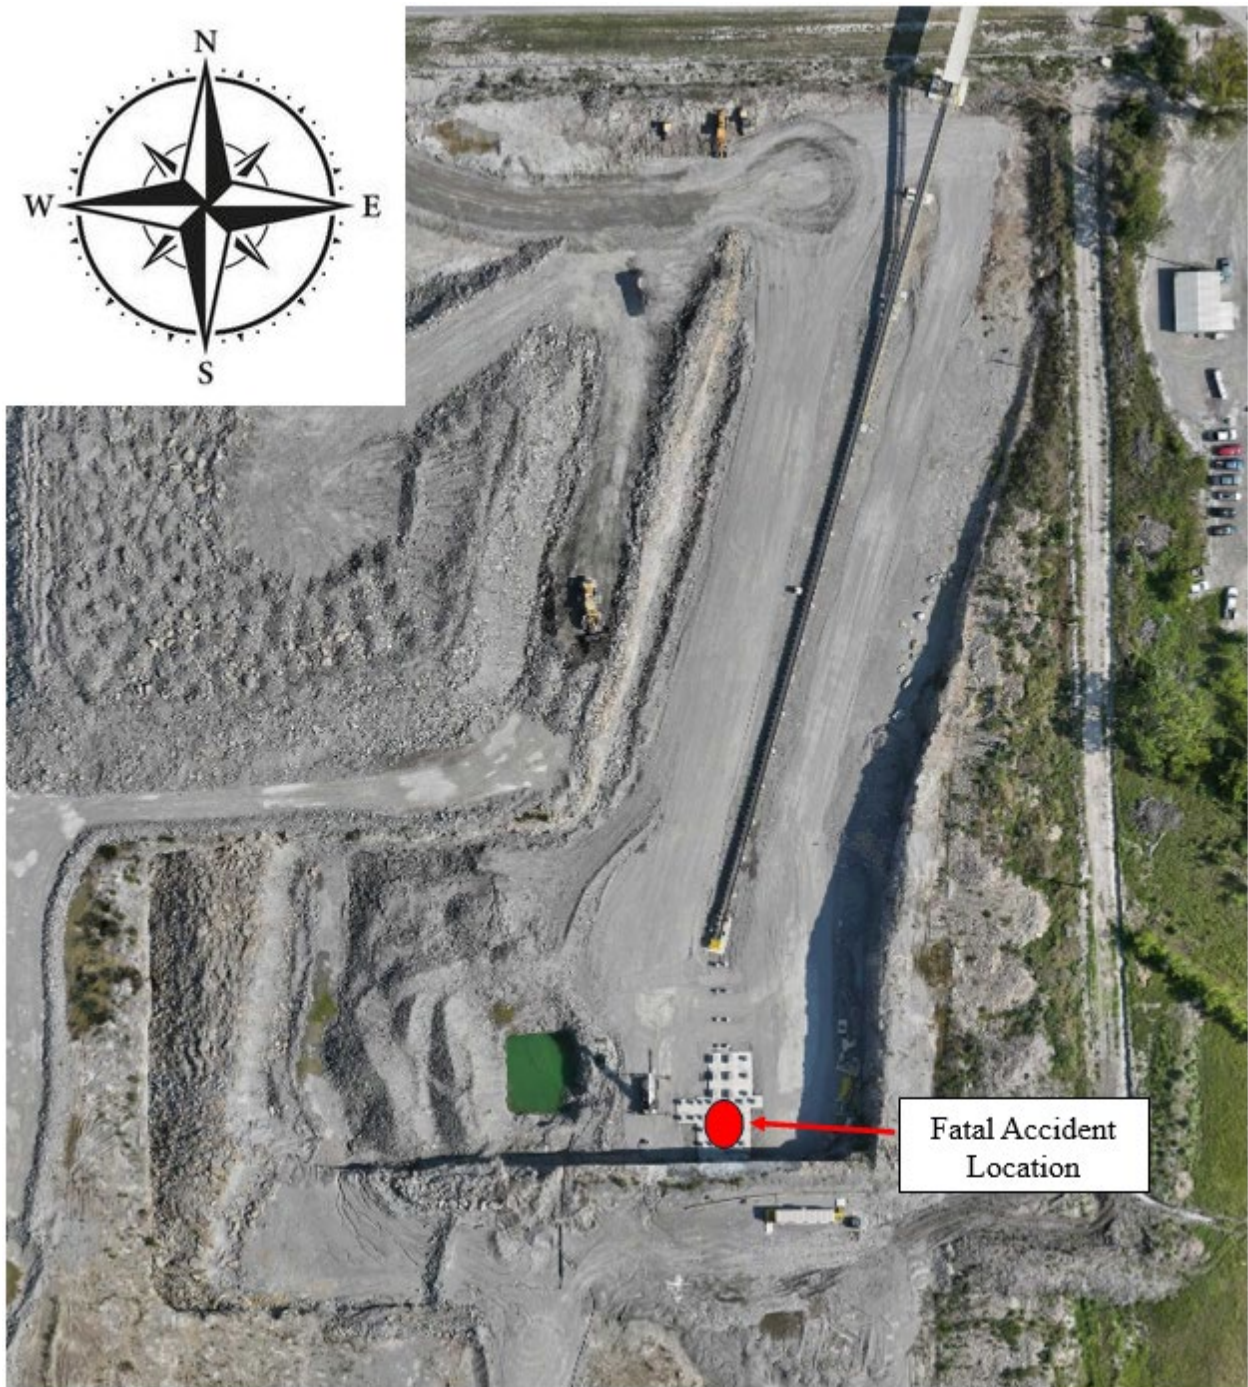
APPENDIX C – Aerial View of Accident Location

Delgadillo noticed a dust cloud on the ground level and thought that one of the springs had popped loose and fallen to the ground. Delgadillo realized someone had fallen when he looked back and saw a yellow vest. Estrada had stepped into the opening created by the motor mount removal earlier in the day while he was seating the middle springs and fell approximately 21 feet to the ground below. Rodriguez went to Estrada to render first aid.

The accident occurred at the newly erected 36th Street Primary Plant on the third-level feeder platform (see Appendix C).
