REPORT OF INVESTIGATION

Fatal Drowning Accident
August 22, 2024

Vasquez Standup (C1484)
Montrose, Pennsylvania

Paguay Stone Quarries
Paguay Stone LLC
Hallstead, Susquehanna County, Pennsylvania
ID No. 36-08942

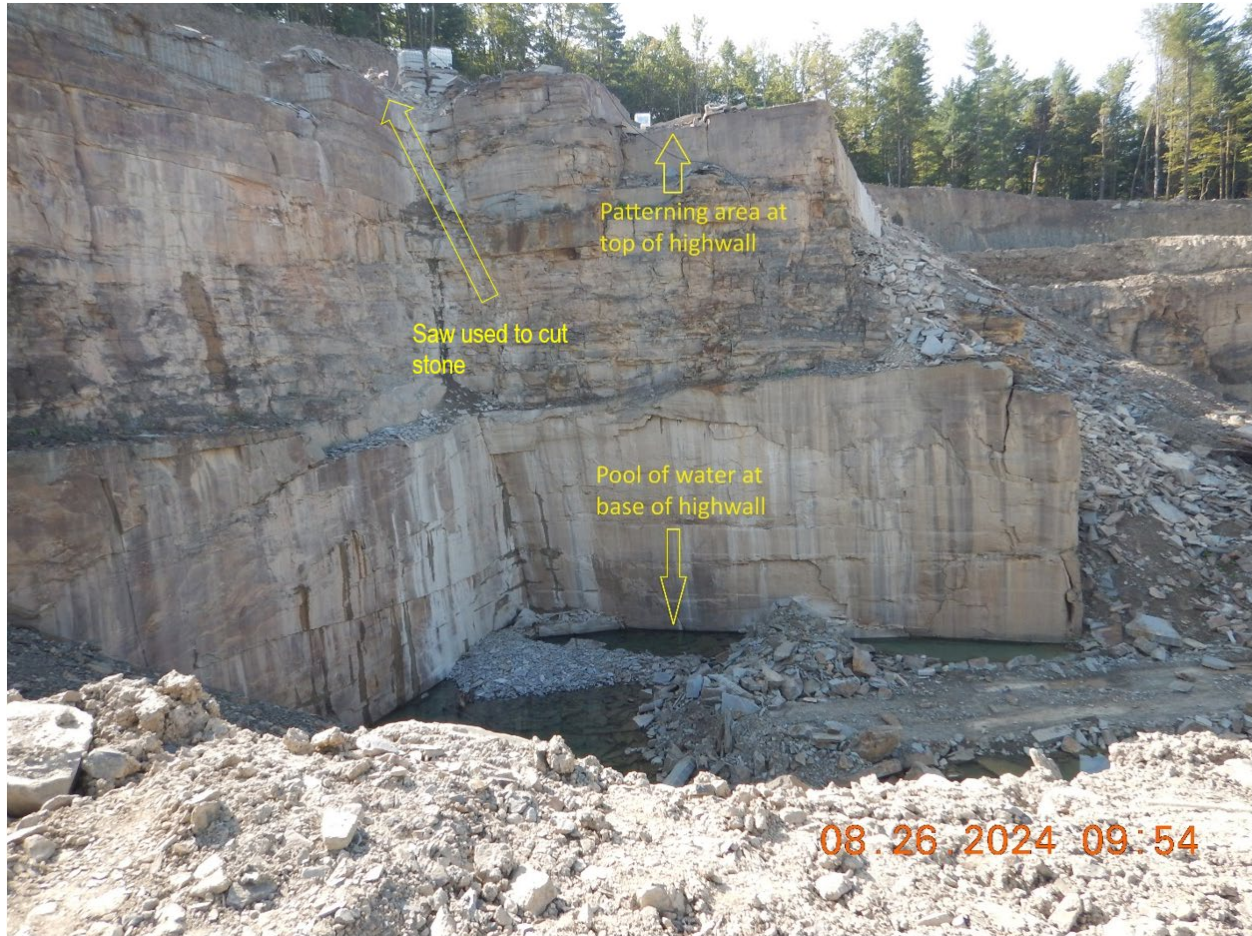
APPENDIX A – Quarry Highwall

At approximately 7:50 p.m., Luis Paguay (L. Paguay), Owner, received a phone call from Roman Landi, Contract Miner, stating that Vasquez was missing. Paguay looked through still photos from the mine's security camera for any evidence of Vasquez leaving the mine. At 8:28 p.m., Paguay returned to the mine site with Luis Alfredo Paguay, Miner, and began looking for Vasquez. At 8:49 p.m., L. Paguay found Vasquez submerged in a pool of water at the base of a highwall (see Appendix A). L. Paguay called his wife and requested she call the police.

The accident occurred at a pool of water at the toe of the highwall below the stone patterning area (see Appendices A and C). The pool of water was approximately eight feet wide by 15 feet long, and approximately four feet deep. Investigators were not able to determine how or why Vasquez entered the water.

Corrective Action: The mine operator will retrain all miners on hazards of drowning, including the use of fall protection or a life jacket, when required.
