REPORT OF INVESTIGATION

Facility
(Aluminum Ore-Bauxite Mining)

Fatal Slip or Fall of Person Accident
August 4, 2024

Gramercy Operation
Atalco Gramercy LLC
Gramercy, Louisiana
ID No. 16-00352

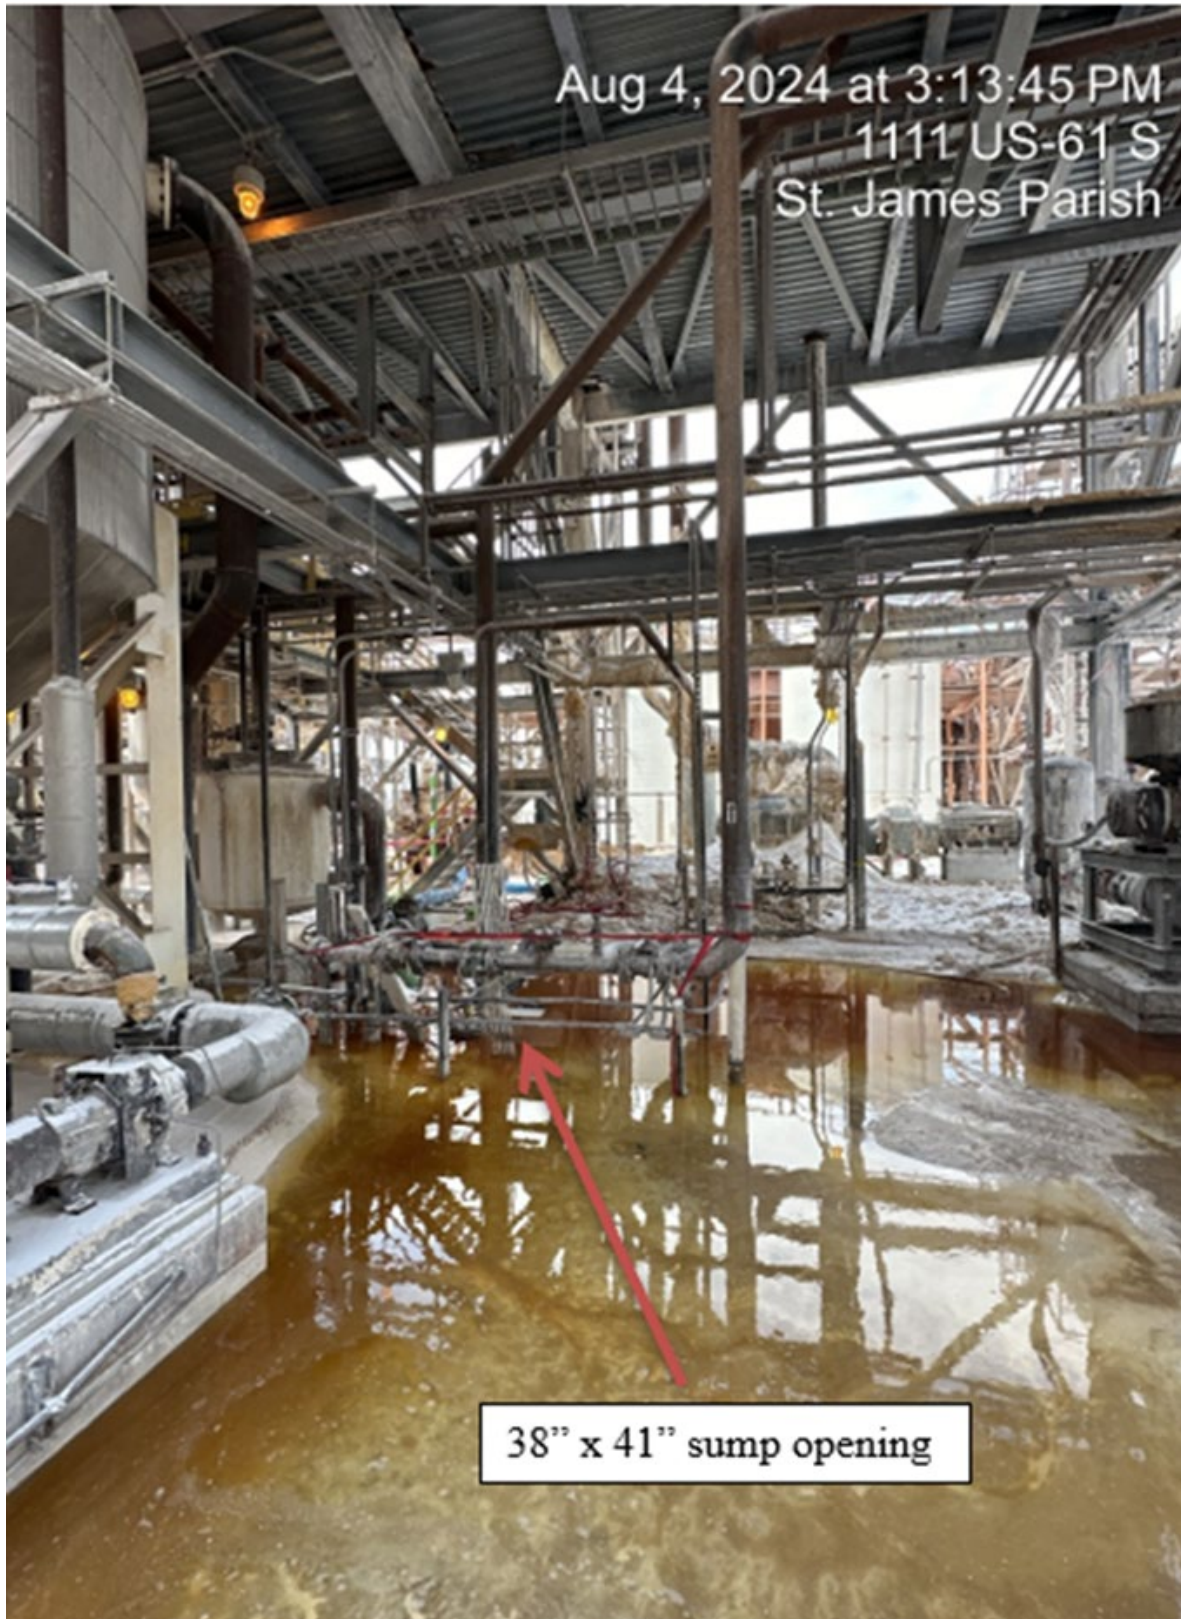
APPENDIX A – South View of Number 5 Filter Floor Area

On July 30, 2024, the mine operator identified a defective sump pump in the Number 5 Filter area located in the Calcination section. According to interviews, the Number 5 Filter was taken offline. Kirk Rose and Ridge Deslatte, General Repairmen, removed the defective sump pump and floor grating at the direction of Charles Battles, Maintenance Coordinator; Jeff Whitney, Senior Manager of Logistics and Manufacturing; and Jaramy Burrus, Calcination Area Coordinator. Danielle Keller, Production Shift Crew Supervisor, assigned Blain Babin, Supervisor for Waste-Pro USA, to support the maintenance team by providing a vacuum truck to clean up the water and caustic liquid that had collected in the area where the sump pump was removed (see Appendix A).

The accident occurred at the Number 5 Filter in the Calcination section of the mill (unit) (see Appendix D). The floor level of the unit contained approximately three to four inches of caustic, ore, and hot water estimated at 200 degrees Fahrenheit. The caustic liquid is a corrosive chemical that can cause severe skin burns and eye damage. The caustic liquid was not clear,

which limited the miners' visibility to see the opening on the floor. Investigators determined this condition contributed to the accident.

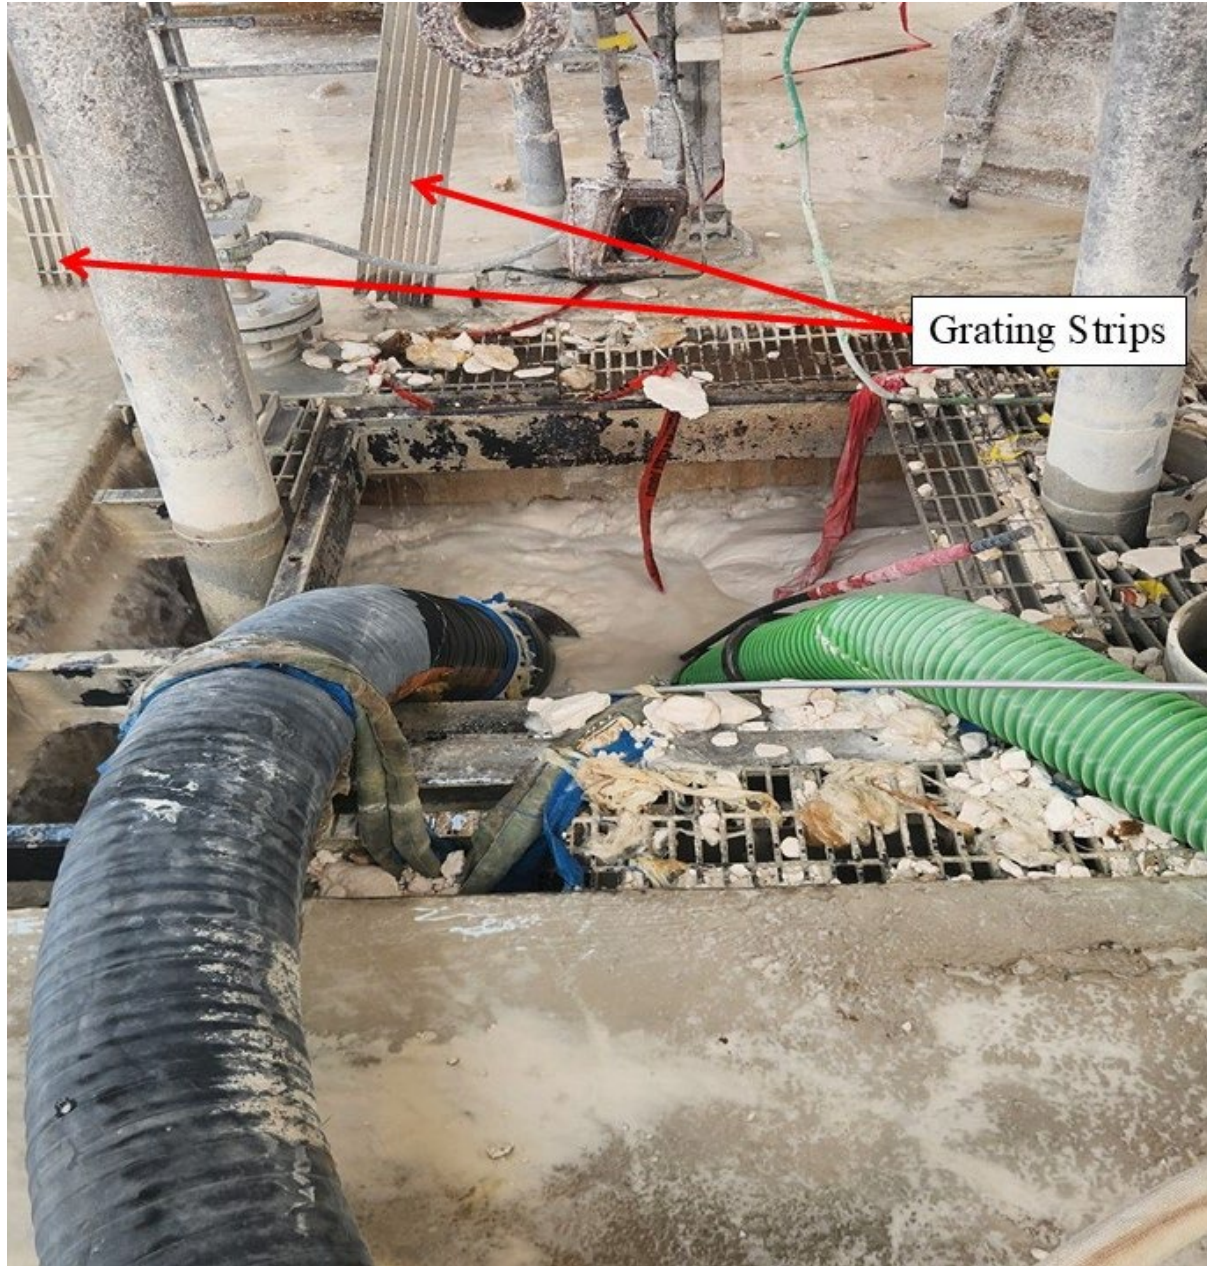
APPENDIX B – 38" x 41" Opening created by removing the Sump Pump

Between July 30, 2024, and August 2, 2024, the mine operator assigned scalers to scale and wash the area, starting on the upper level of the filter area down to the floor. On August 2, 2024, the cleanup on the upper levels was completed and Whitney and Burrus decided to put the Number 5 Filter back online without installing the sump pump or installing barricades (see Appendix B).

The removed piece of equipment that created the opening was referred to as the Number 5 Filter Sump Pump. The grating and sump pump were removed on July 30, 2024, creating a 38-inch by 41-inch opening. There was no scheduled time for the reinstallation of the pump and grating.

Investigators determined that the mine operator had a standard operating procedure (SOP) for the removal of sump pumps, but it was not followed. Since Waste-Pro USA was going to vacuum out the sump and was in the area, the mine operator and contractor that removed the pump, deviated from the SOP and did not re-install the grating or erect a barricade. Investigators determined this condition contributed to the accident.

1. Root Cause: The mine operator and the contractor did not install barricades or covers in the opening on the floor.

Corrective Action: The mine operator and contract company trained all miners in the procedures for installing barricades when openings in the flooring exist.

Corrective Action: The mine operator repaired the sump pump and installed it back into the opening. The company also trained all miners in the sump pump and grading removal procedure.
