REPORT OF INVESTIGATION

Fatal Electrical Accident
August 9, 2024

Eaton Corporation (B3089)
Grapevine, Texas

Maryneal Quarry and Mill
Buzzi Unicem USA
Maryneal, Nolan County, Texas
ID No. 41-00283

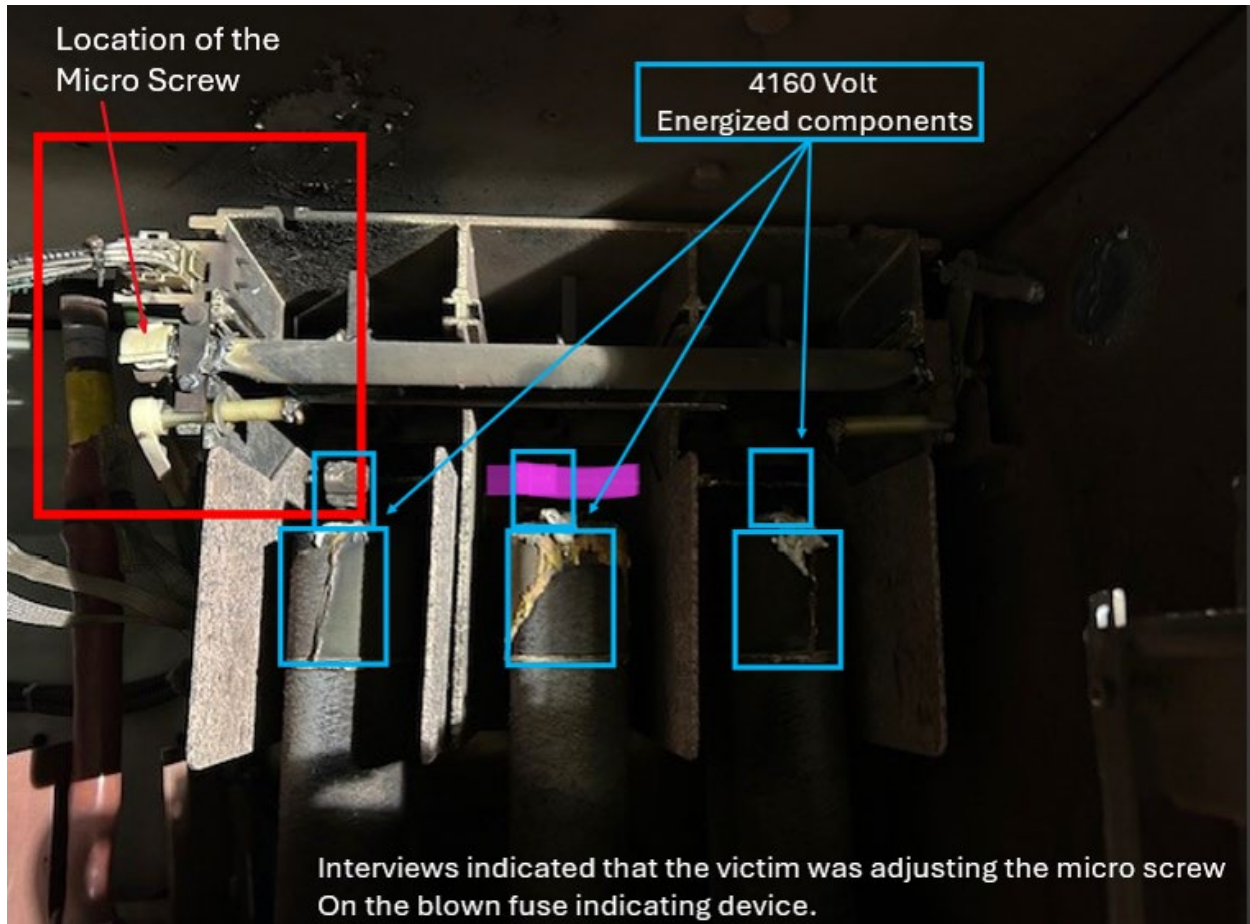
APPENDIX C – Photo of the Damaged Switchgear

The equipment involved in this accident was an electrical panel labeled SYW138741-010 supplied by Eaton Corporation. According to interviews, Harger was adjusting the micro screw on the blown fuse indicator device on the switchgear portion of the electrical panel (see Appendices C and D). This panel was energized by a 4,160-volt alternating current busbar. The

power to the Shipping Motor Control Center was provided by the S02 Substation. The electrical power to the electrical panel was not de-energized, locked out, and tagged out prior to work began. Investigators determined that this contributed to the accident.
