REPORT OF INVESTIGATION

Fatal Powered Haulage Accident
July 12, 2024

Wyco Surface Mine
Pocahontas Coal Company, LLC
Helen, Wyoming County, West Virginia
ID No. 46-09627

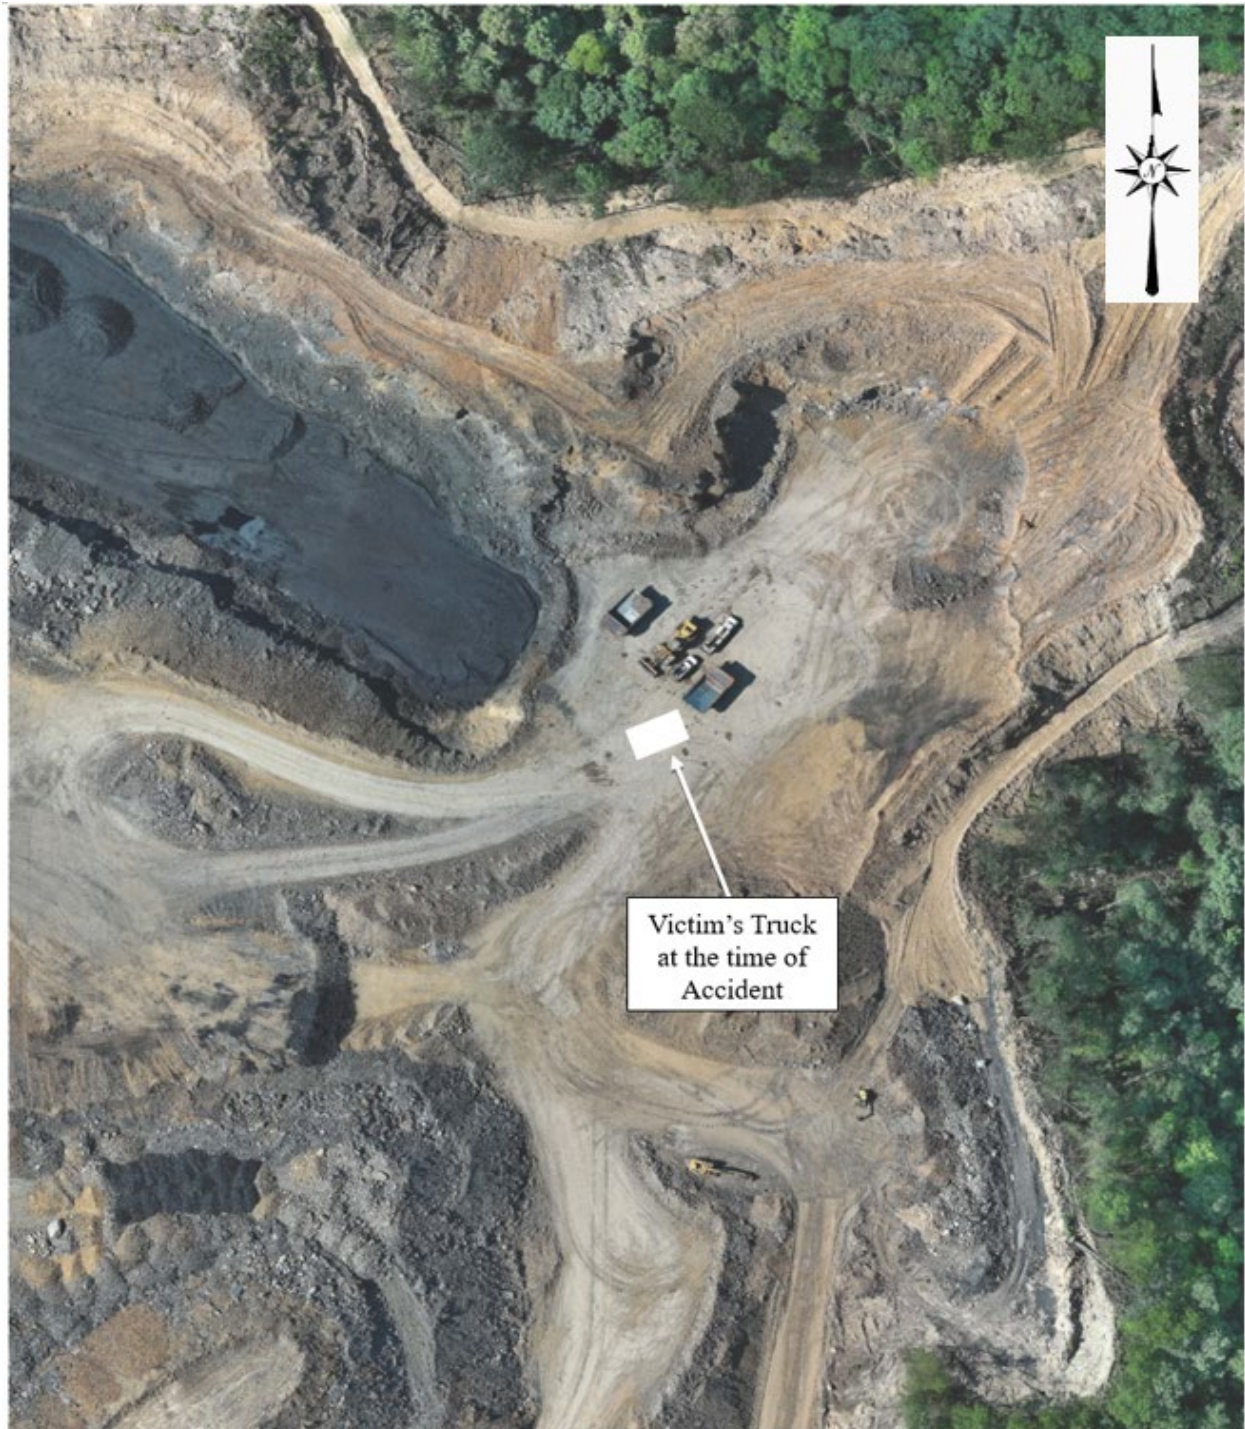
APPENDIX B – Aerial View of the South Pit

The accident occurred in the South Pit (see Appendix B).

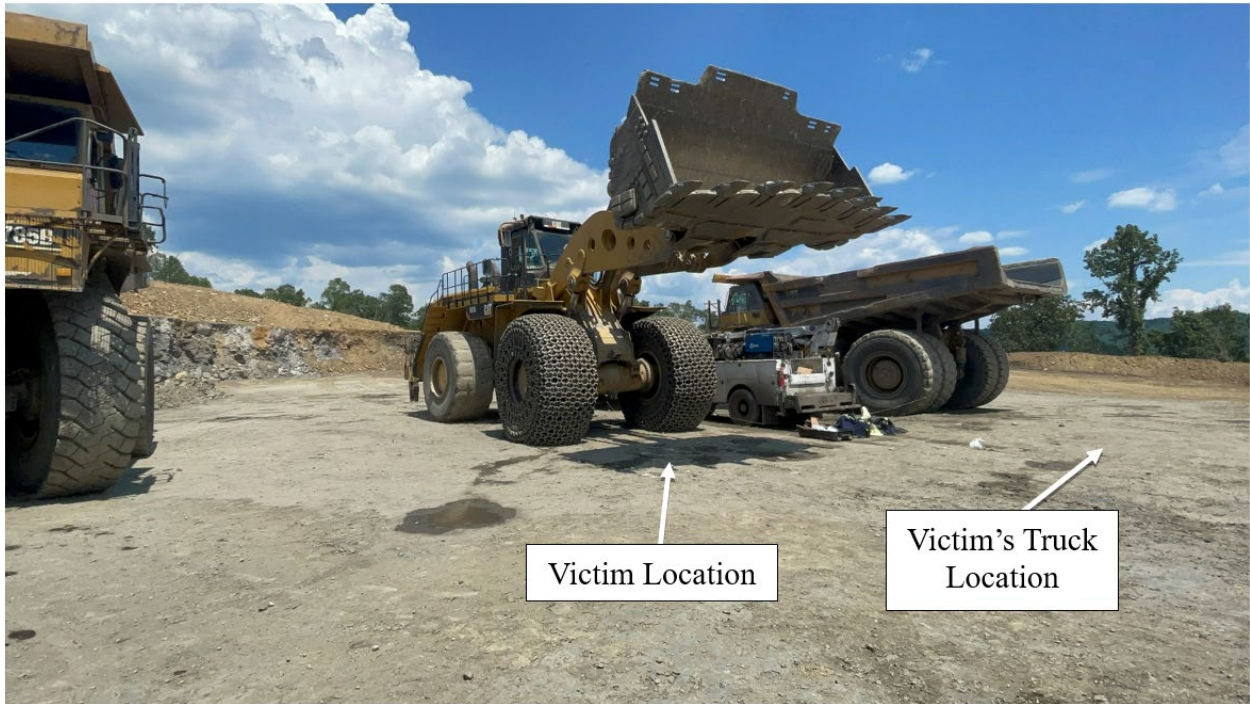
APPENDIX C – Caterpillar 993K Front-End Loader

The front-end loader involved in the accident was a Caterpillar 993K. Investigators measured the loader to be 18 feet, 4 inches tall; 50 feet long; and 16 feet, 7 inches wide. Based on the examination of the accident scene, the loader operator had limited visibility in the area around the loader while positioned in the operator's seat (see Appendices C and D). This area of limited visibility, referred to as the "safety zone," was not barricaded to prevent miners from entering

areas out of view of the loader operator or passing under the bucket of the loader while it was in operation. Investigators determined this contributed to the accident.

Corrective Action: The mine operator submitted a revision to their Ground Control Plan and revised their Surface Mobile Equipment Program. The revisions include requiring a conspicuous safety zone around equipment undergoing maintenance outside of the designated maintenance area. The mine operator trained all miners on the revisions.
