REPORT OF INVESTIGATION

Fatal Fire Accident
June 14, 2024

Littlerock Quarry
Hi-Grade Materials Co
Littlerock, Los Angeles County, California
ID No. 04-04802

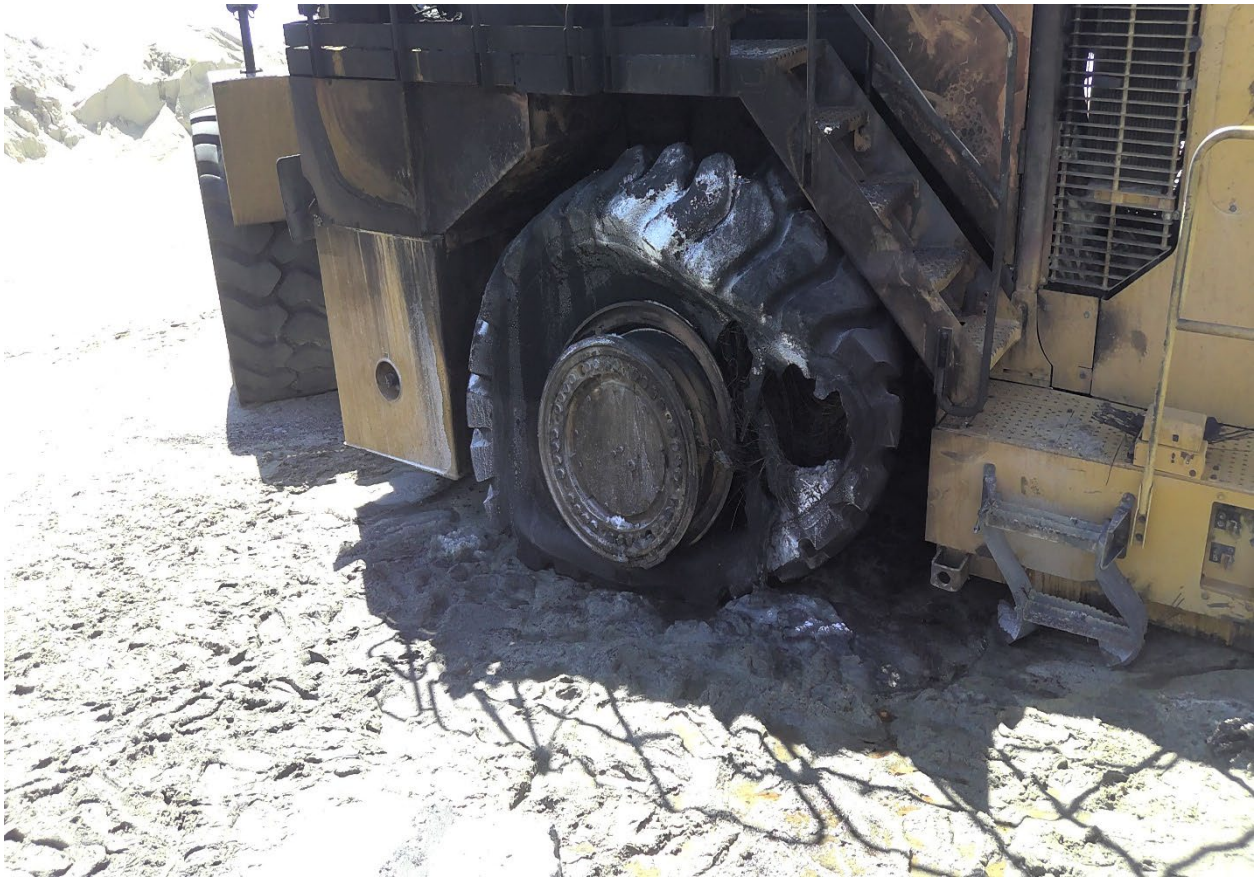
APPENDIX C – Caterpillar 988K Front-End Loader's Left Rear Tire

The equipment involved in the accident was a 2015 Caterpillar 988K front-end loader, company number 79 (see Appendix C). The front-end loader's tires were Bridgestone V-Steel N-Traction (VSNT) 35/65R33 radial with a diameter of 81.7 inches and a width of 35.6 inches. The rear tires were inflated with compressed ambient air between 90 and 100 pounds per square inch (PSI). The front tires were inflated with compressed ambient air to 100 PSI. The front-end loader was not equipped with a fixed fire suppression system. Due to the condition of the front-end loader after the fire, investigators were unable to conduct an examination to determine the cause of the fire.

Investigators determined Pontious was standing approximately four feet away from the front-end loader's left rear tire when the tire exploded. According to the LACoFD, the force of the explosion expelled debris up to 350 feet from the left rear tire (see Appendix D). The left rear tire explosion was more powerful than the right rear tire explosion. Only the rubber and steel cord components of both tires' sidewalls were expelled during the explosion; the multi-piece rim assemblies remained intact.

The force of the explosion in this accident expelled debris up to 350 feet from the left rear tire. The left rear tire explosion was more powerful than the right rear tire explosion. Only the rubber and steel cord components of both tires’ sidewalls were expelled during the explosion; the multi-piece rim assemblies remained intact.

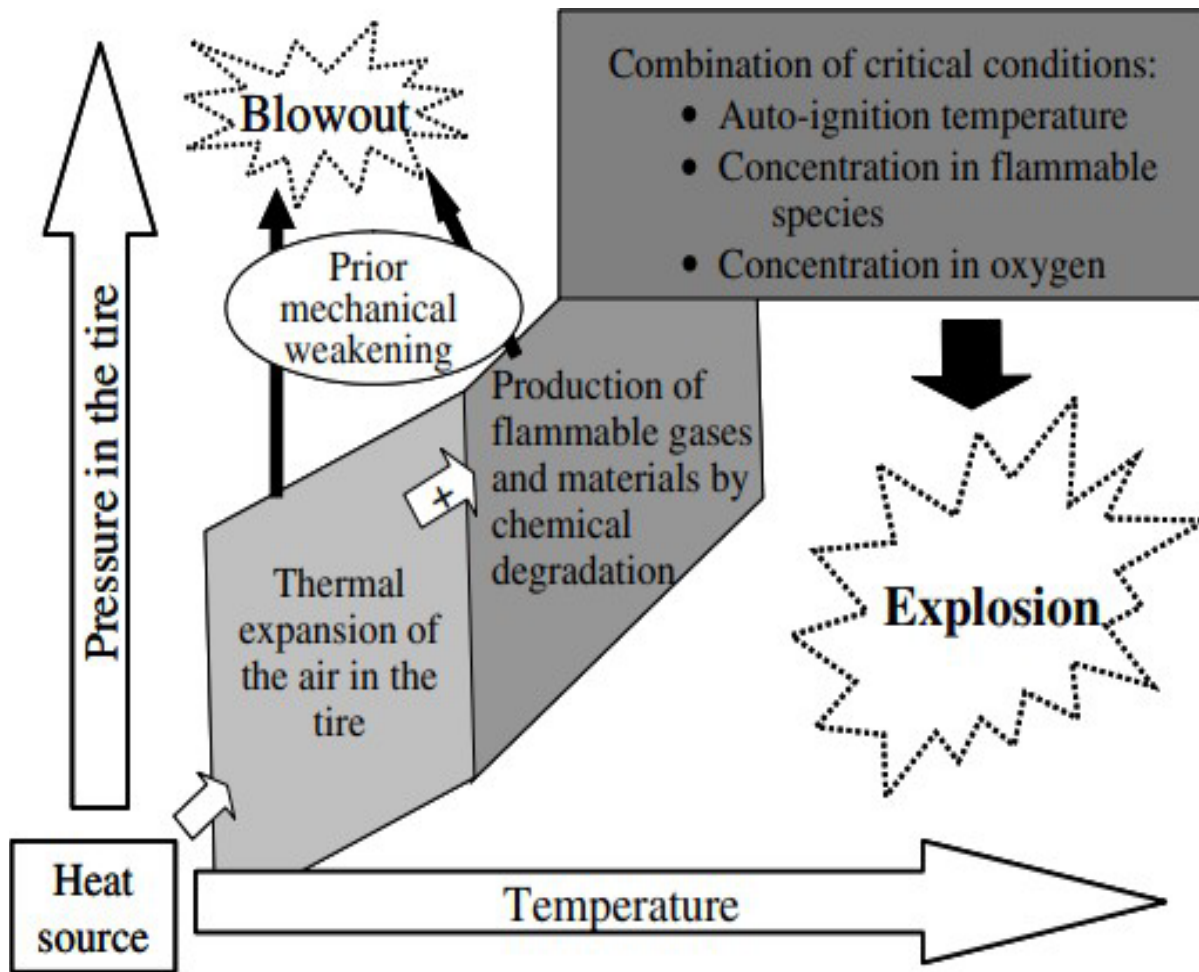
APPENDIX G – Process Leading to Tire Blowout or Explosion (Dolez et al., 2007)

There are three steps to the process that may lead to the explosion of tires exposed to heat. First, the air pressure inside the tire will increase as the internal temperature rises. The pressure of a tire inflated to 90 psi can rise to approximately 235 psi during fire exposure. Unless there is a mechanical defect within the tire or rim assembly, the pressure increase due to the expansion of the air inside the tire will not typically lead to failure (blowout).

Second, when the rubber of the tire reaches about 365° Fahrenheit, it will begin undergoing thermo-chemical degradation reactions, collectively called pyrolysis, and release gases within the tire. The gases released can be flammable and add to the quantity of gas already inside, further contributing to the increasing pressure within the tire.

The thermo-chemical degradation reactions are complex and typically both exothermic and endothermic. The heat from the fire can lead to interior surface burning (smoldering) of the tire rubber lining material which also generates heat and additional gases. The exothermic nature of the interior surface burning is often not visible externally and can allow the continuation of pyrolysis inside the tire even if the external heat source is removed, including after the exterior fire has been extinguished. The gases produced inside the tire are ignitable with a heat release rate comparable to natural gas, gasoline vapors, etc.

A combustion explosion of the tire can occur once the flammable concentration reaches or exceeds its lower explosive limit (LEL). Ignition can occur if the mixture reaches its auto ignition temperature, or if a credible hot ember from interior surface burning is dislodged into the mixture. The actual LEL will depend upon the specific composition of the flammable gas mixture but can be as low as about one percent fuel in air by volume. As the concentration rises above the LEL, the severity of the explosion once ignition occurs, will also increase. The explosion can generate blast waves at pressures over 1,000 psi and project fragments outward at high velocities that travel great distances. These “missile” effects can also cause serious or fatal
