REPORT OF INVESTIGATION

Fatal Powered Haulage Accident
May 9, 2024

Streetman Plant
Arcosa LWS, LLC
Streetman, Navarro County, Texas
ID No. 41-01628

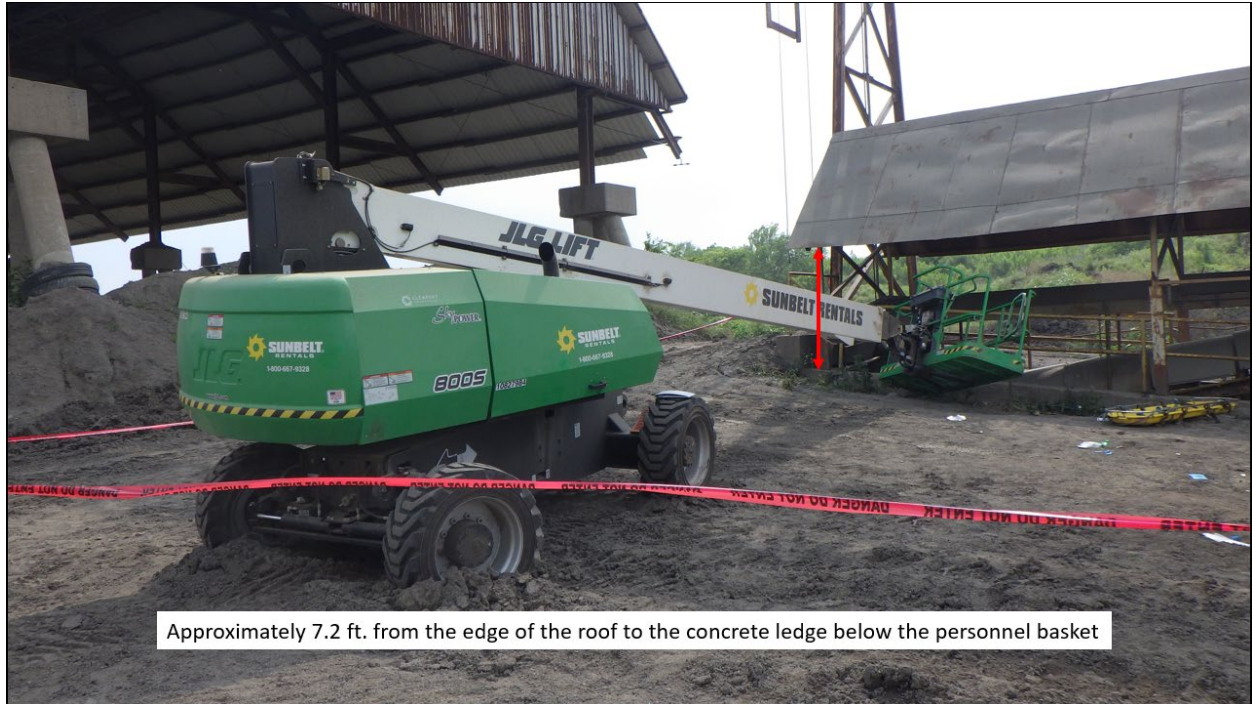
APPENDIX D – Accident Scene

The accident occurred at the Raw Shale Storage area at the C-35 belt conveyor tunnel and the C-34 elevated belt conveyor (see Appendices C and D). The area was dry with no visible dust. Ground conditions were smooth and lightly compacted with an approximate two to three percent grade.

Investigators observed no hazards, obstacles, or obstructions in the area other than the roof. The roof's lower edge was approximately 7.2 feet from the ground.

On May 9, 2024, at approximately 8:00 a.m., a fatal accident occurred at this mine when a miner was pinned between the 800S JLG personnel lift basket and the roof covering conveyor tunnel structure above the C-35 belt conveyor tunnel. While positioning the personnel lift with his back towards the C-35 belt conveyor tunnel, the miner did not maintain control to prevent contact with the conveyor tunnel structure.

Corrective Action: The mine operator developed and implemented a new written procedure for operating personnel lifts. The procedure includes:

1. Plan out equipment positioning/access to identify possible hazards in the working area.
2. Whenever possible, travel with the boom in the back of the main body with the operator and controls facing towards the work area. When the personnel lift is operated with the operator facing away from the direction of travel, a spotter will be used to communicate obstructions to the operator.
3. When nearing or in proximity to structures, all personnel lifts shall be operated in the low-speed mode.
