REPORT OF INVESTIGATION

Surface
(Sand and Gravel)

Fatal Machinery Accident
November 16, 2024

Ervin Hill Enterprises Inc
Ervin Hill Enterprises Inc
Hillsboro, Highland County, Ohio
ID No. 33-04527

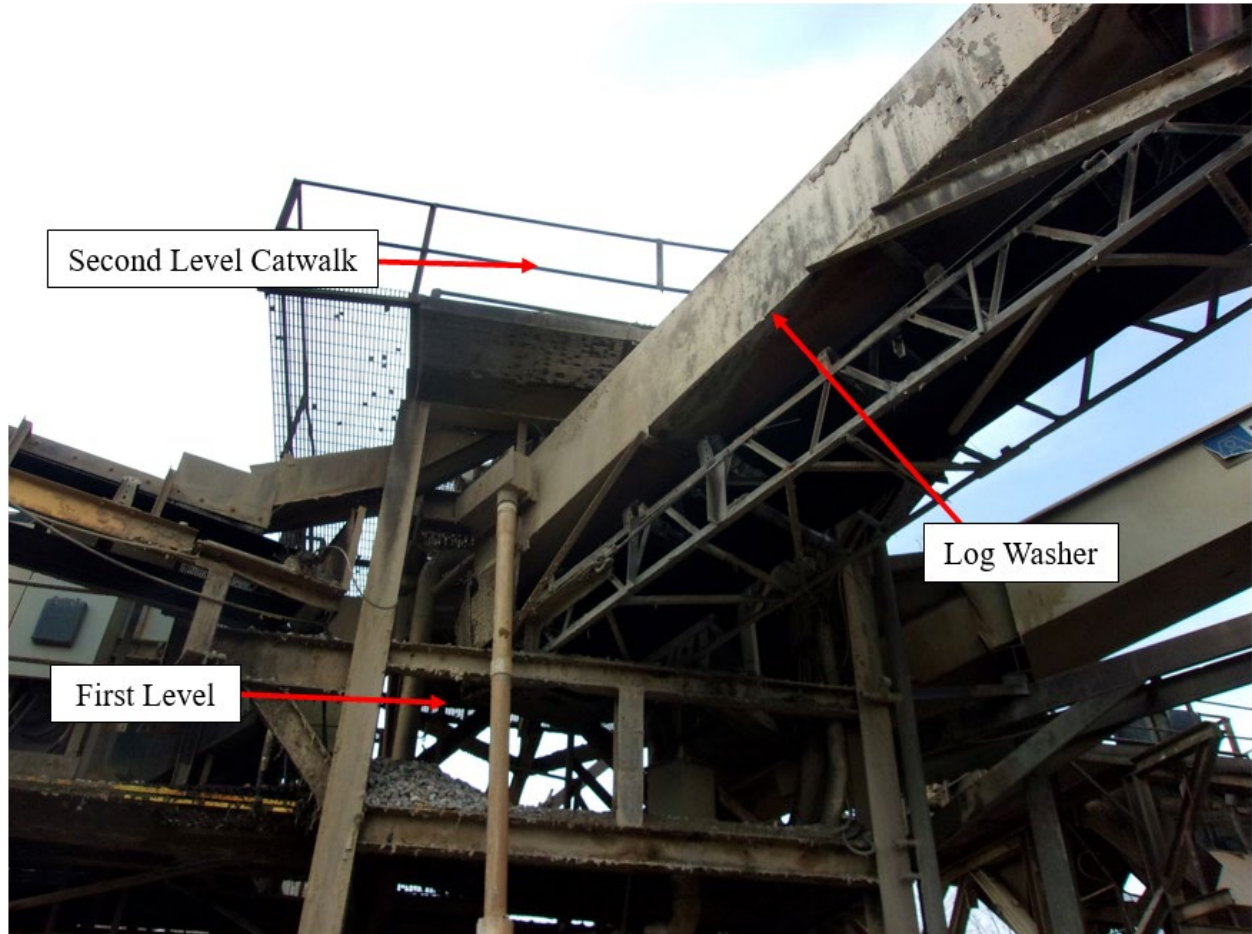
APPENDIX A – Wash Plant Levels

At approximately 7:40 a.m., Campbell noticed a reduced flow of material on the #4 belt. Campbell proceeded to the switch house, noticed smoke coming from the log washer's drive belt, and de-energized the log washer. Campbell went to the second-level of the wash plant and observed the #4 size gravel overflowing into the log washer. Campbell called Rhodes by cell phone and asked Rhodes and Spriggs to come to the plant to help clear the #4 size gravel from the log washer. Campbell, Rhodes, and Spriggs worked on clearing the log washer using metal rods and a water hose. At approximately 8:15 a.m., a customer truck arrived, and Campbell left the wash plant to load the customer truck. Rhodes and Spriggs were on the first level of the wash plant at the cleanout ports. Rhodes went to the second-level catwalk to use the water hose to continue the cleaning process. Spriggs remained on the first level and continued using the metal rods to remove the gravel from the cleanout ports (see Appendix A).

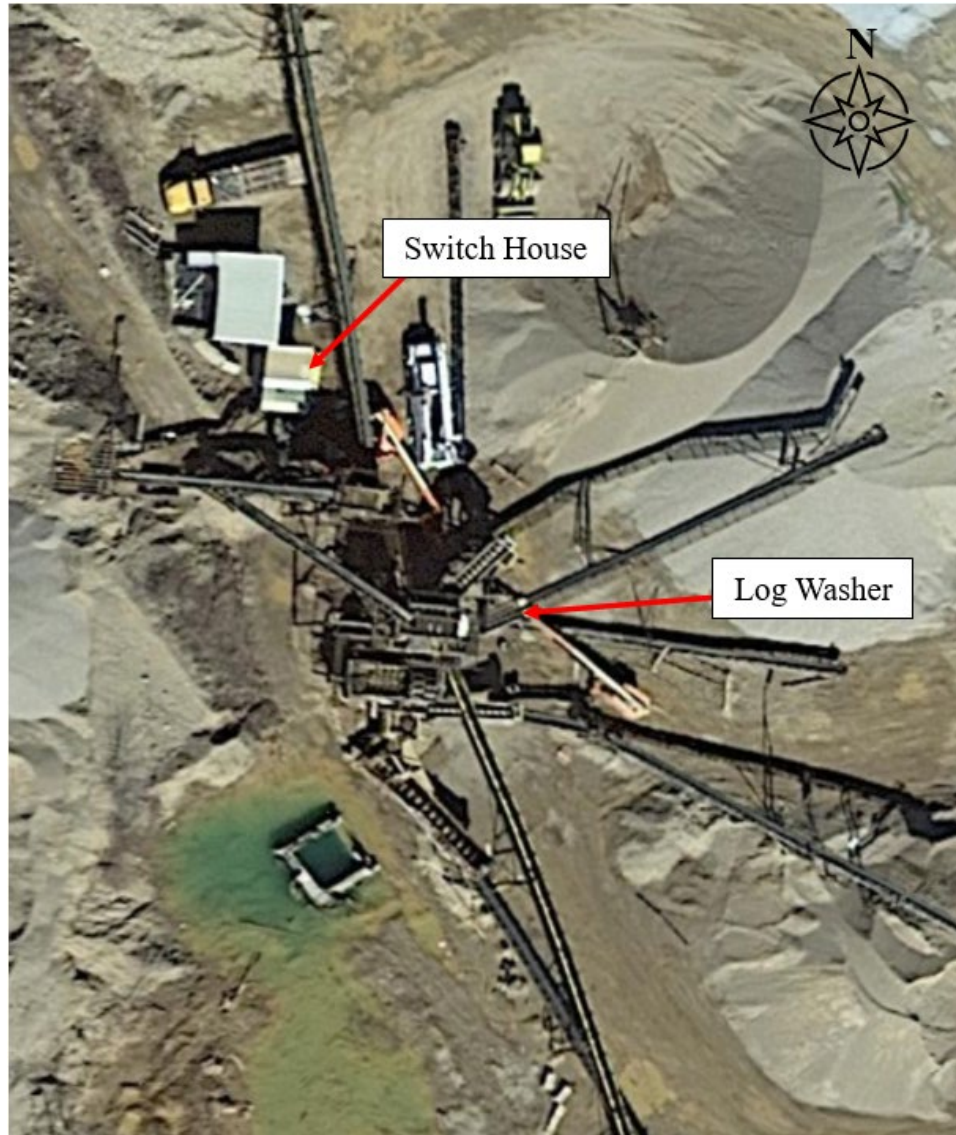
APPENDIX C – Aerial View of Wash Plant

The accident occurred at the log washer located at the wash plant (see Appendices C and D). The lower and upper ends of the log washer were 11 feet and 19 feet above the ground, respectively. The second-level catwalk was approximately 20 feet above the ground.

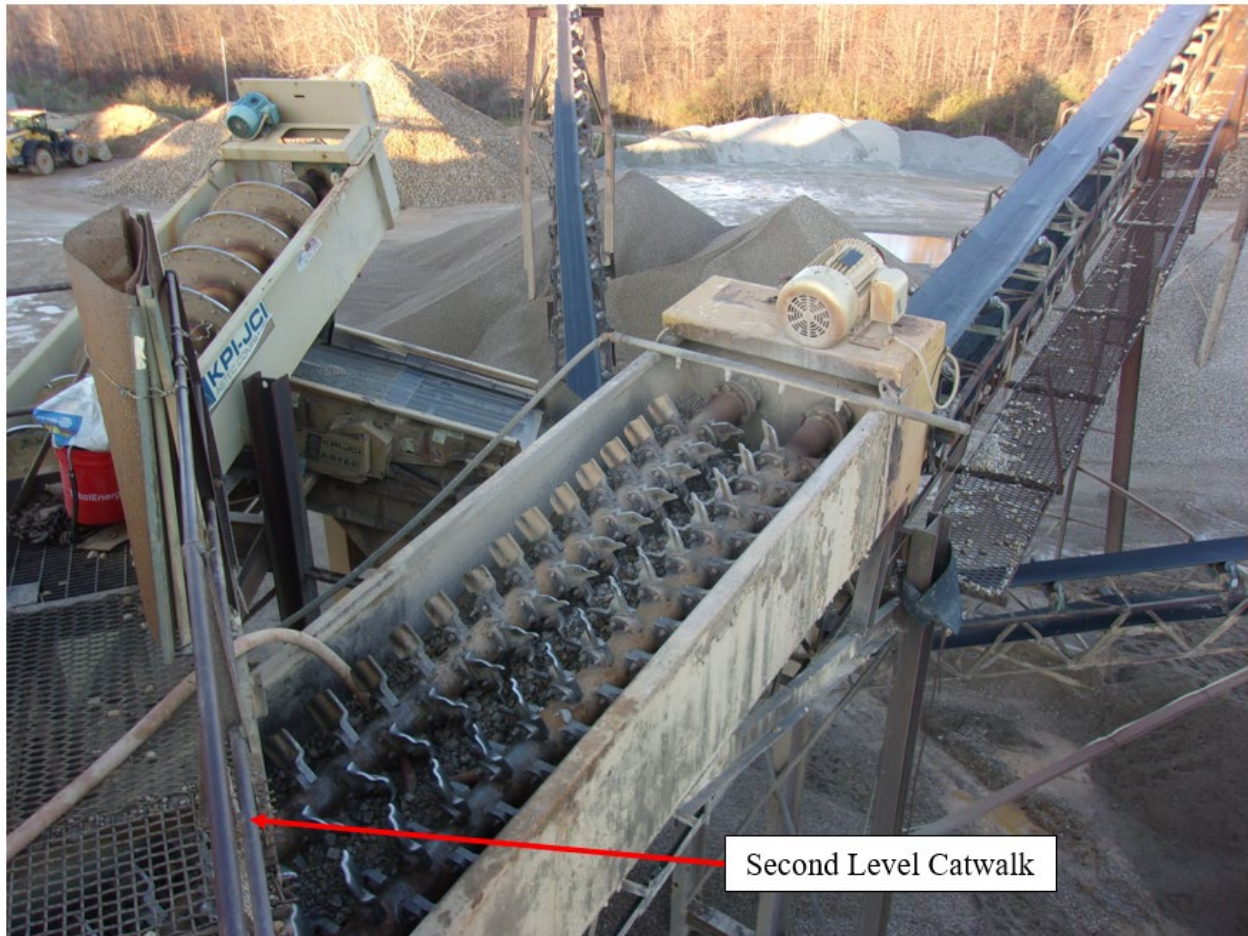
APPENDIX D – Eagle Sol-Clay Log Washer at Wash Plant

The log washer involved in the accident was an Eagle Sol-Clay Log Washer. The manufacturer's manual, which the mine operator provided to MSHA, had a warning statement on page seven which read, "WARNING TO PREVENT INJURY: TURN OFF AND LOCK THE POWER TO THIS MACHINE BEFORE DOING ANY SERVICE WORK. EACH MAN WORKING ON ANY MACHINE SHOULD PLACE HIS OWN PADLOCK ON THE DISCONNECT SWITCH AND REMOVE ONLY WHEN HE IS DONE WITH HIS SERVICE OPERATION." Investigators tested the controls on the log washer and found no defects that contributed to the accident.

Investigators determined Rhodes became entangled in the log washer while it was energized and not blocked against motion. The mine operator did not de-energize and block the log washer against motion while performing maintenance.

1. Root Cause: The mine operator did not de-energize and block the log washer against motion while performing maintenance.

Corrective Action: The mine operator developed and implemented new written procedures for plant maintenance procedures. The mine operator trained all miners on these procedures.
