UNITED STATES
DEPARTMENT OF LABOR
MINE SAFETY AND HEALTH ADMINISTRATION

REPORT OF INVESTIGATION

Fatal Powered Haulage Accident
November 27, 2024

Cargill Deicing Technology-Cleveland Mn
Cargill Deicing Technology
Cleveland, Cuyahoga County, Ohio
ID No. 33-01994

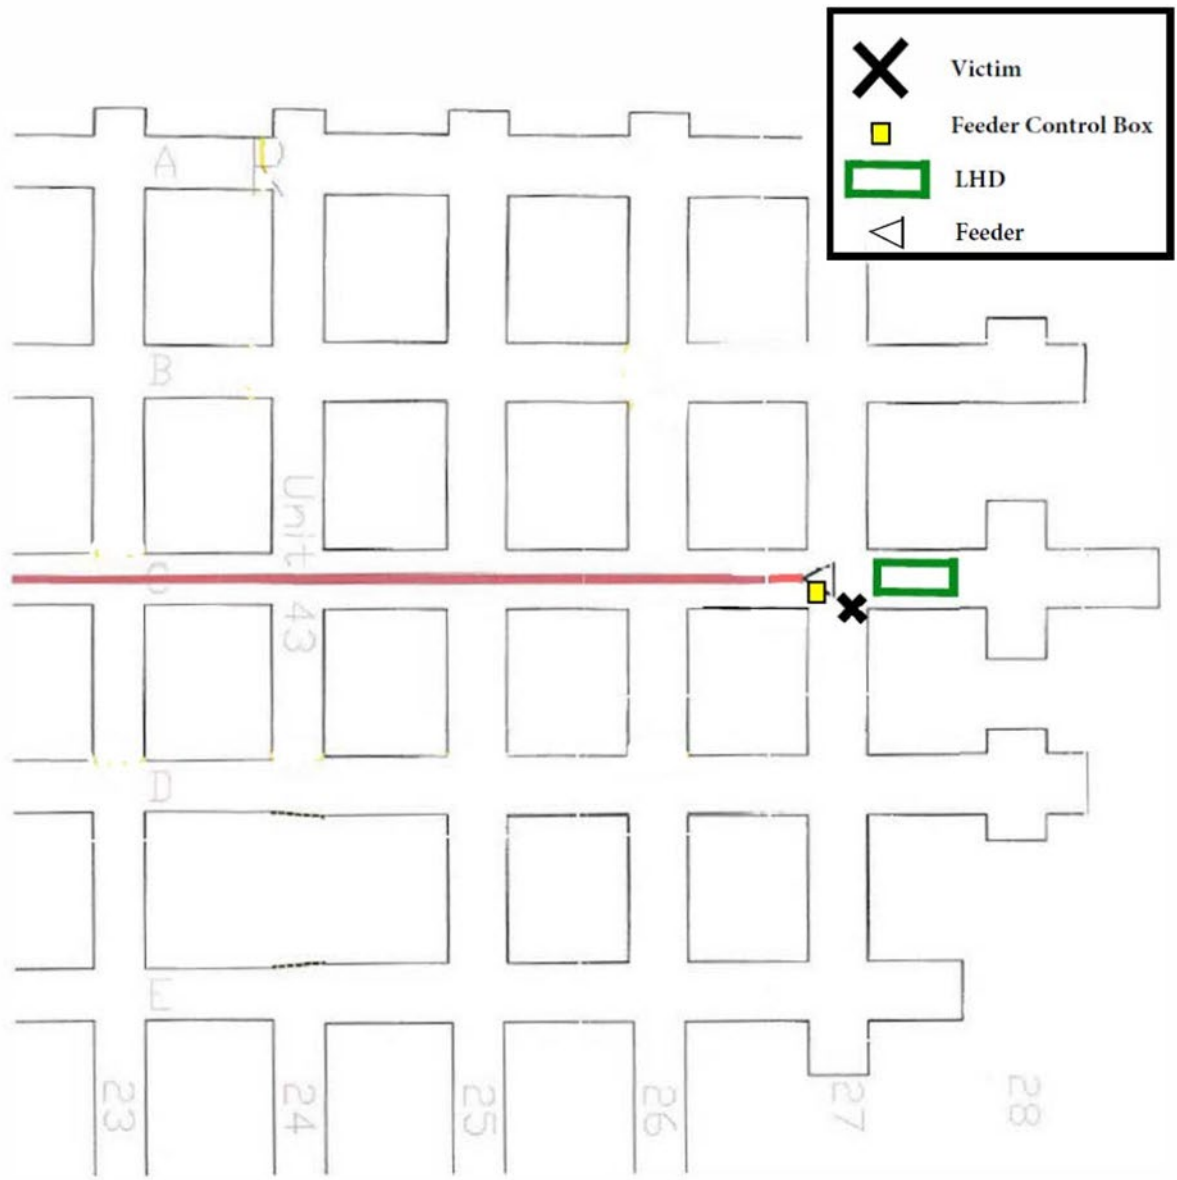
APPENDIX A – Unit 43 Crusher Area

On November 27, 2024, at 2:40 p.m., Sychla arrived at the mine. According to interviews, Sychla traveled underground to the electrical rebuild shop and began his regular duties of repairing motors for various equipment. At 5:05 p.m., the crusher in Unit 43 stopped functioning. Corey Cline, Underground Maintenance Supervisor, called Sychla on the underground phone and assigned him to troubleshoot the crusher. Sychla traveled to Unit 43 in a utility vehicle and parked in the crusher control panel area (see Appendix A).

At 5:40 p.m. Sychla reset the breaker and put the crusher back into operation. Sychla got into his utility vehicle and began to back out of the crusher control panel area. At the same time, Travis Stigall, Production Operator, who had been operating an LHD loader to clean up overspill from the crusher's feed hopper, was traveling forward into the crusher control panel area with the LHD loader bucket raised approximately 37 inches off the floor. The LHD loader collided with Sychla's utility vehicle, pushing it approximately ten feet forward and causing Sychla to either fall or jump out of the utility vehicle. Sychla was then run over by the front left tire of the LHD loader. The LHD loader was then put in reverse, dragging the utility vehicle underneath the LHD loader bucket for 10.5 feet, until Stigall saw Sychla on the ground.

The accident occurred at crosscuts C and 26 of Unit 43.

Investigators found evidence of music and/or video devices in the LHD loader and utility vehicle but could not determine if Stigall and Sychla were distracted by these devices. Stigall was unaware that Sychla was in the crusher control panel area and therefore communication was not established between the two miners. The mine operator did not place signs or signals that warn of hazardous conditions at appropriate locations, which contributed to the accident.

Corrective Action: The mine operator developed and implemented a new written procedure that requires placards to be placed on the entrance to the units and on the placard board that indicate to all miners that an LHD loader is operating in an area and whether authorization is required to enter the unit. Additionally, the mine operator updated the traffic control policy to prohibit any devices or items that could cause a distraction inside the equipment operator's compartment. The mine operator trained all miners on these procedures.
