REPORT OF INVESTIGATION

Fatal Powered Haulage Accident  
November 5, 2024

Cactus  
DelHur Industries, Inc.  
McCamey, Crane County, Texas  
ID No. 41-05396

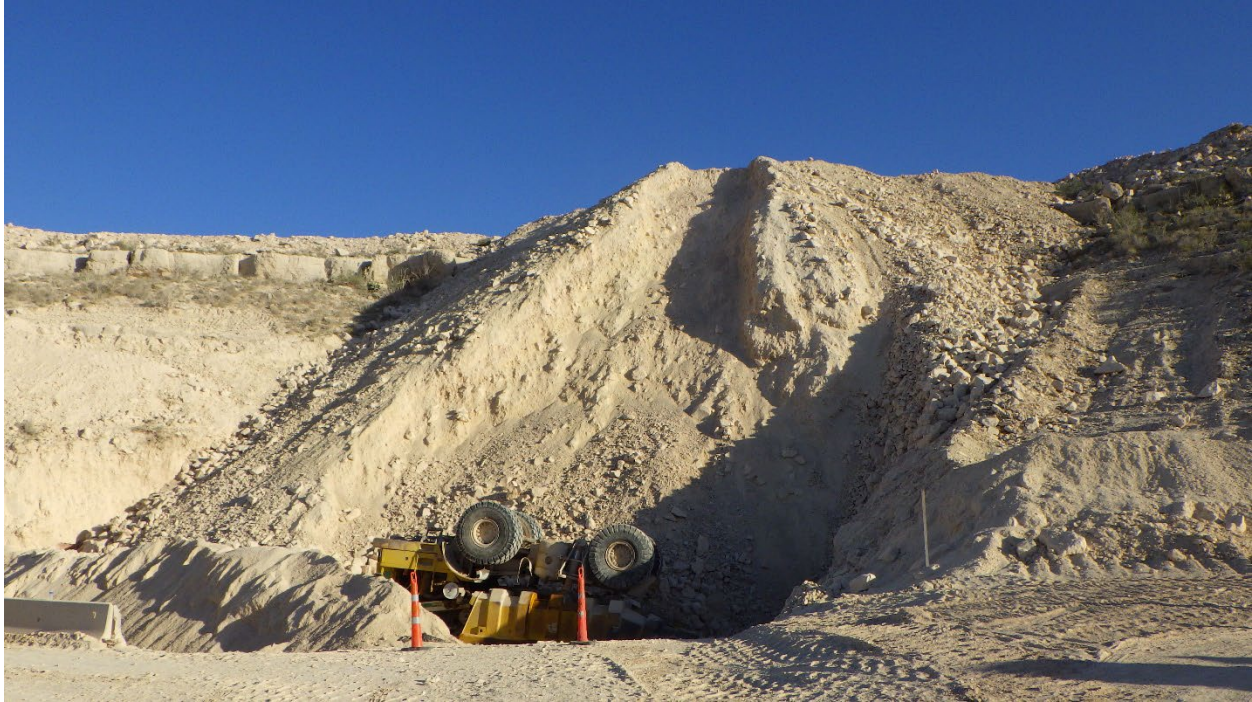
On November 5, 2024, at approximately 1:00 p.m., Troy Tarr, a 32-year-old haul truck operator with nine weeks and two days of experience, died when the ground at the dump point failed, causing the haul truck to roll over multiple times and come to rest at the base of the primary crusher stockpile.

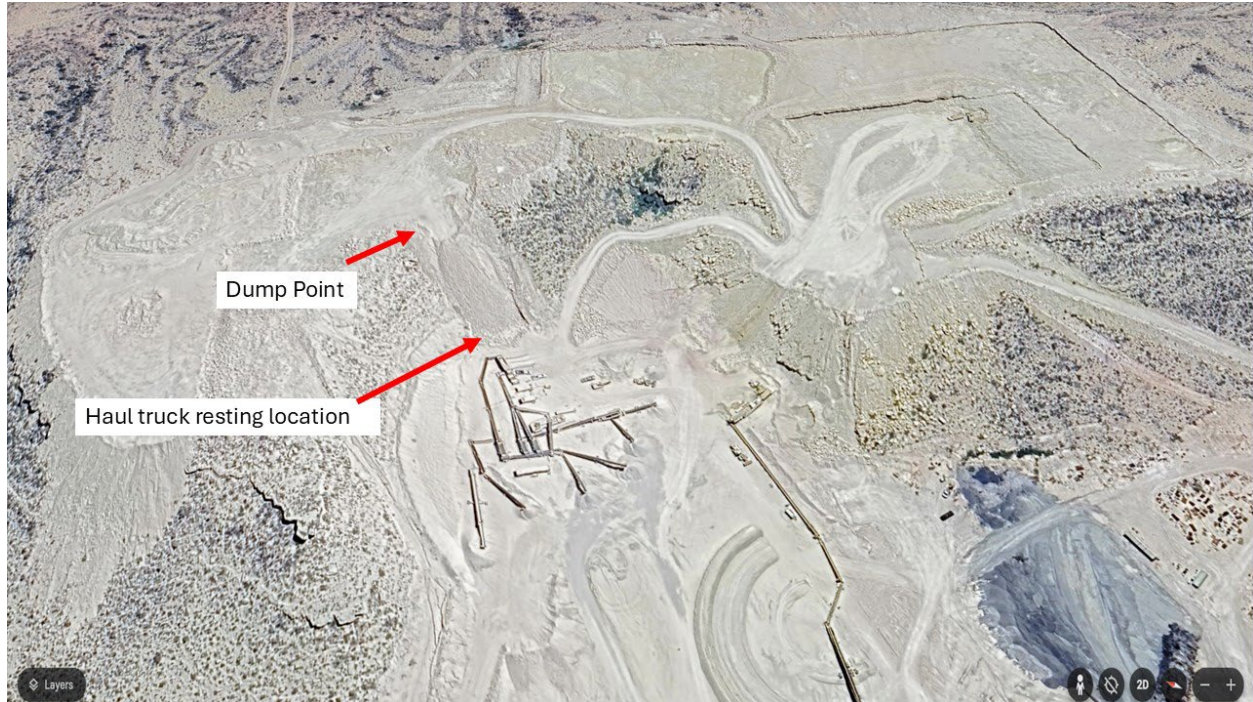
## APPENDIX C – Accident Location

The accident occurred at the primary dump point above the primary crusher (see Appendices B and C). The ground failed beneath the haul truck causing it to overturn multiple times down the approximately one-hundred foot of the face of the stockpile, coming to rest at the base.

Investigators determined the top of the dump point had extended approximately 80 feet beyond the solid rock of the plateau due to continuous dumping of unconsolidated material. The front-end loader loading from the base of the stockpile undermined the integrity of the slope. These two factors created obvious and extensive hazardous conditions at the dump point. The haul truck should have dumped the material a safe distance back, and a bulldozer should have pushed the material over the edge of the dump point. A bulldozer was available for use at the top of the dump point but was not used on the day of the accident. The weight of the loaded haul truck on the unconsolidated material caused the dump point to fail. The mine operator did not ensure the dump point could support the weight of the loaded haul truck, which contributed to the accident.

Corrective Action: The existing dumping point has been eliminated. It has been replaced by a dumping location that does not require dumping from the top of the pile.

Corrective Action: A new dumping location has been established which does not require dumping from the top of a pile. Therefore, the edge of a dumping point is eliminated.
