REPORT OF INVESTIGATION

Fatal Slip or Fall of Person Accident
September 20, 2024

I-75 Quarry
Blue Water Industries
Heiskell, Knox County, Tennessee
ID No. 40-01247

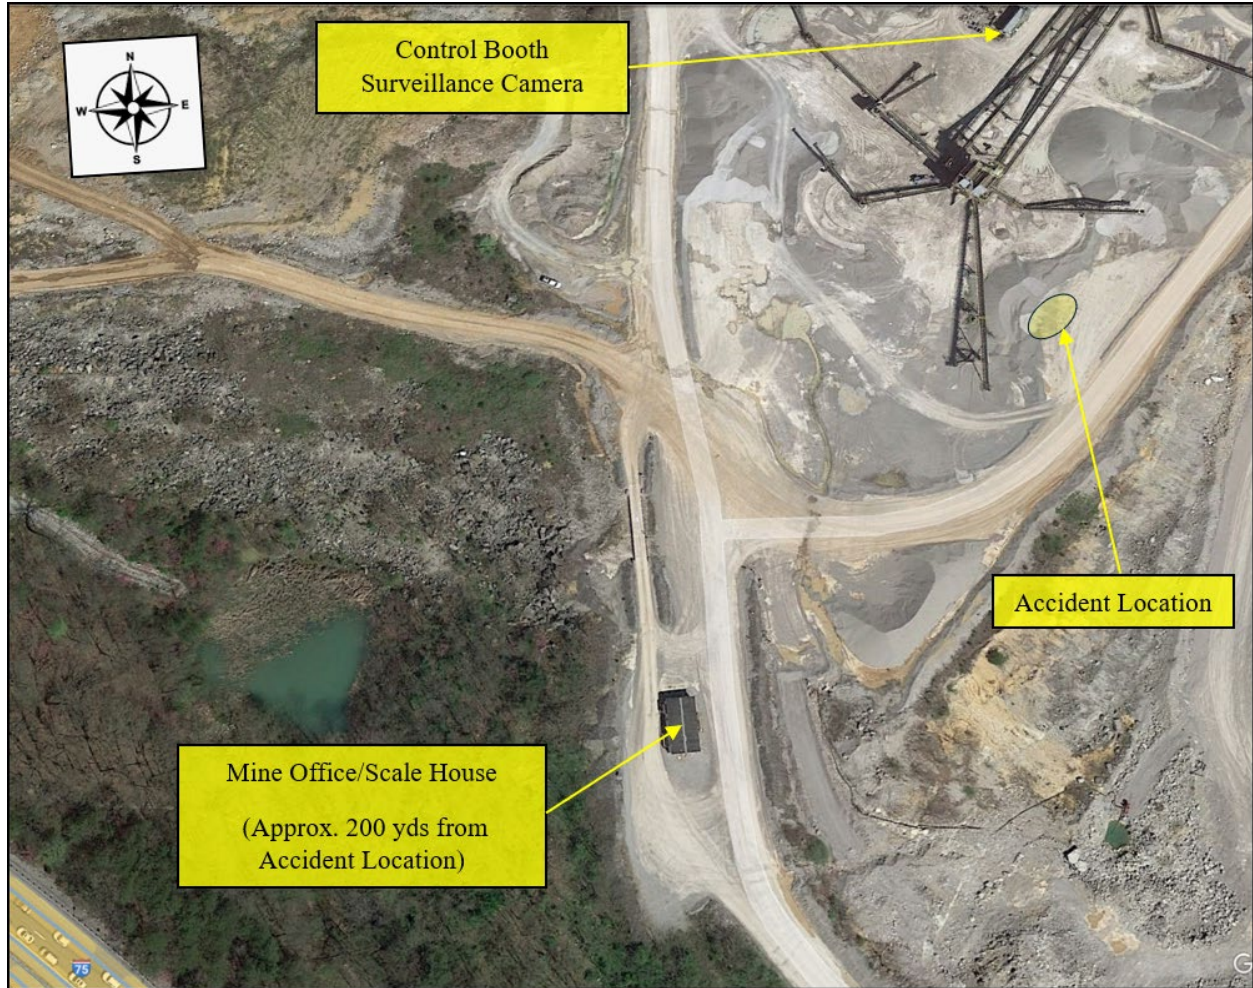
APPENDIX A – Aerial View of I-75 Quarry

On September 20, 2024, at 2:53 p.m., company video surveillance shows Cobb operating, then parking, the Caterpillar 980K loader at the #7's Loadout Area, south of the C-16 belt conveyor (see Appendix A). According to interviews, at 3:07 p.m., Harlan Cox, Driver for SA Recycling, observed Cobb lying on the ground and tried to get Cobb to respond to him. Cox received no response and there was no indication that Cobb was breathing. Cox called 911 via cell phone and proceeded to the office to notify the mine operator.

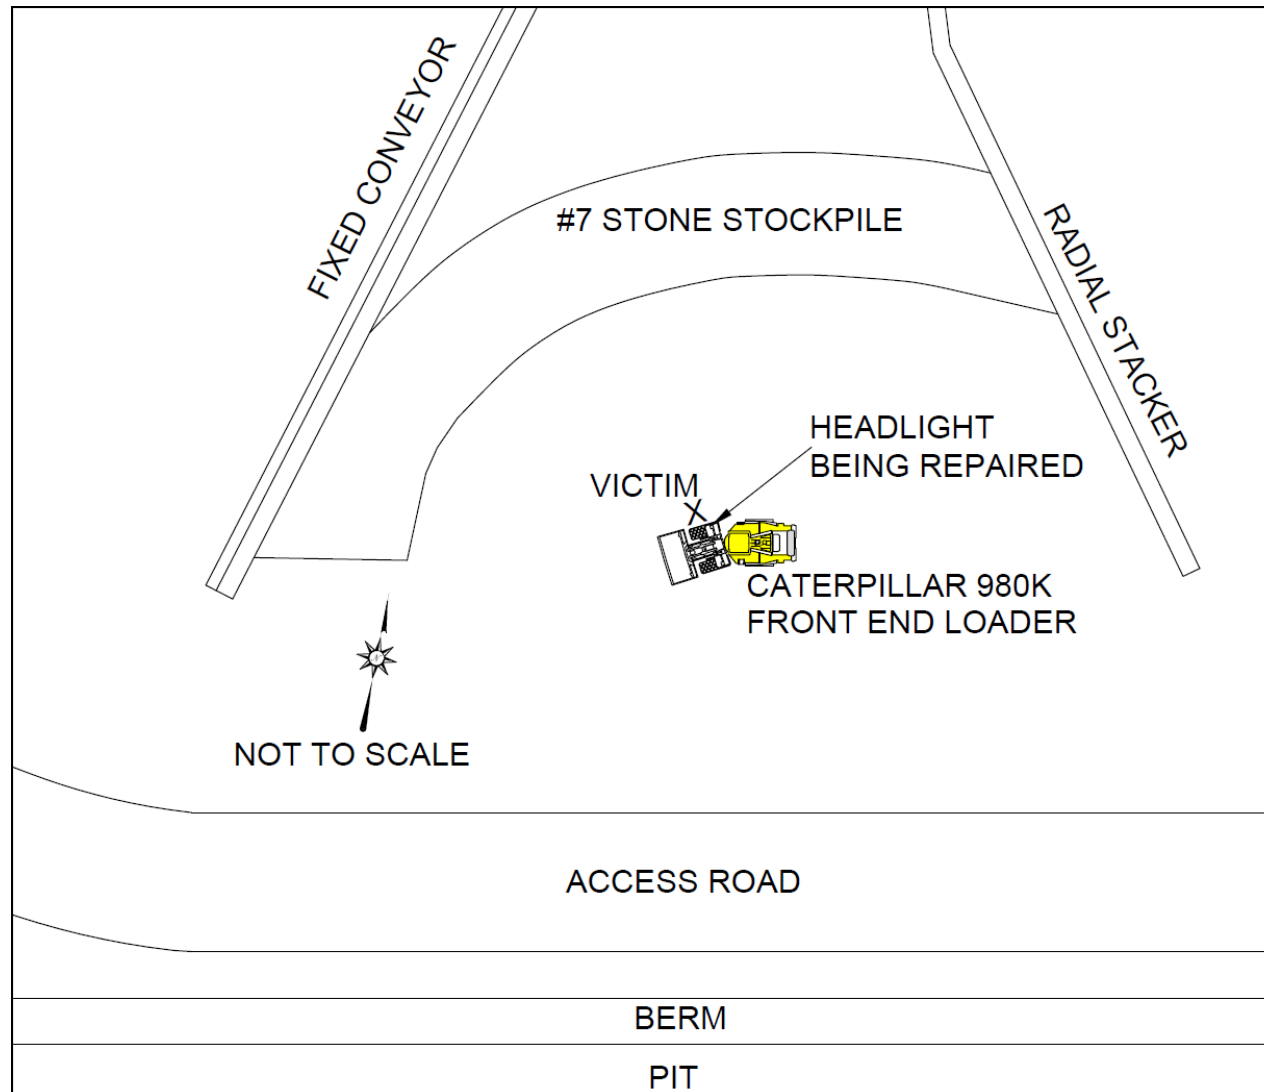
APPENDIX C – Sketch of Accident Location

The accident occurred at the #7's Loadout Area south of the C-16 belt conveyor belt (see Appendices C and D). The area was dry, with ground conditions being smooth and compacted with an approximate one to two percent grade. Investigators observed no hazards, obstacles, or obstructions in the area.

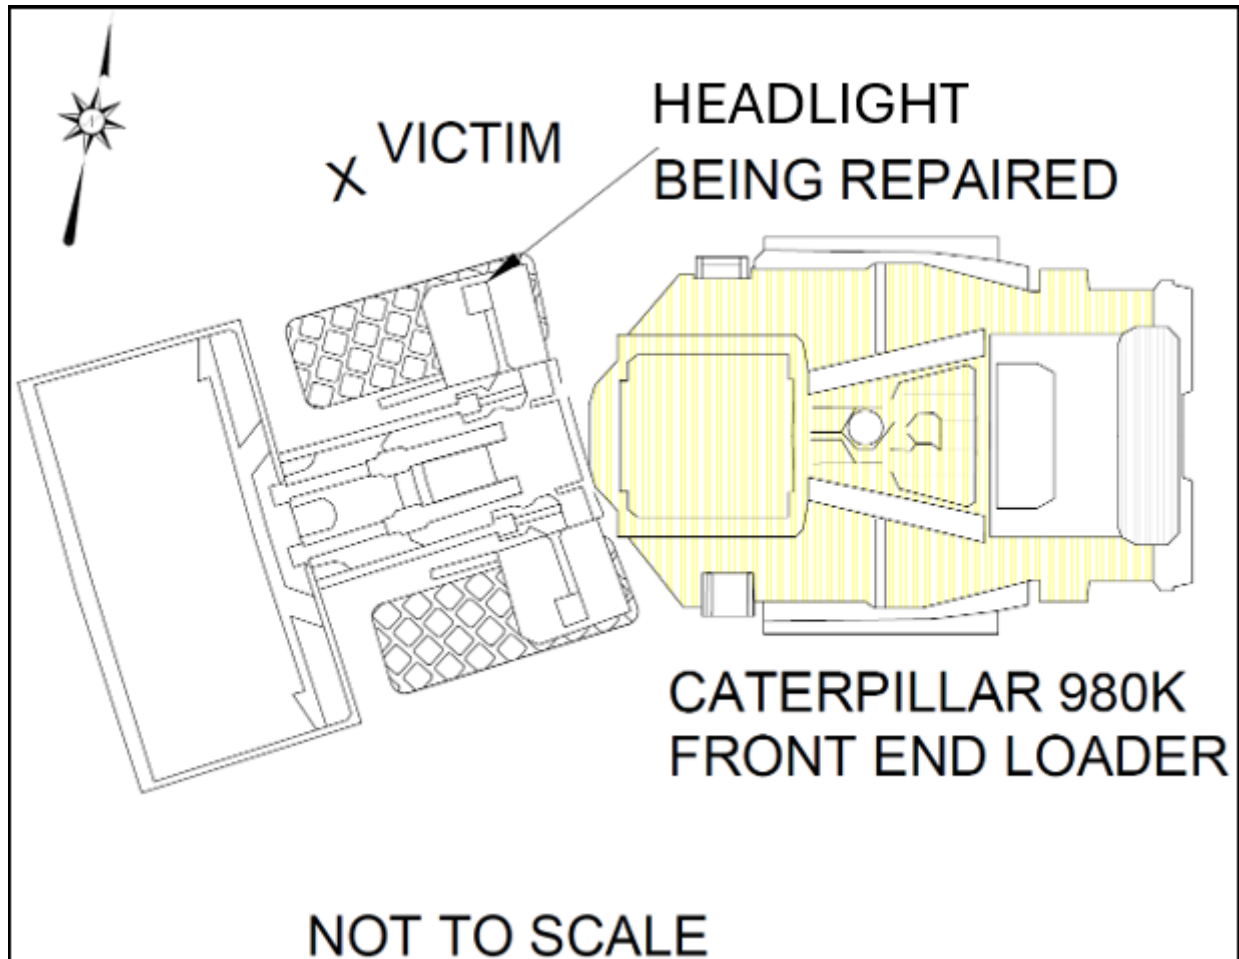
APPENDIX D – Sketch of Accident Scene

Investigators found footprints on the loader's boom and handprints on the windshield that indicated Cobb had crossed from the left fender to the right fender across the loader's boom, then began performing maintenance on the right front headlamp in while standing on the right front tire, 72 inches off the ground. The mine operator did not provide and maintain safe means of access for Cobb to the working place where maintenance was being performed. Investigators determined that this contributed to the accident.

Corrective Action: The mine operator conducted additional training with all employees on safe work practices from elevated areas based on policy already in place.

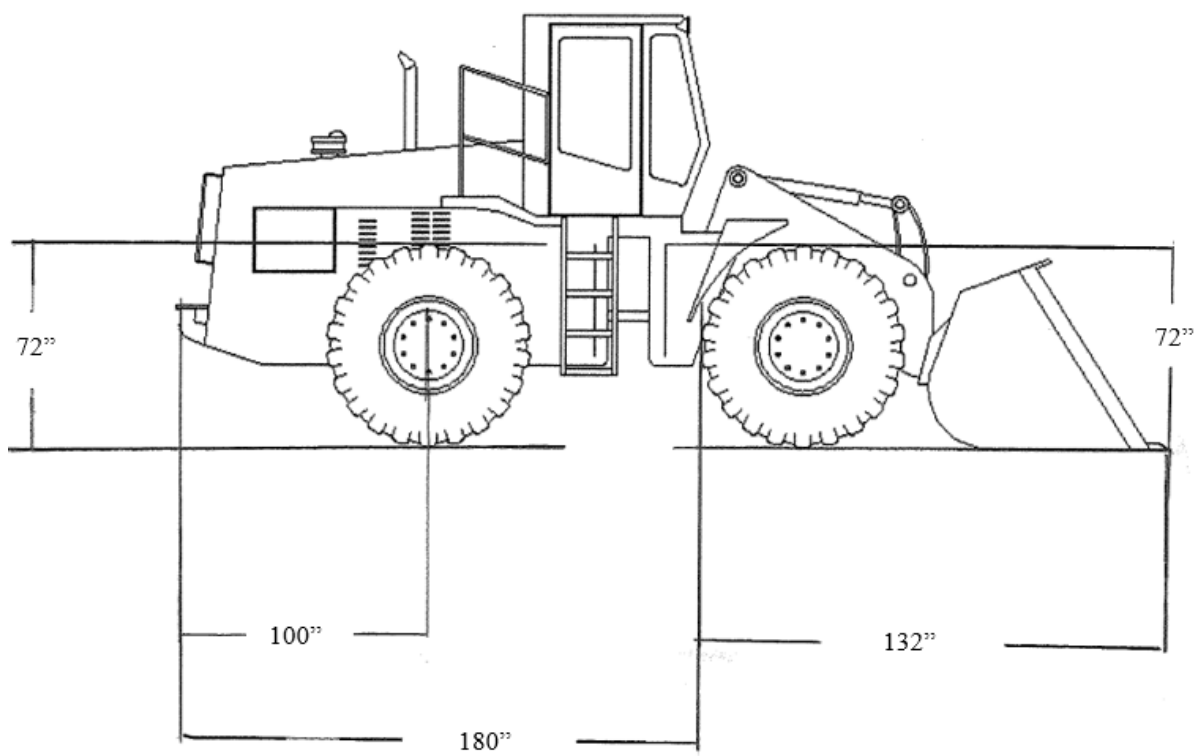
APPENDIX E – Sketch of Cat 980K Front-End Loader

The mine operator owned the Caterpillar 980K loader (see Appendix E) involved in the accident. It was manufactured in 2014. According to interviews, Joseph Rutherford, Plant Operator, and Brian Delk, Plant Maintenance, both stated that Cobb had come into the shop area at the start of the shift and asked where replacement bulbs for the lights on the Caterpillar 980K loader were located. Rutherford and Delk located the bulbs and offered to replace the bulb for Cobb, but he refused and said he would take care of it later. This was the only indication of any issues with the loader.

Investigators performed a functionality test and determined the brakes, steering, safety controls, and sounding devices were all operating properly. Investigators found no equipment defects. All but one screw on the right front headlight had been loosened.
