REPORT OF INVESTIGATION

Fatal Fall of Roof or Back Accident  
September 25, 2024

Oak Grove Mine  
Crimson Oak Grove Resources LLC  
Adger, Jefferson County, Alabama  
ID No. 01-00851

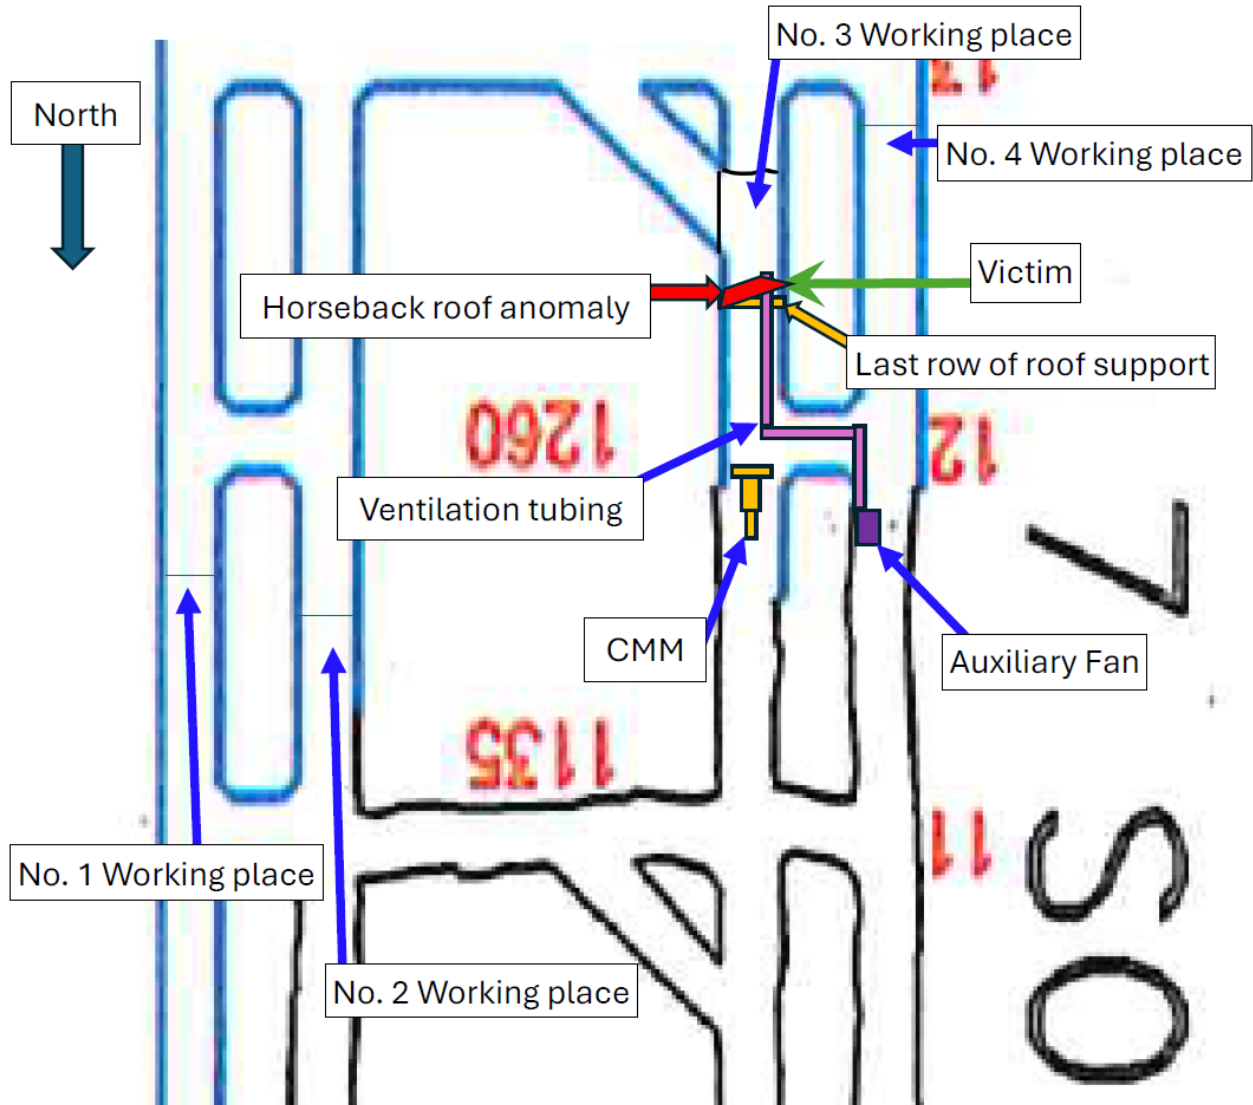
APPENDIX B – 7 South Section Map

The accident occurred in the 7 South Section, No. 3 entry, inby crosscut No. 12, approximately five feet inby the last row of roof support. See the map in Appendix B.
