REPORT OF INVESTIGATION

Fatal Machinery Accident
September 28, 2024

Leer Mine
ACI Tygart Valley
Thornton, Taylor County, West Virginia
ID No. 46-09192

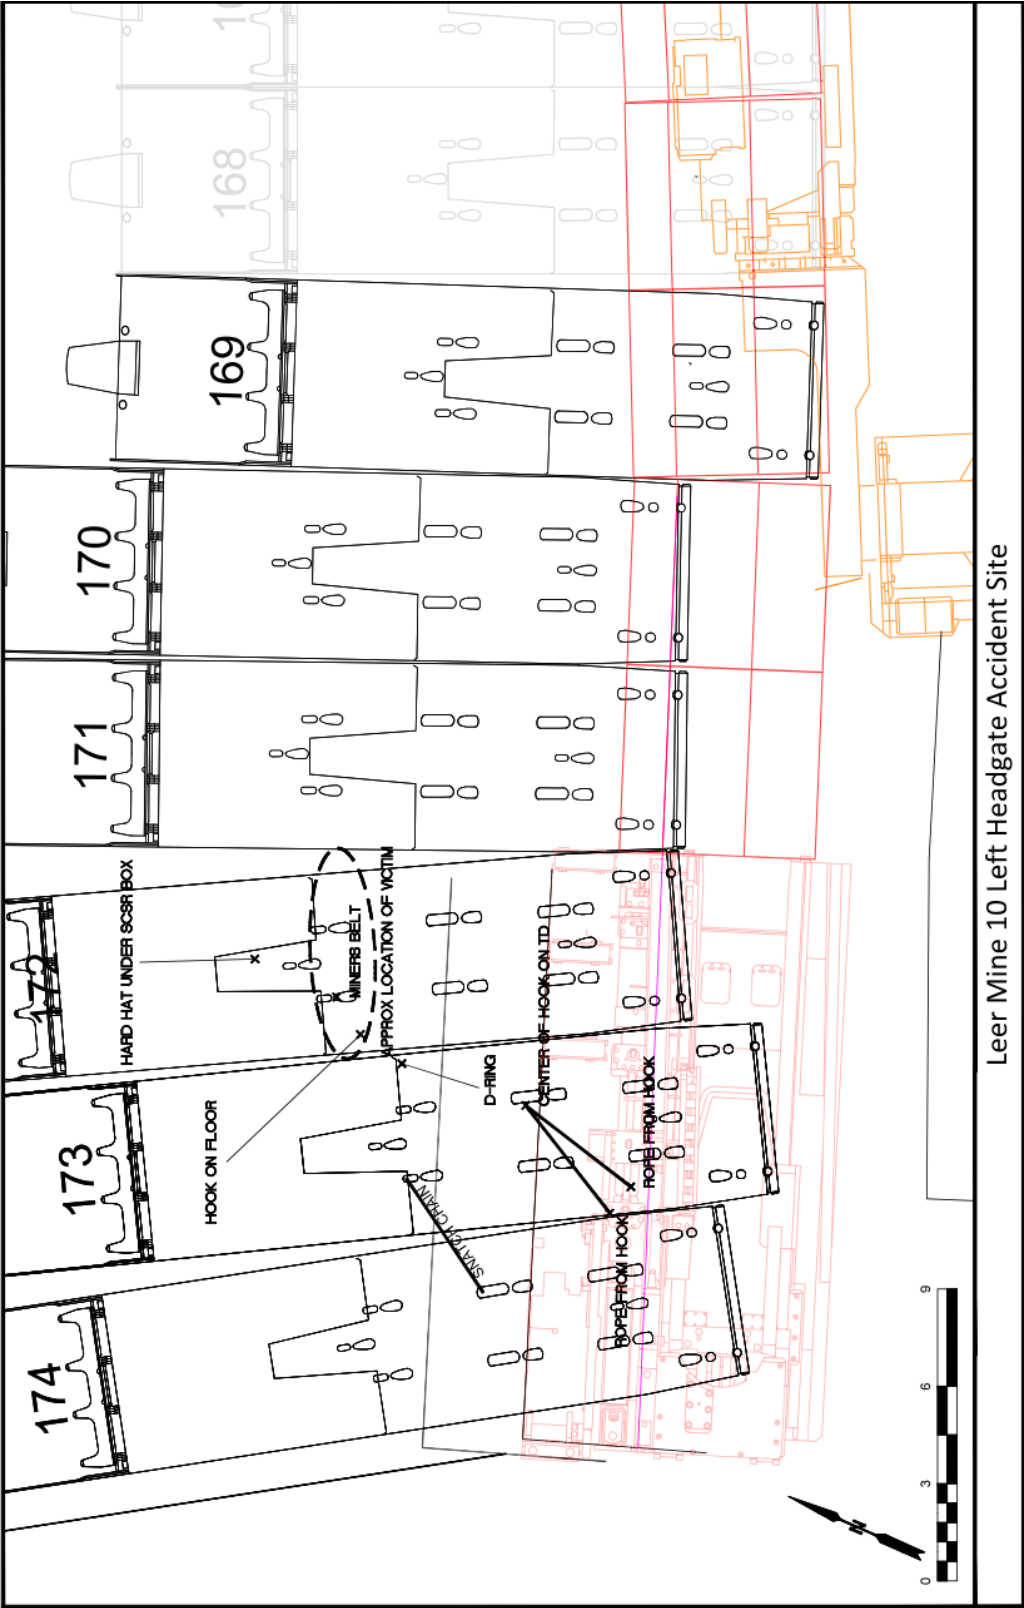
Leer Mine 10 Left Headgate Accident Site

Jeffrey Borgman, Longwall Foreman, placed a chain and hook sling between the No. 174 and No. 173 shields and a nylon rope and hook sling between the No. 173 and No. 172 shields to help keep the shields from leaning as they were advanced (see Appendix B). The slings help guide the shield as the ram jacks advance the shields. The slings remained attached to the shields at the end of the afternoon shift. The investigators traveled to the tailgate shields and determined that the mine floor had leveled out and the shields were not leaning at the time of the accident.

The shield operator will position himself at least three shields away from the shields that are connected with a device, prior to moving either of the connected shields. For example, if shields 208 and 207 are connected, the shield operator may not move either shield 208 or 207 from any position closer than shield 204 or 211. The shield will be manually operated during this time.

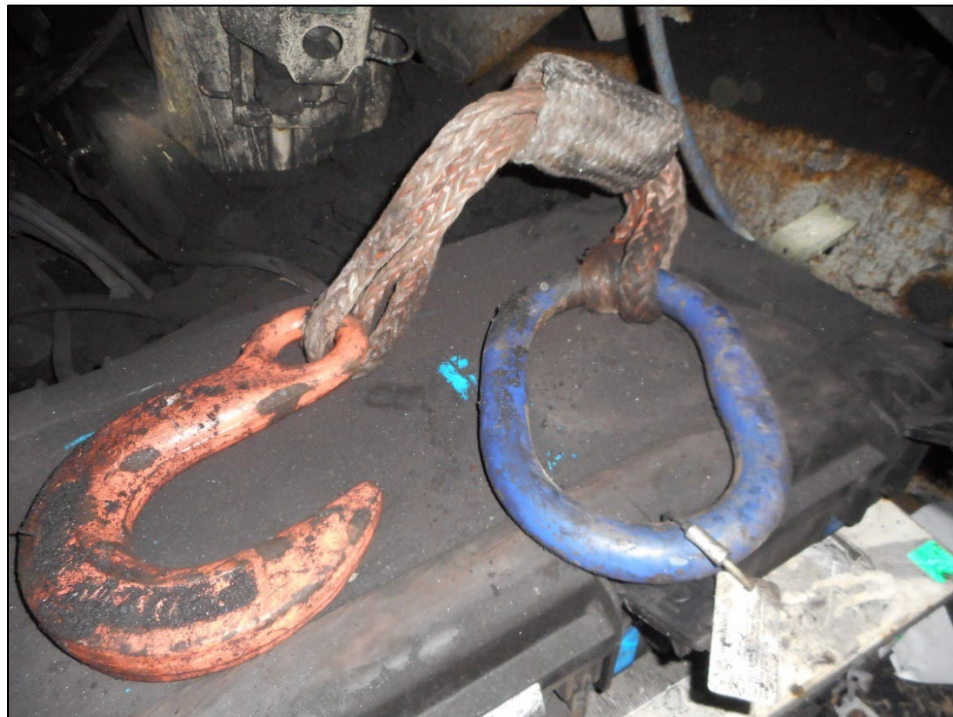
Walls was the first person to advance the tailgate shields after the slings were installed. Based on the longwall computer data, Walls first advanced the No. 174 shield and then automatically advanced the No. 173 shield from the No. 172 shield controls. Investigators concluded that the nylon rope and hook sling were overextended and broke when the No. 173 shield was advanced and set in automatic mode. When the nylon rope broke a portion of the sling struck Walls. Investigators found one portion of the nylon rope and hook sling on the tail drive and the other portion of the sling consisting of the hook and D-ring on the mine floor near Walls' location (see Appendix C). Investigators concluded that Walls was struck by the hook and/or D-ring portion of the sling.

Sling Portion Found on Mine Floor

Only suitable connecting devices, without rings, will be used on the active longwall face.

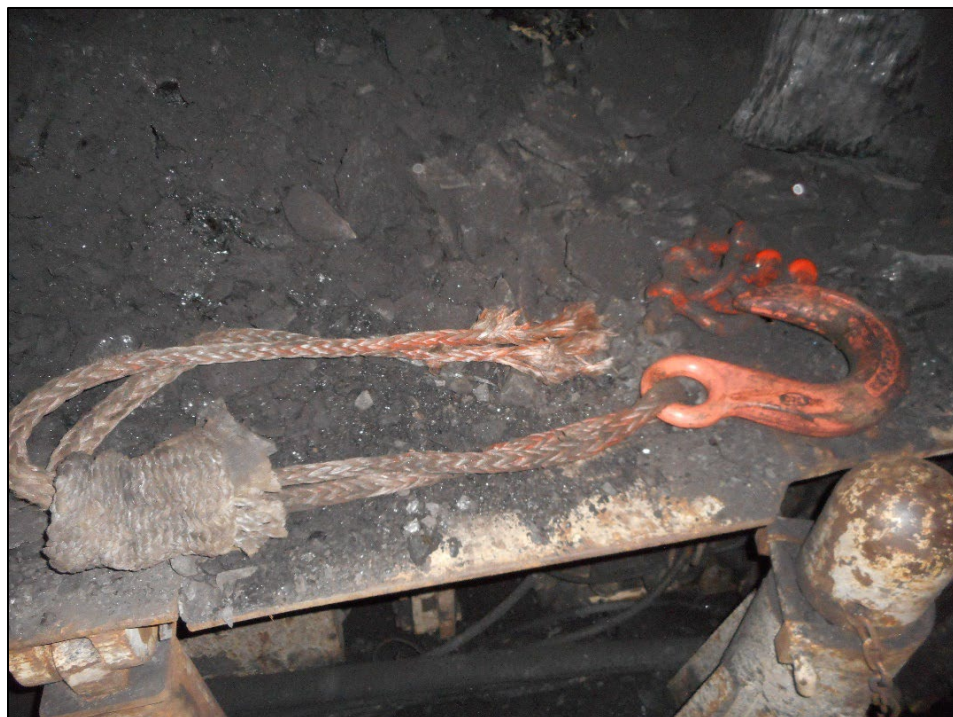
Sling Portion Found on the Tail Drive
