REPORT OF INVESTIGATION

Fatal Powered Haulage Accident  
September 6, 2024

Bosket Mountain  
Bosket Brothers Bluestone, LLC  
Deposit, Broome County, New York  
ID No. 30-04141

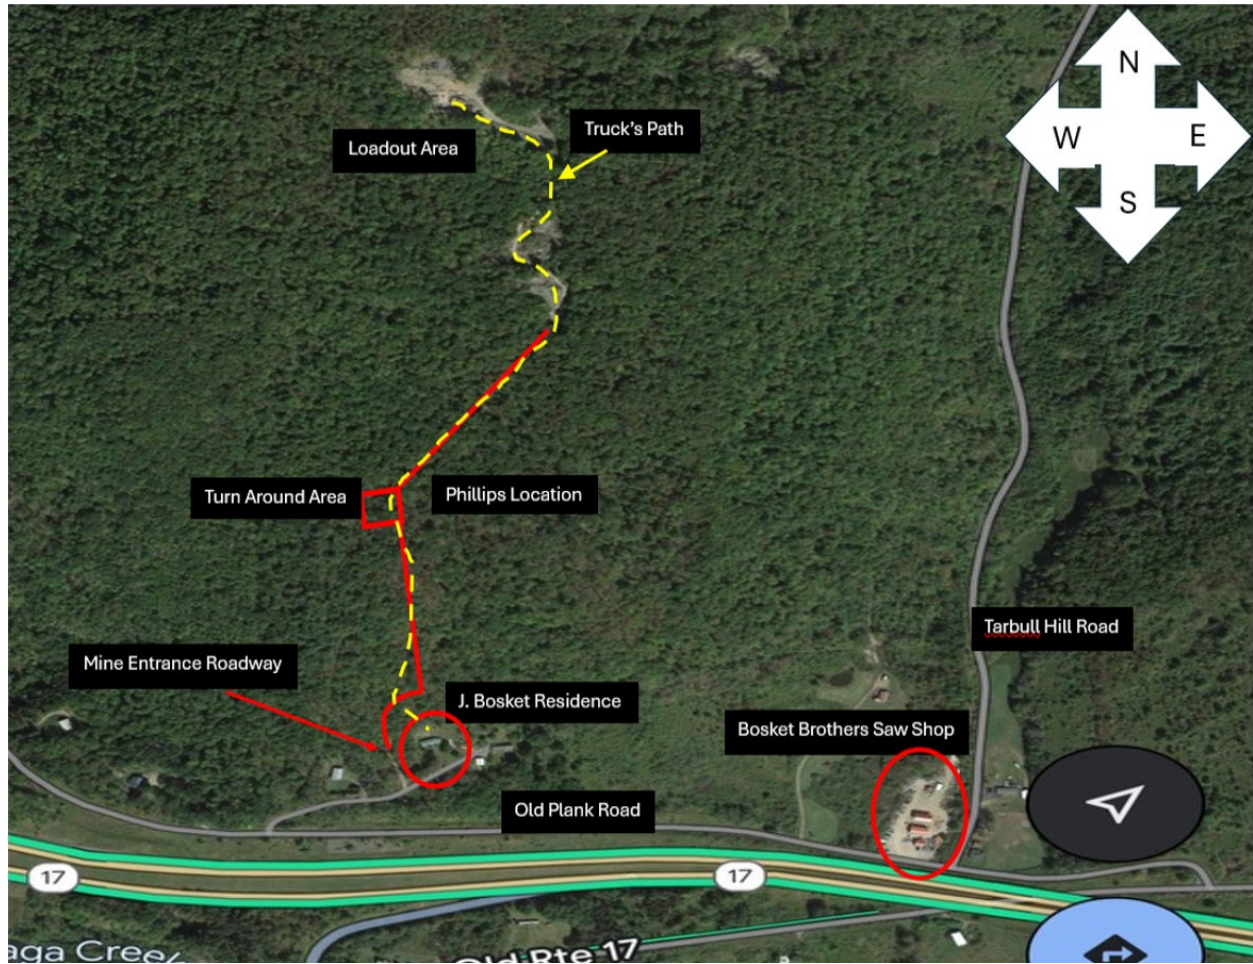
## APPENDIX B – Aerial View

The accident occurred on the mine entrance roadway (see Appendix B). The roadway had a turnaround that measured 48 feet wide and 52 to 36 feet long. The grade of the roadway at the turnaround was approximately 20 percent. From the turnaround, the truck traveled down a 24-percent grade for 288 feet, then turned into a small patch of woods. The truck traveled down an 8-foot-tall embankment and across a 39-foot-wide roadway. There were no tire tracks observed on the embankment wall or the roadway, indicating that the truck jumped the roadway due to the

steep grade, the high rate of speed, and the weight. The truck then entered a thicker patch of woods, traveled 95 feet until it entered the backyard of the residence, and finally traveled 158 feet through the backyard and into the residence.
