REPORT OF INVESTIGATION

Fatal Fall of Roof or Back Accident  
September 6, 2024

Mountaineer II Mine  
Mingo Logan Coal LLC  
Sharples, Logan County, West Virginia  
ID No. 46-09029

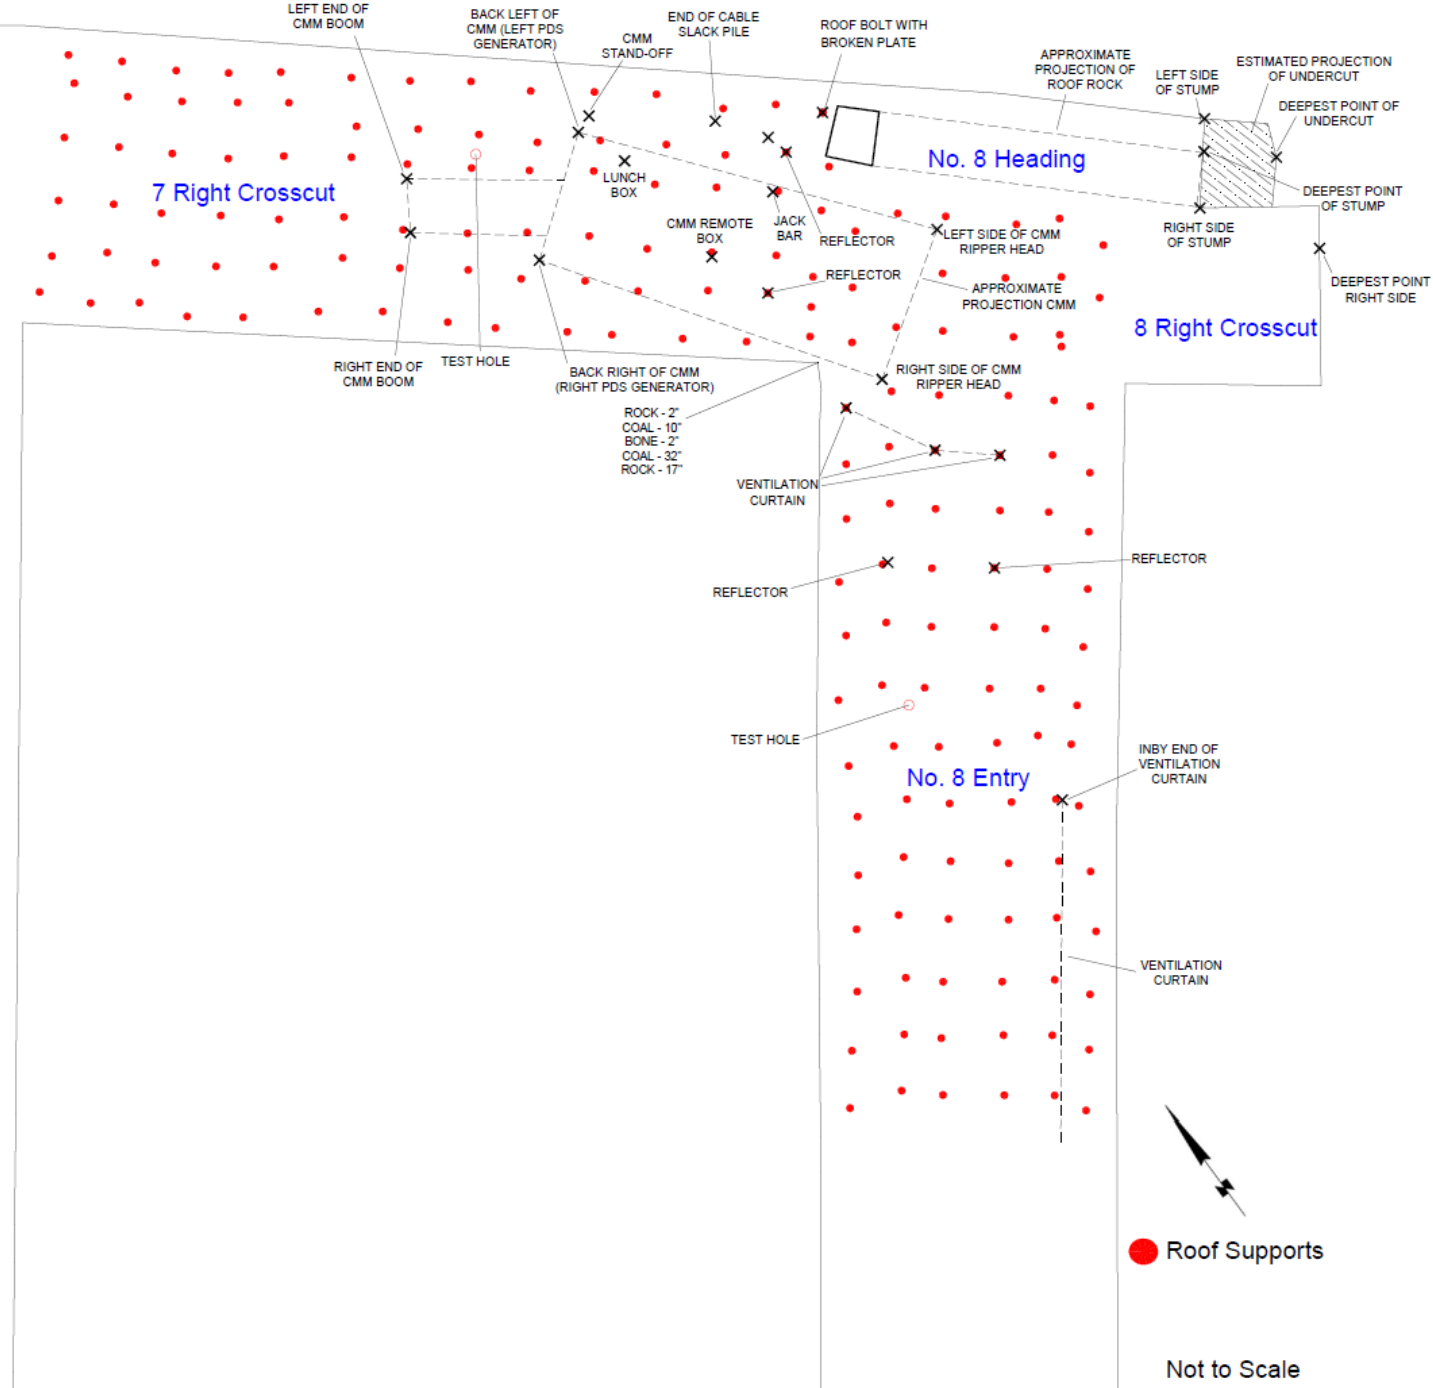
APPENDIX A – Sketch of Accident Area

After receiving instruction on the mining sequence, Chapman walked to the No. 6 entry and conducted a pre-operational examination of the right side CMM he would be operating. At 4:30 p.m., Williams completed an examination of the 7 Right crosscut as evidenced by his date, time, and initials on the 7 Right coal rib. According to interviews, at approximately 4:30 p.m., Chapman positioned his CMM in the 7 Right crosscut. During the previous shift, the 7 Right crosscut had been mined into the No. 8 heading. The No. 8 heading had been mined ten feet short, leaving a stump of uncut coal in the face (see Appendix A).

Chapman mined the eight-foot wide, 20-foot-long stump in the No. 8 heading from the 7 Right crosscut and an additional 13 feet into the 8 Right crosscut. Investigators measured this cut a total distance of 33 feet from the last complete row of roof bolts. While mining the stump, Chapman lowered the cutting head to avoid cutting the roof bolts previously installed in the No. 8 heading. Investigators determined this by observing the CMM's cutting bit pattern on the mine roof. This action left an eight-foot wide, 20-foot-long section of draw rock measuring eight to 18 inches thick where the stump was mined. The RCP states, "Draw rock will be taken as the extended cut is mined" (Page 11, Item 32). This unmined draw rock left in the mine roof fell and struck Chapman.
