REPORT OF INVESTIGATION

Fatal Powered Haulage Accident
September 8, 2023

Sewickley Mine
Neiswonger Construction Inc
Saltsburg, Indiana County, Pennsylvania
ID No. 36-09542

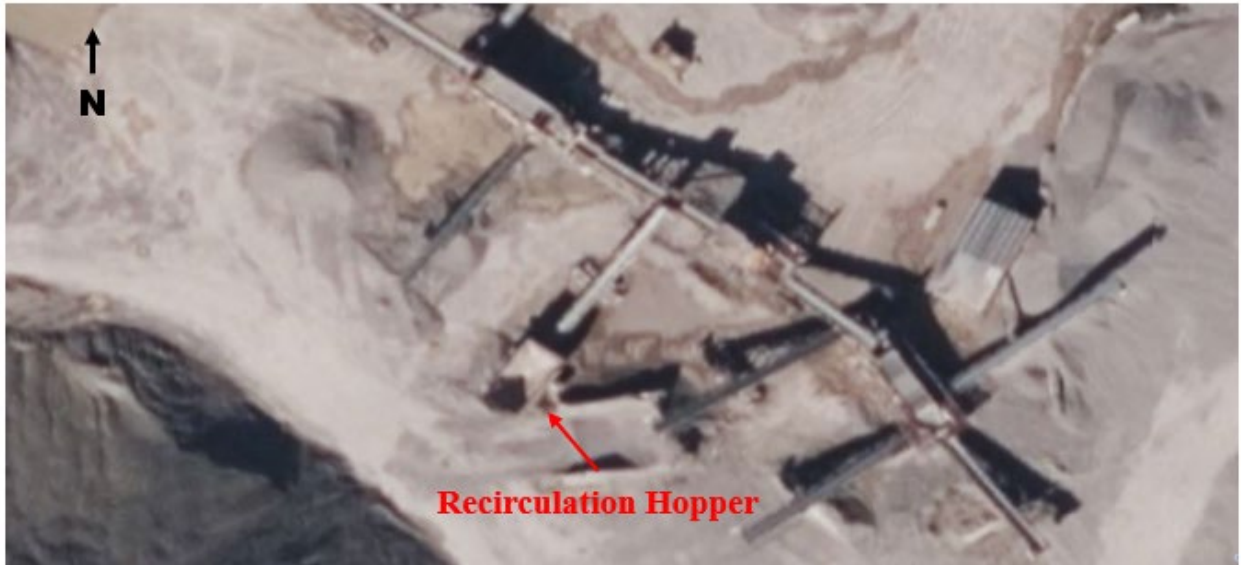
APPENDIX B – Aerial View

The accident occurred at the recirculation hopper located between the secondary crusher and the tertiary crusher (see Appendix B).

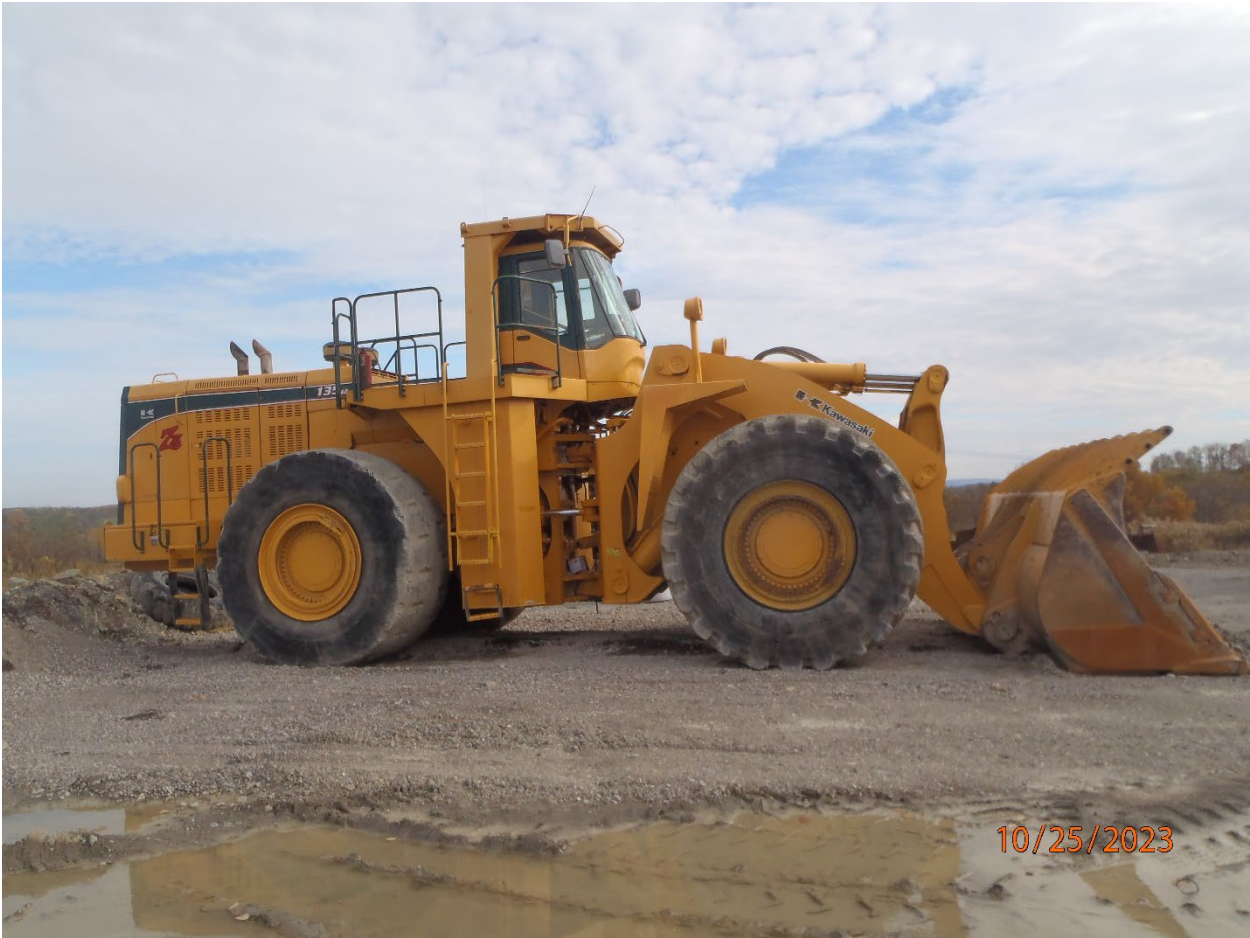
APPENDIX C – Photo of Front-End Loader

The front-end loader involved in the accident was a Kawasaki 135 Z-IV (see Appendix C). Examination of the front-end loader did not reveal mechanical deficiencies or defects that contributed to the accident.
