REPORT OF INVESTIGATION

Fatal Hoisting Accident  
August 26, 2025

Marfork Processing  
Marfork Coal Company, LLC  
Whitesville, Raleigh County, West Virginia  
ID No. 46-08374

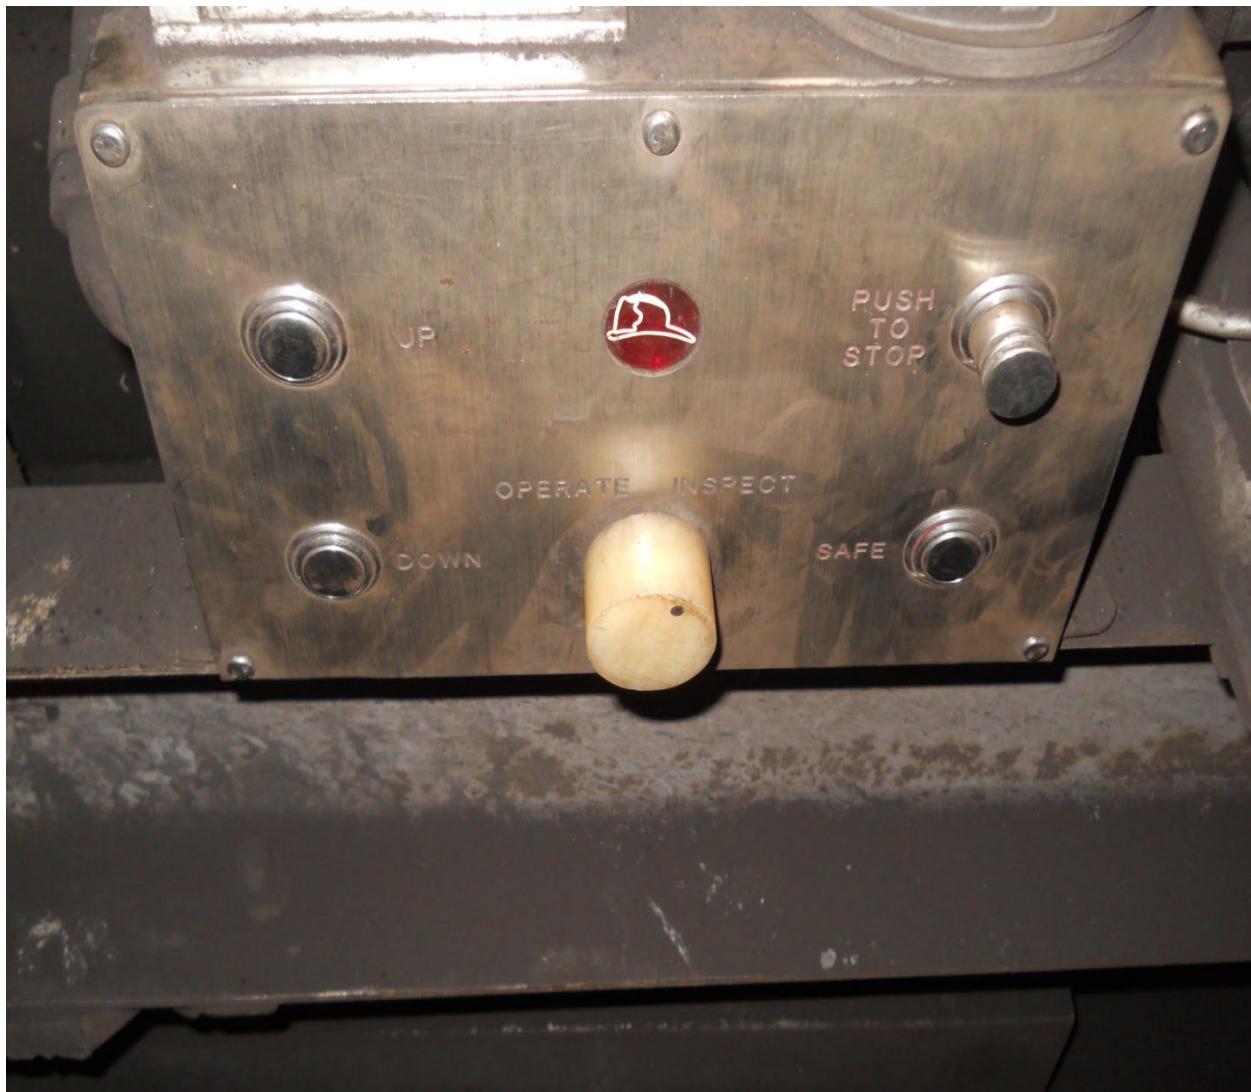
## APPENDIX B – Elevator Control Box

At approximately 10:15 a.m., Bartram sent the elevator to the fifth floor so access to the top of the elevator could be made from the sixth floor. Once the elevator stopped, Bartram opened the doors on the sixth floor and switched the controls from “operate” to “inspect” mode on the control box located on top of the elevator (Appendix B). Once on top of the elevator, Bartram stated the Go/No-Go gauge (Appendix C) used for measuring wire rope diameter was not in its usual location. After stepping off the top of the elevator, Bartram switched the controls back to “operate,” then he and McNeely entered the elevator and rode it to the first floor. McNeely decided to begin the inspection in the elevator’s pit area below the first floor. The elevator returned to the sixth floor.

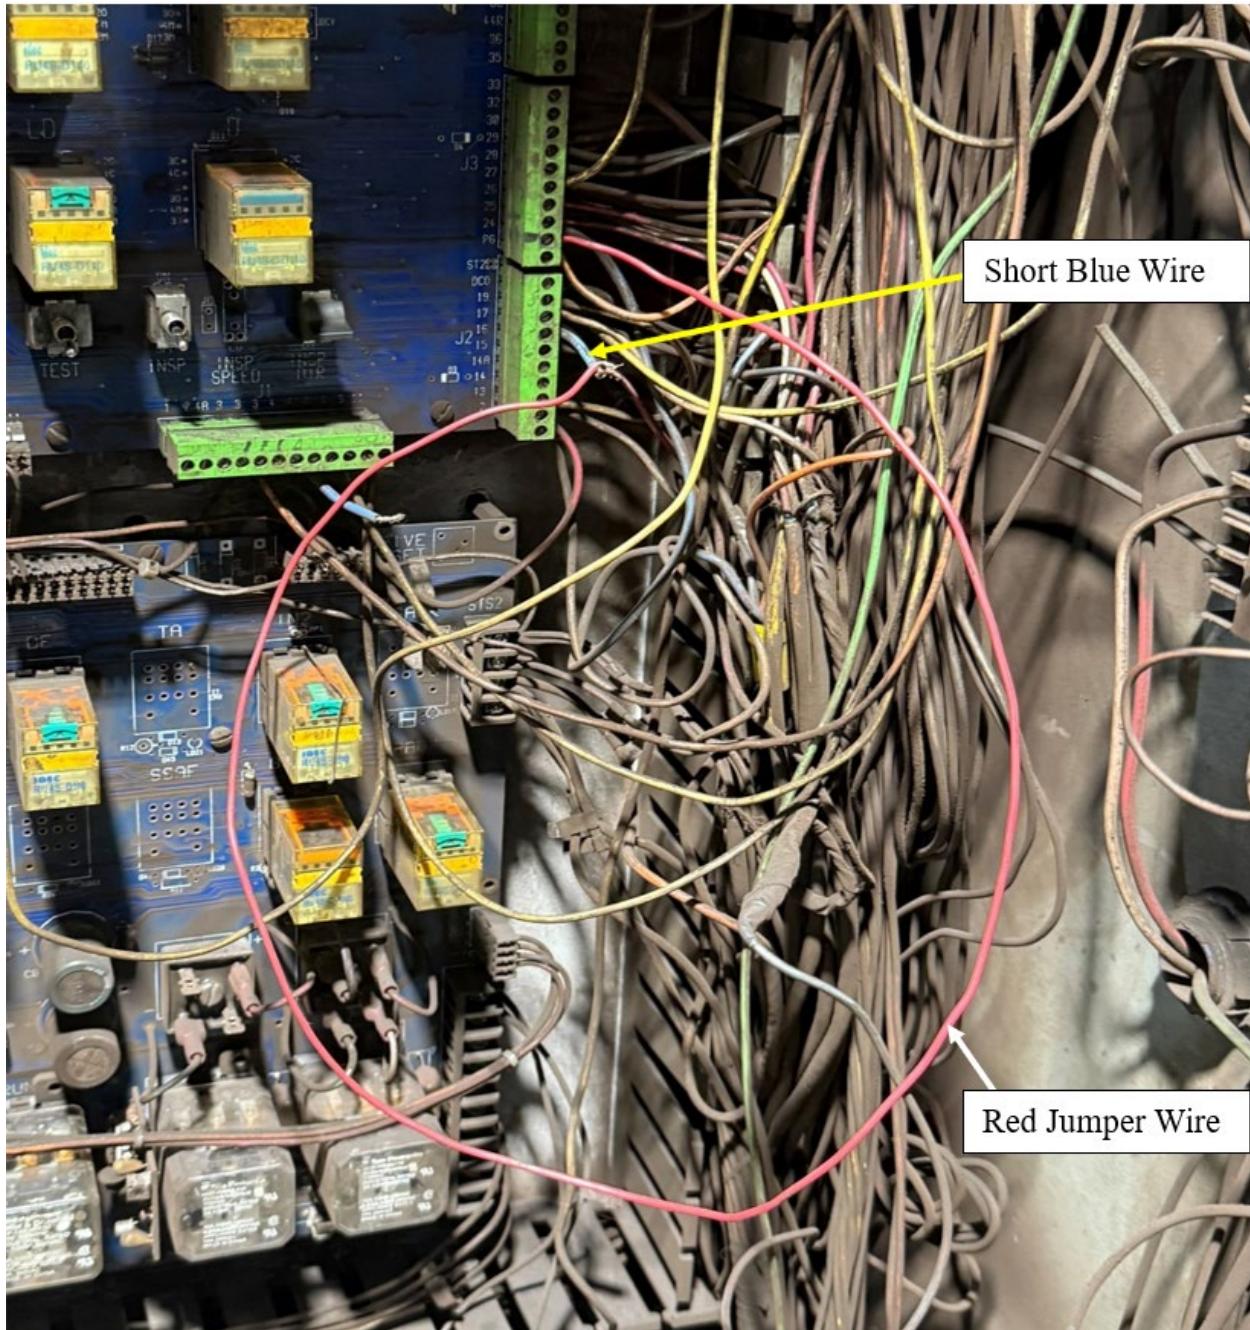
APPENDIX E – Red Jumper and Short Blue Wires between Terminals 17 and 24

Investigators examined the electrical system and determined that a red jumper wire in the J3 circuit control board under terminal 24 was connected to the J2 circuit control board under terminal 17 by a short blue wire (Appendix E). This created a bypass of safety features for the e-stop buttons, limit switches, buffer switches, and governor switches. Investigators found written instructions for these jumper wires on the inside of the door of the electrical enclosure where these wires are located.

Although the troubleshooting and maintenance were completed and the elevator became operational prior to the accident, the red jumper wire was left in place. The installation of the red jumper wire to bypass the safety features appears to have been a common testing and troubleshooting practice because the short blue wire was permanently installed in the terminal block. Investigators could not determine who installed or who was aware of these red and blue wires.

Corrective Action: The mine operator removed the jumper wire from the elevator circuit control panel, rewired and reconnected the wiring according to the electrical schematics, and demonstrated proper operation of the elevator.

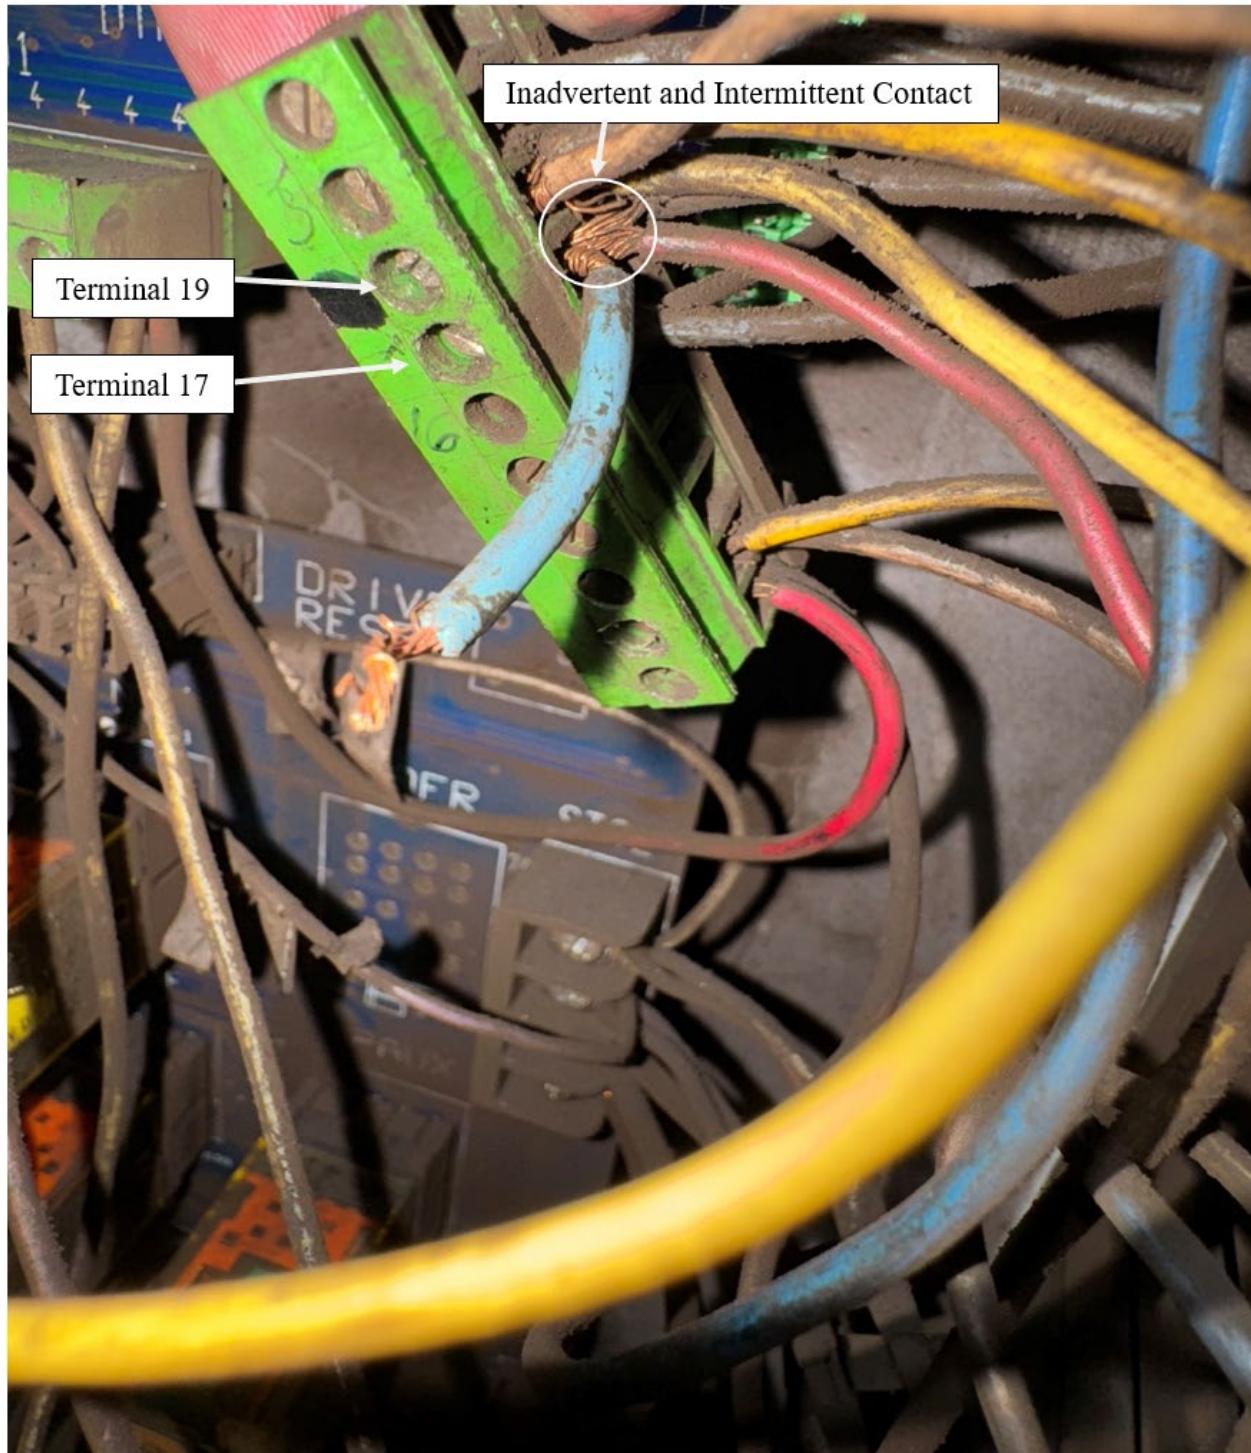
APPENDIX F – Inadvertent and Intermittent Contact of Wires between Terminals 17 and 19

Additionally, an inadvertent and intermittent electrical connection existed in the J2 circuit control board between terminals 17 and 19 due to one or more strands of copper wire that didn't fit into these terminals (see Appendix F). The mine operator did not intend for this electrical connection to be made. It resulted from poor workmanship and organization in the electrical enclosure. Vibrations from normal plant operation would cause the wires to connect intermittently. Investigators observed the connection and measured it to be between four ohms and 15,000 ohms. This created a bypass of all the door interlock switches at each landing, allowing the elevator to move with the exterior elevator doors open.
