UNITED STATES
DEPARTMENT OF LABOR
MINE SAFETY AND HEALTH ADMINISTRATION

REPORT OF INVESTIGATION

Powered Haulage Accident Fatality Report
August 7, 2025

202501
Highpoint Sand and Gravel LLC
Rockland, Ontonagon County, Michigan
ID No. 47-03973

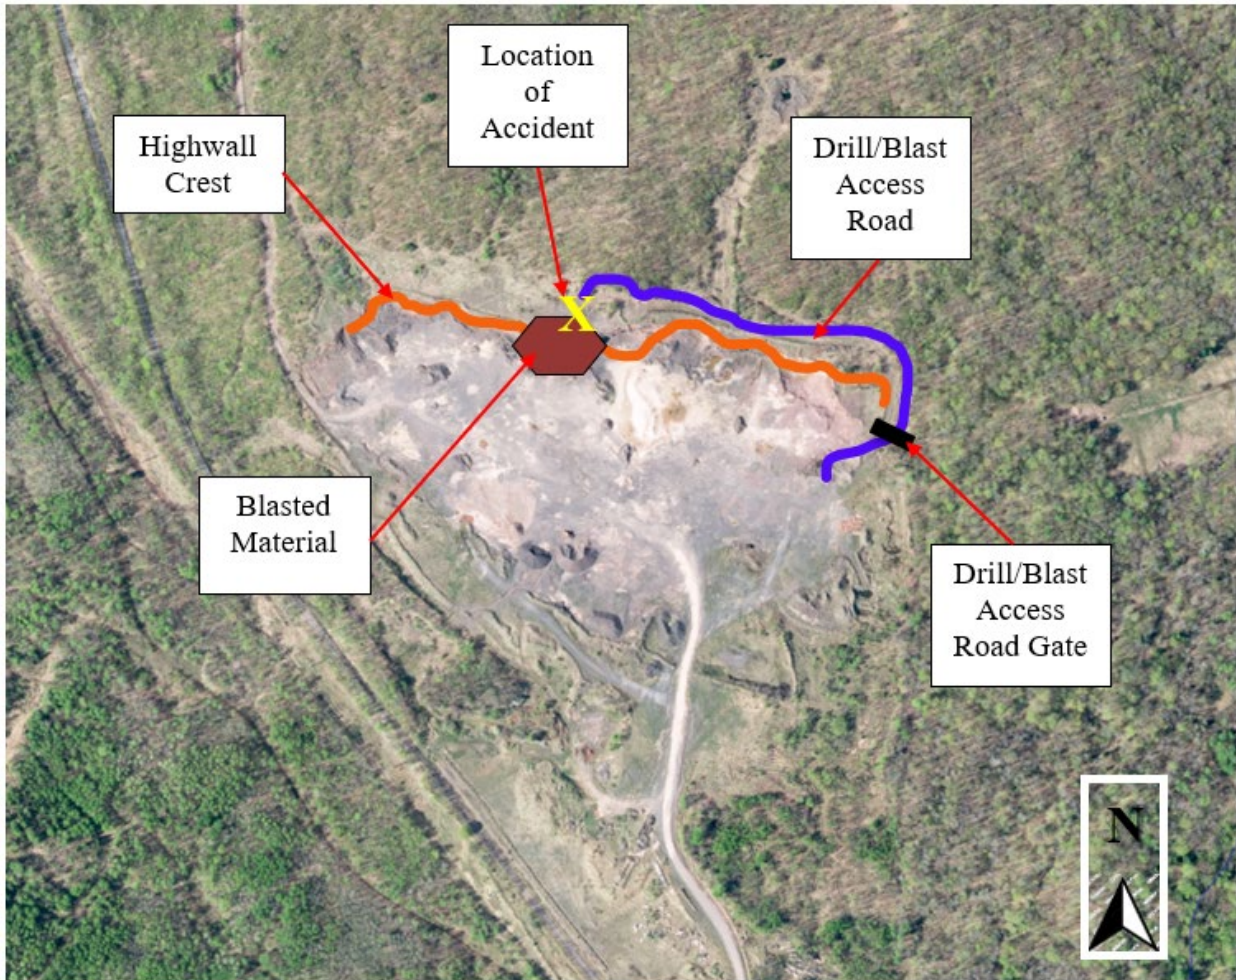
APPENDIX B – Aerial View of Rockland Quarry

The accident occurred on the north side of this mine at the end of the highwall access road (Appendices B and C). The front-end loader was at the crest of the 50- to 60-foot highwall bench on an approximate 3% grade with a bucket of overburden to be used to construct a berm.

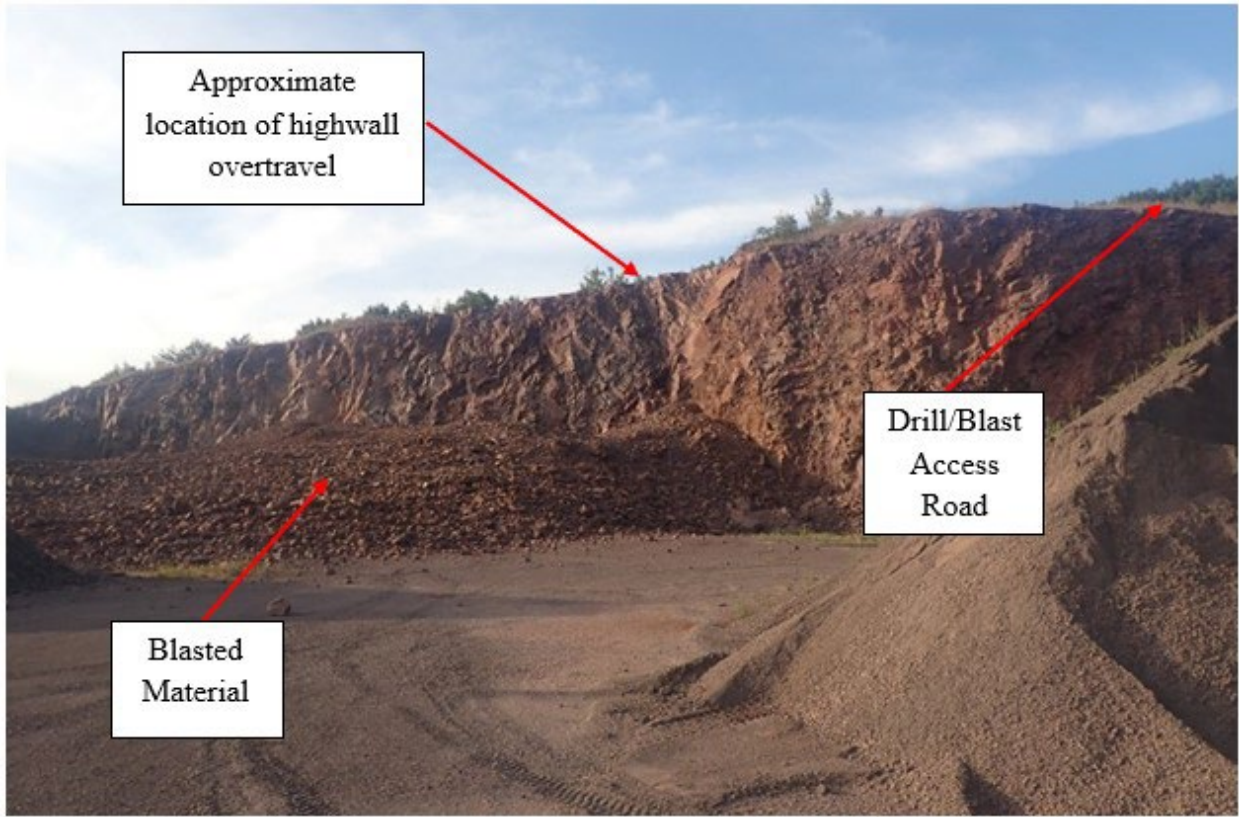
APPENDIX C – Highwall and Blasted Material

over the edge of the highwall. Johnson and the front-end loader both went over the highwall and fell approximately 50 feet into the blasted material below at approximately 2:15 p.m.
