UNITED STATES  
DEPARTMENT OF LABOR  
MINE SAFETY AND HEALTH ADMINISTRATION

REPORT OF INVESTIGATION

Fatal Powered Haulage Accident  
December 18, 2025

Lower War Eagle  
Greenbrier Minerals, LLC  
Cyclone, Wyoming Conty, West Virginia  
Mine ID: 46-09319

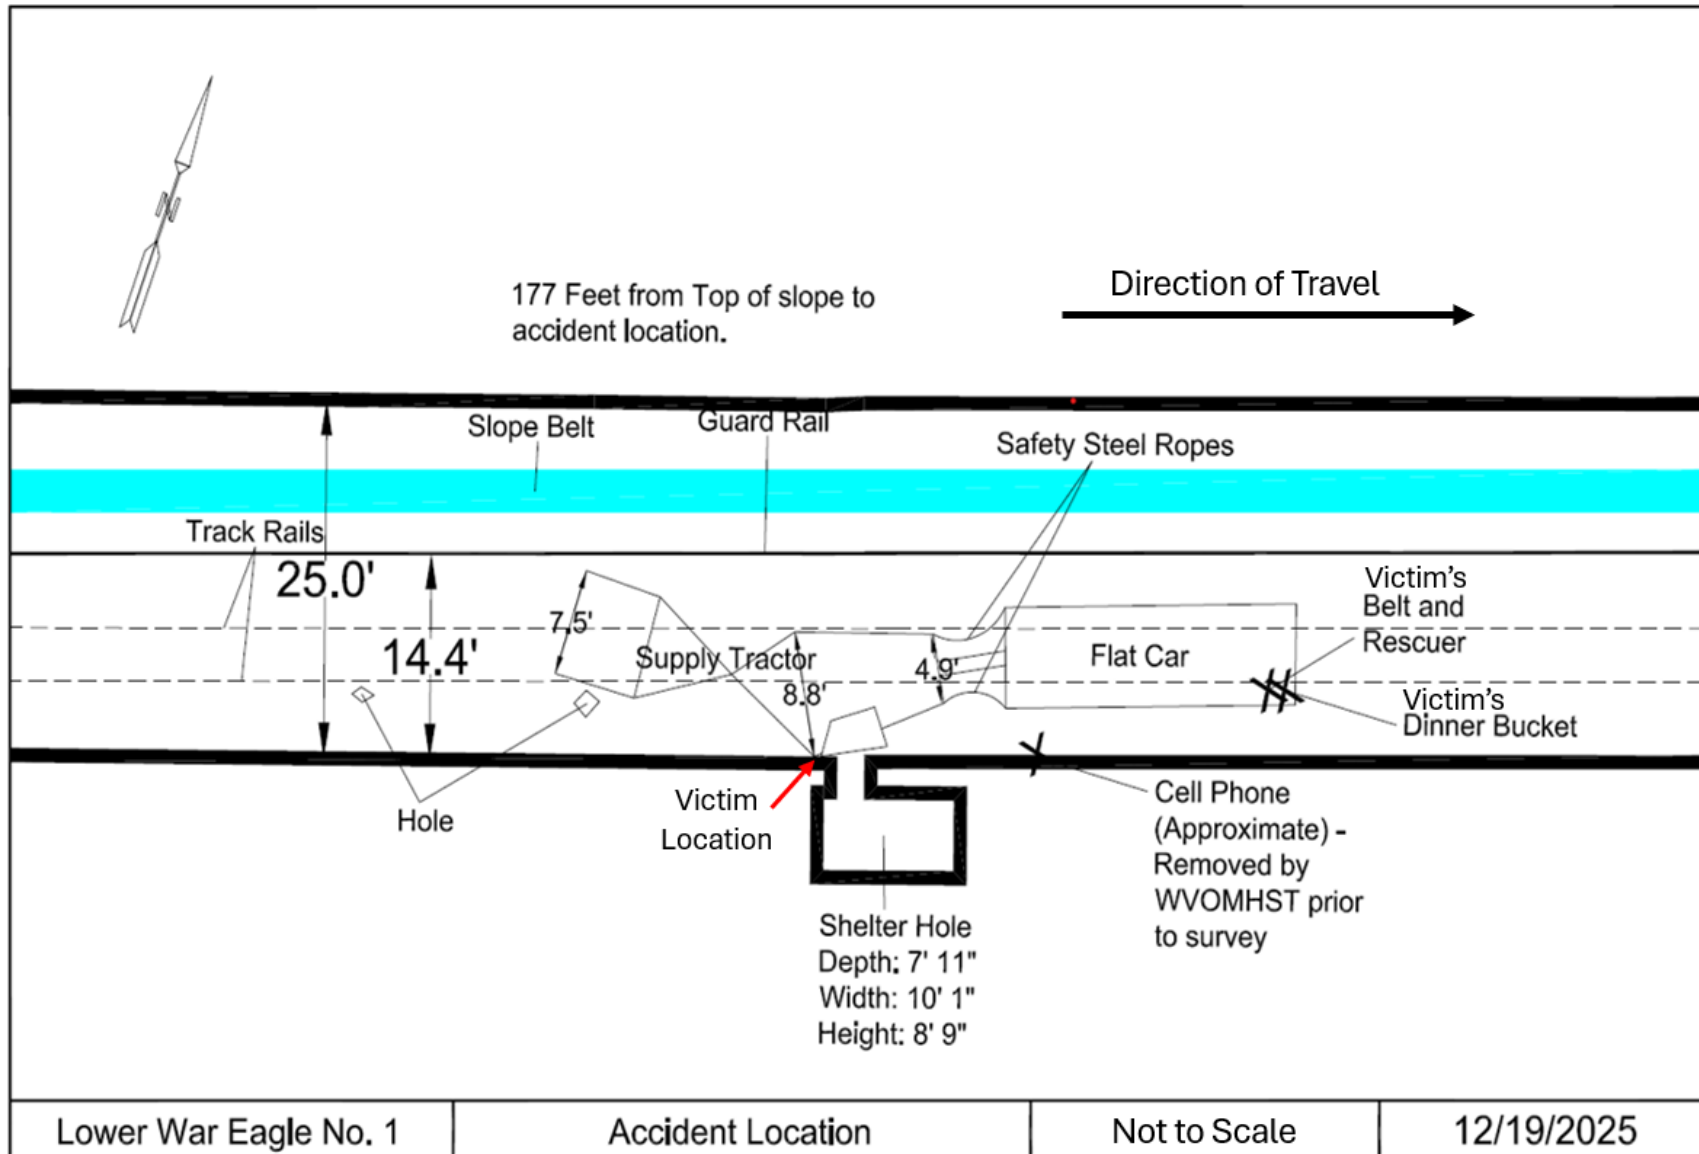
APPENDIX B – Map of the Accident Location

The accident occurred on the production slope near the second shelter hole, 177 feet from top of the slope (Appendices B and C). The slope entry was approximately 25 feet wide with a maximum grade of 8.7 degrees and an overall grade of 8.1 degrees. Investigators evaluated the concrete floor of the slope and determined that it was adequately maintained.

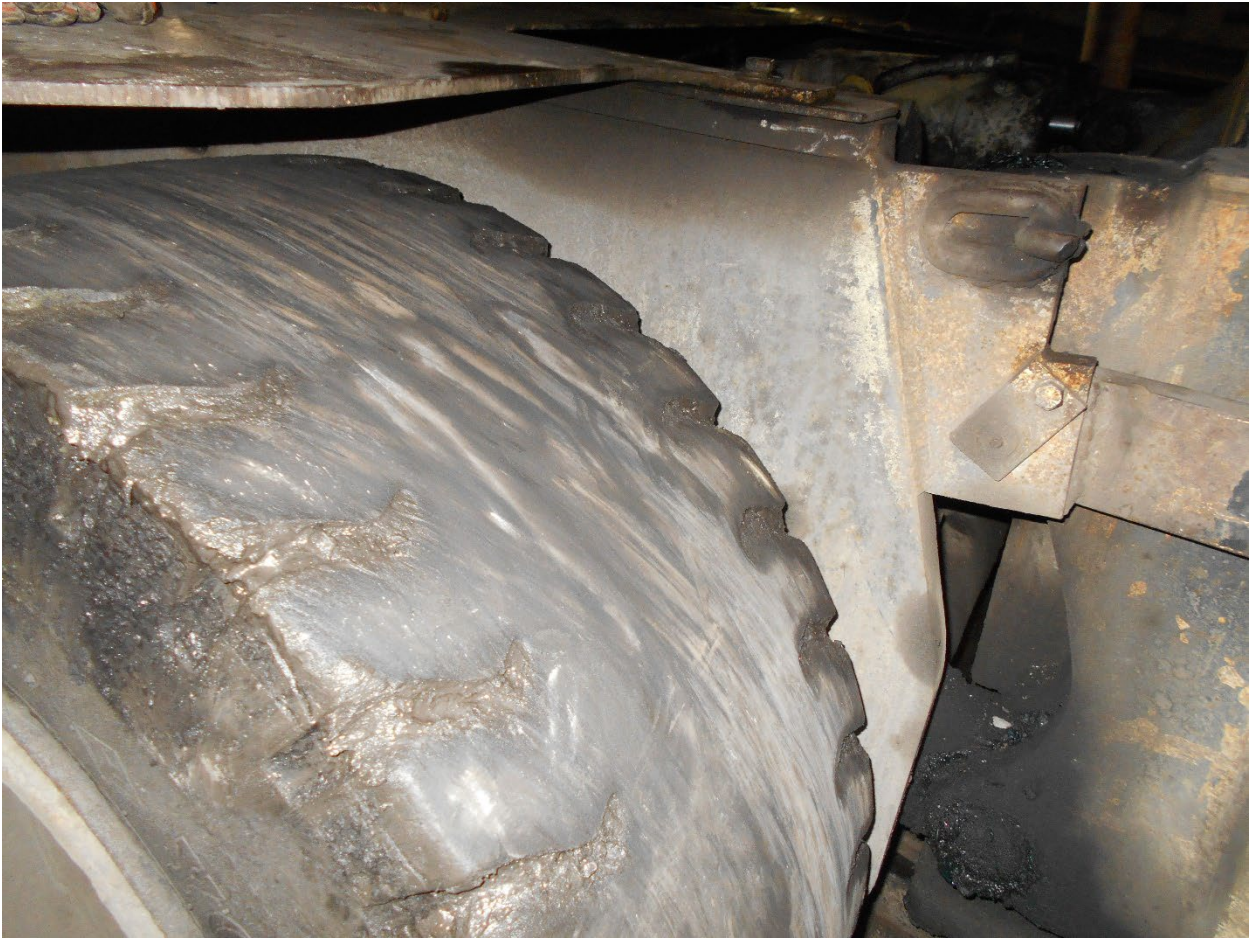
APPENDIX D – Photo of Tractor Tire

Investigators conducted functional tests of the tractor, including the panic bar system, braking system, steering functions, and lights, and found no defects. Investigators conducted a visual examination of the tractor and found that three of the four tires had excessive tread wear which adversely affected the operator's ability to maintain control of the equipment (Appendix D).

During the investigation, multiple tire manufacturer representatives stated there is no out-of-service criterion for tread depth on mine equipment tires due to the various conditions in which mine tires are used. The manufacturer states the tire's traction and stopping capabilities are greatly diminished when they have worn down to 4/32 (1/8) inches. The service life of the tires is left to the discretion of the user.

After the mine operator replaced the tractor's tires, investigators performed a functional test. During the accident, the tractor skidded approximately 30 feet after de-energization. With the new tires and the same load on the slope, the tractor skidded only 6 feet. Investigators determined that both the condition of the tires and the absence of a policy to determine when tire wear had become unsafe contributed to the accident.

On December 18, 2025, an outby foreman was fatally injured at this mine when he was pinned between the Co. No. 168 GE Fairchild tractor and the steel arch support wall, 177 feet from the top of the slope. The tractor lost traction, causing it to slide into a miner traveling on foot resulting in fatal injuries. The tractor was not being maintained in safe operating condition by being operated with both front tires and one rear tire on the operator's side in an excessively worn condition.

Corrective Action: The mine operator replaced the tires of the tractor and implemented examination procedures that included: The tractor tires being visually examined during the weekly examination of the tractor. Tread depth will be checked at 4 inches from the center of the tire on the inside and outside. When the tread depth reaches less than 1/8 inches the tractor will be taken out of service until the tire(s) with less than 1/8 inches of tread are replaced.
