UNITED STATES
DEPARTMENT OF LABOR
MINE SAFETY AND HEALTH ADMINISTRATION

REPORT OF INVESTIGATION

Fatal Machinery Accident
February 12, 2025

CCU Sexton Strip
CCU Coal and Construction LLC
Cadiz, Harrison County, Ohio
ID No. 33-04577

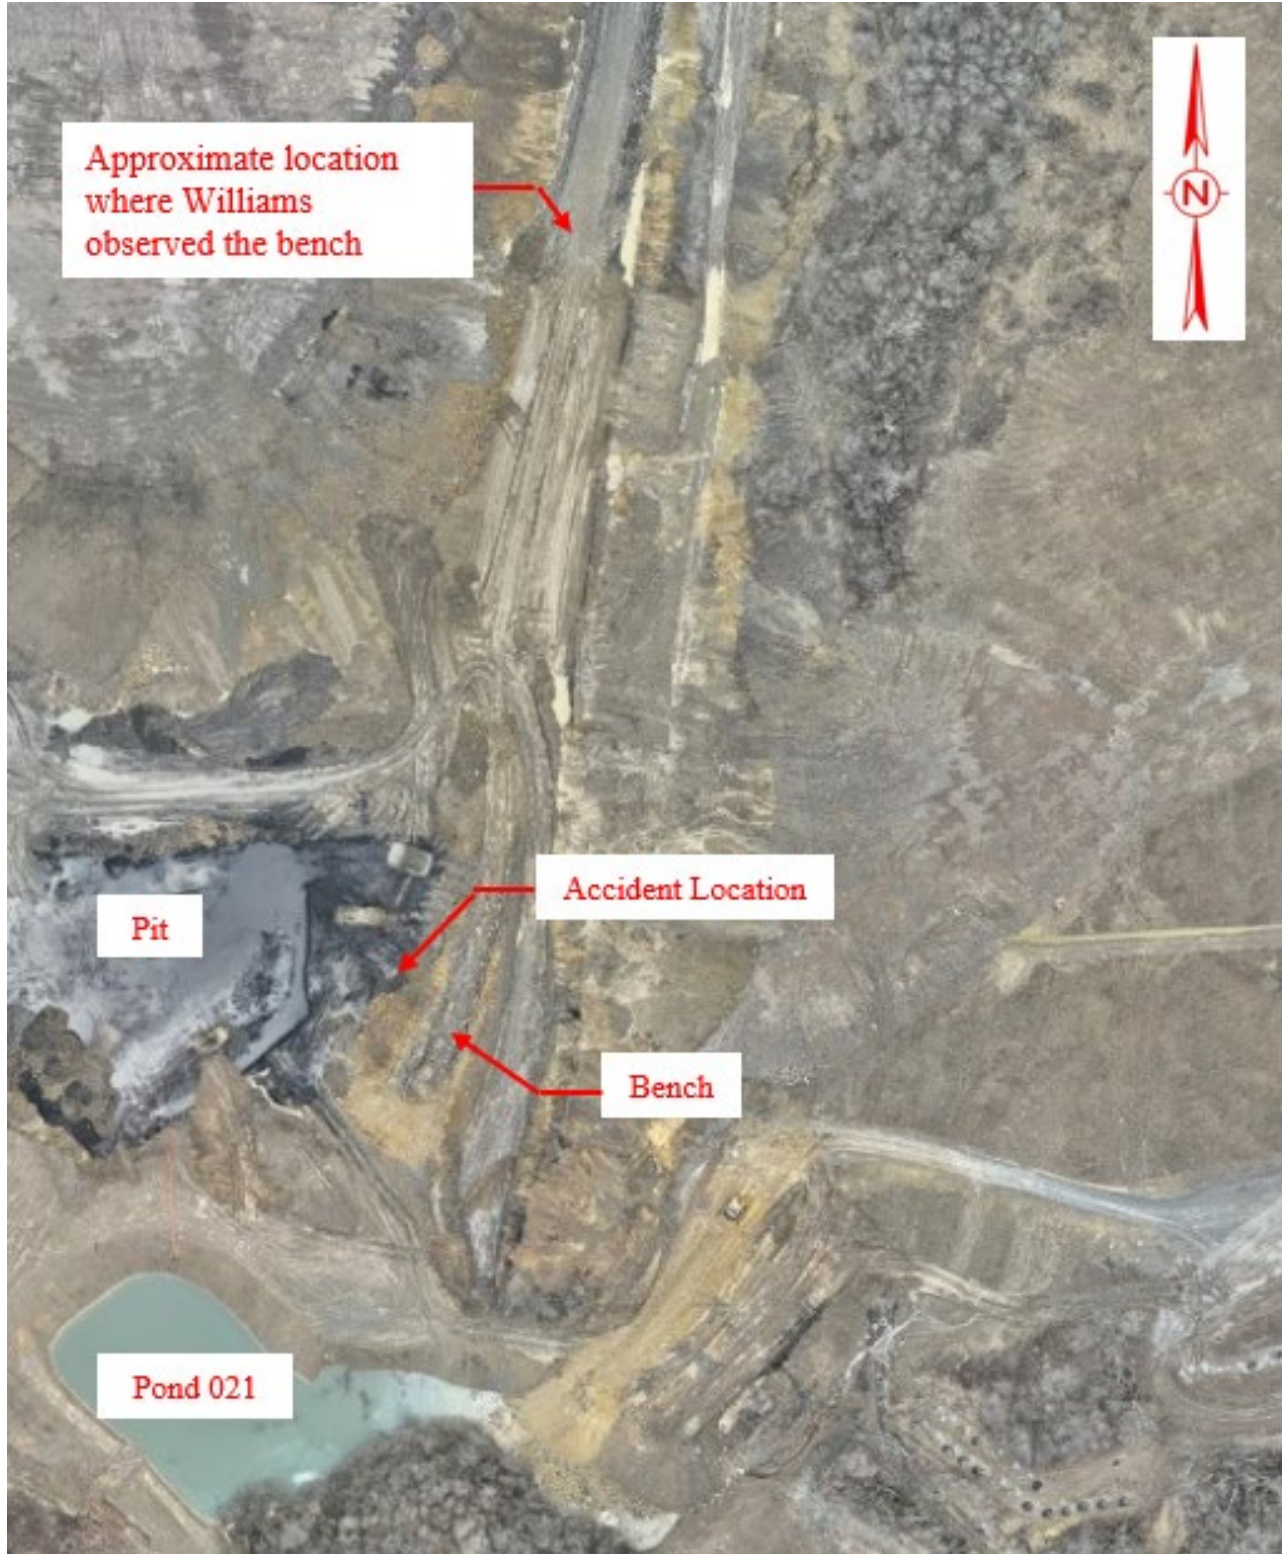
APPENDIX A – Pond 021 Pit Area

On February 12, 2025, at 4:00 a.m., Blomquist began his shift by tramming the drill to the 021 Pond Pit highwall bench (see Appendix A). He started drilling a row of blast holes furthest from the edge of the highwall. At 7:37 a.m., employees from Wampum Hardware Co. began arriving at the bench, and Blomquist was drilling the row of blast holes closest to the edge of the highwall. The drill's tracks were aligned parallel to the edge of the highwall.

Aerial view of the accident site taken February 27, 2025

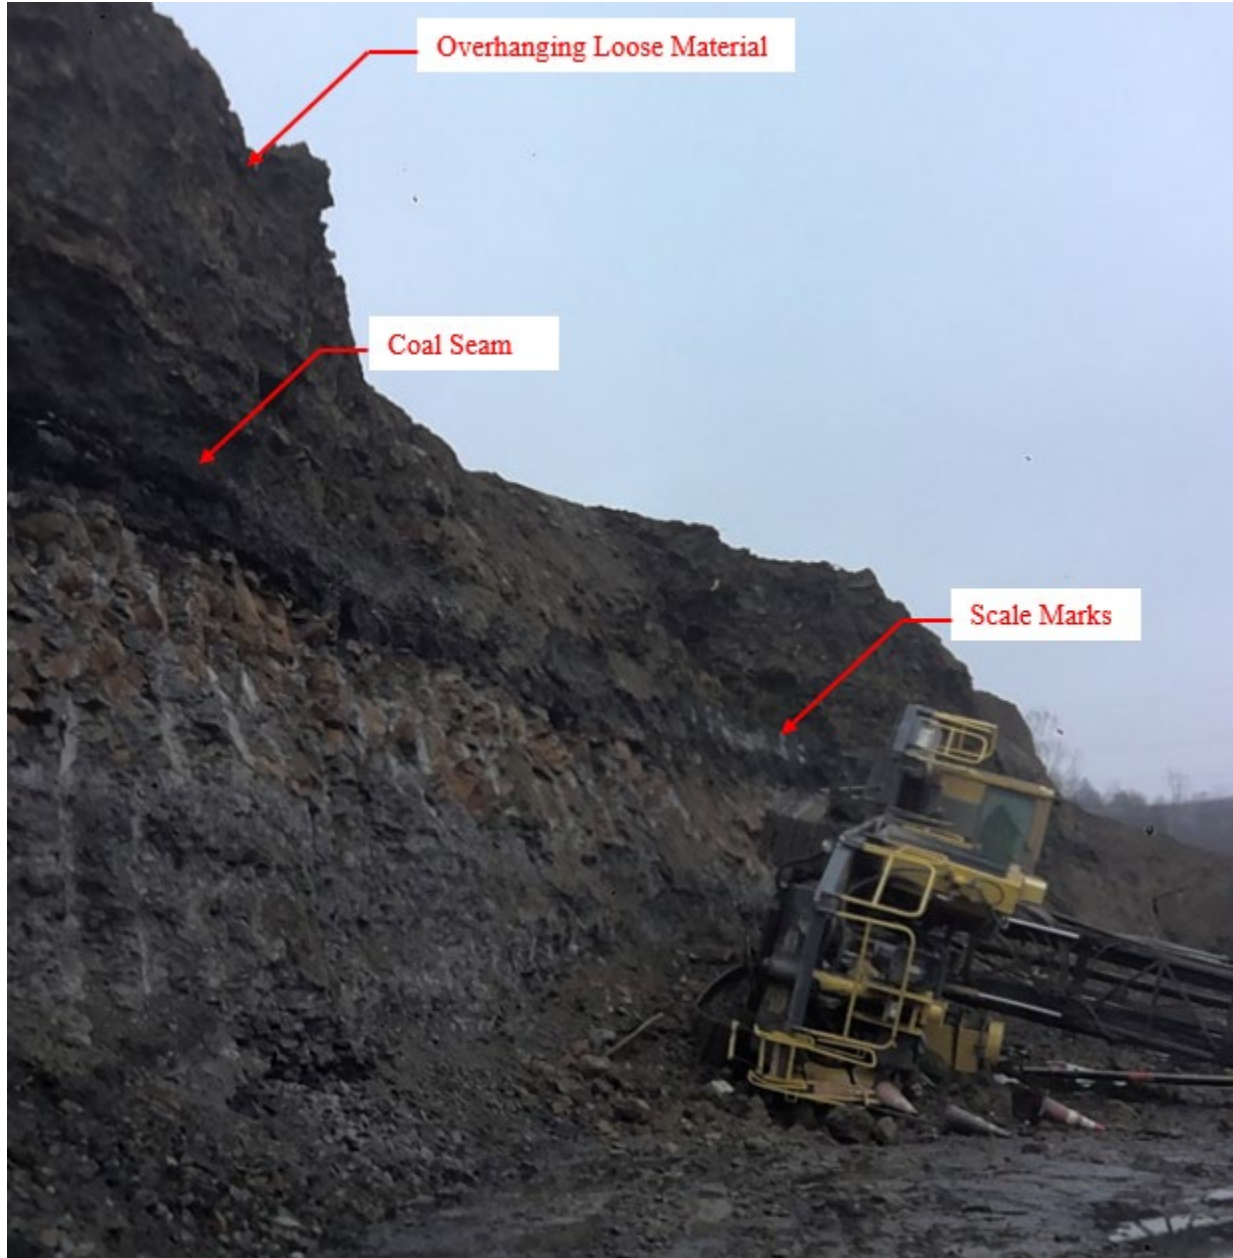
APPENDIX C – 021 Pond Pit Highwall

The highwall where the accident occurred was 30 feet high. The highwall strata consisted of a 20-foot layer of competent in-situ shale and limestone, an approximately two-foot-thick coal seam, four to six feet of weathered shale, covered by four to six feet of loose, unconsolidated brown spoil from the previous mining activity. The highwall bench was 60 feet wide.

The semi-circular ground failure where the accident occurred was approximately 50 feet long by 10.5 feet wide. There were scale marks visible 19 to 20 feet above the pit floor and on the upper coal seam where the failure occurred. No scale marks were observed in the material above the coal seam anywhere on the highwall. Additionally, the highwall on both sides of the failure contained overhanging and over-steepened material above the coal seam (see Appendix C). Investigators determined the loose material above the upper coal seam was not scaled or

removed. The mine operator did not correct or barricade the hazardous condition, which contributed to the accident.

Photo of Physical Conditions of Highwall

1. “The drill bench and highwall shall be observed and examined thoroughly prior to any activities at the beginning of every shift. If any hazards are recognized, activities shall not occur until hazards are eliminated. This shall include but is not limited to any loose or overhanging material being present around the drill bench or highwall. The loose or overhanging material will be scaled down by a bulldozer or a track-hoe, or it will be bermed off to restrict access to that area.”

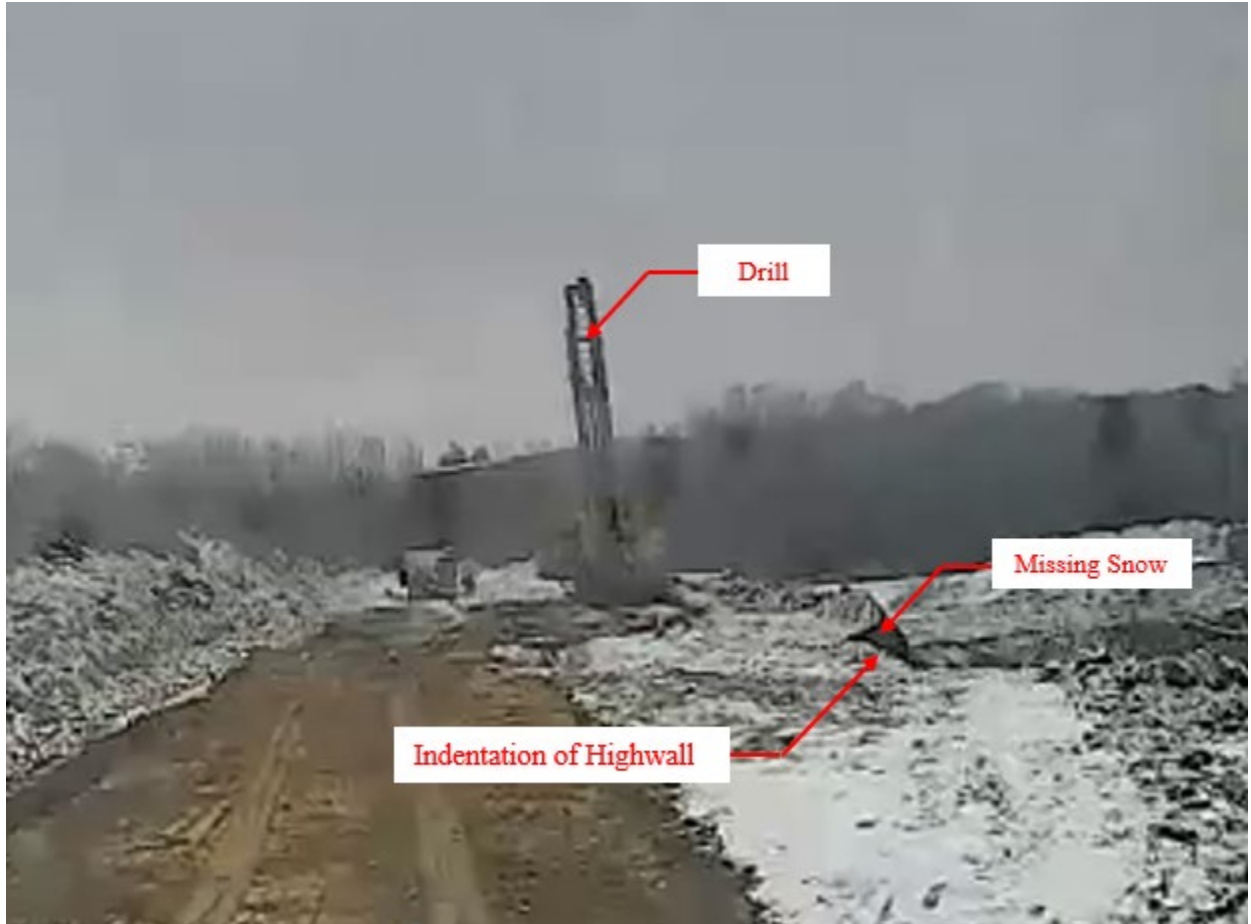
APPENDIX D – Wampum Hardware Co. Bulk Truck Dash Camera

Video evidence shows windrowed material (material left in a narrow ridge by bulldozers) missing, and an indentation of the bench on the outer edge of the highwall (see Appendix D). There was no snow below the indented area on the highwall face indicating a previous ground failure occurred in this area. Investigators believe the missing material from the top of the highwall was the material that impacted a truck and was observed on the pit floor. Blomquist walked past this indented area when he placed the orange alignment cone. This is also the area where the accident occurred as he was positioning the drill.

Photo Indicating Previous Ground Failure
