UNITED STATES
DEPARTMENT OF LABOR
MINE SAFETY AND HEALTH ADMINISTRATION

REPORT OF INVESTIGATION

Fatal Powered Haulage Accident
February 22, 2025

GCC Dacotah Inc
GCC Dacotah Inc
Rapid City, Pennington County, South Dakota
ID No. 39-00022

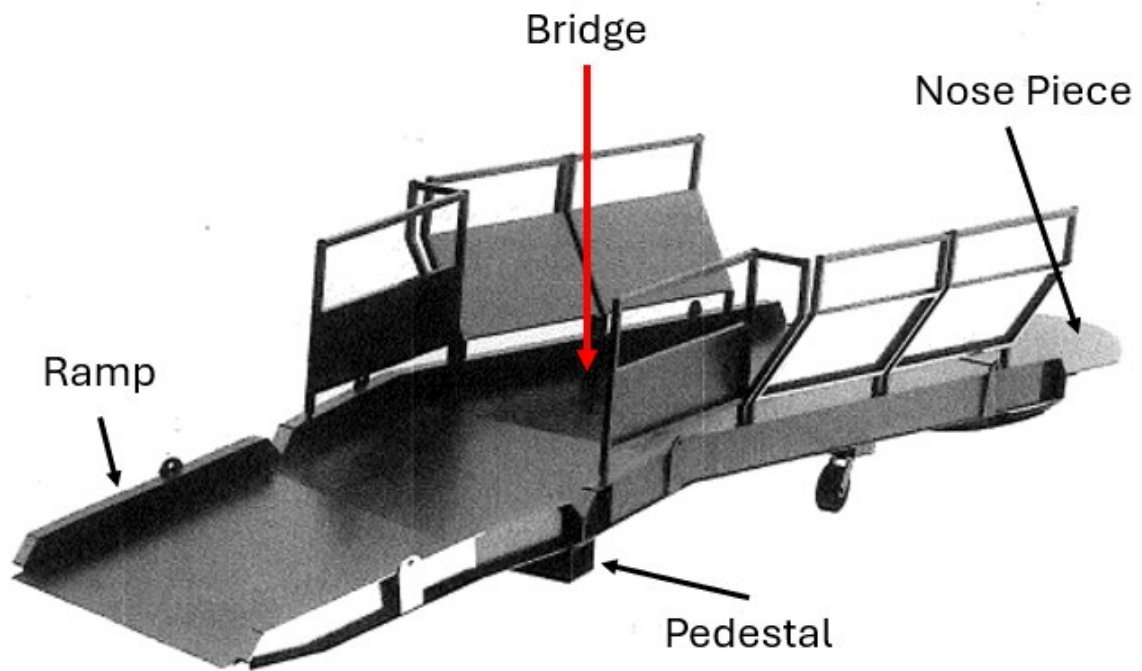
APPENDIX A – Bridge Assembly Drawing

The Bricking Solutions Kiln Access Ramp consists of a bridge section, ramp section, pedestal and nose piece with all pieces fabricated from 6061-T6 aluminum. The ramp was purchased in 2018, and the ramp came with an installation manual. The manual contains information on assembly, installation, and inspection of the ramp and bridge assembly. Investigators determined the pedestal was not properly secured against movement; a requirement outlined in the manufacturer's installation manual. To prepare the kiln for rebricking, the mine operator bolted the bridge and ramp to the pedestal, but not to the floor of the kiln structure as required by the manual. The mine operator also left the nose piece off the unit during assembly. Investigators determined this contributed to the accident. This was further supported by witness statements verifying that the ramp/bridge assembly shifted prior to the accident.

The investigators determined that during previous deployments of the ramp and bridge assembly, it was not properly secured to the floor in accordance with the manufacturer's installation manual. The mine operator also did not develop or provide training for the installation of the

Corrective Action: The mine operator and the contractor developed a new standard operating procedure (SOP) to ensure that the new bridge and ramp assembly will be secured according to manufacturer instructions, and miners were trained on the new SOP.

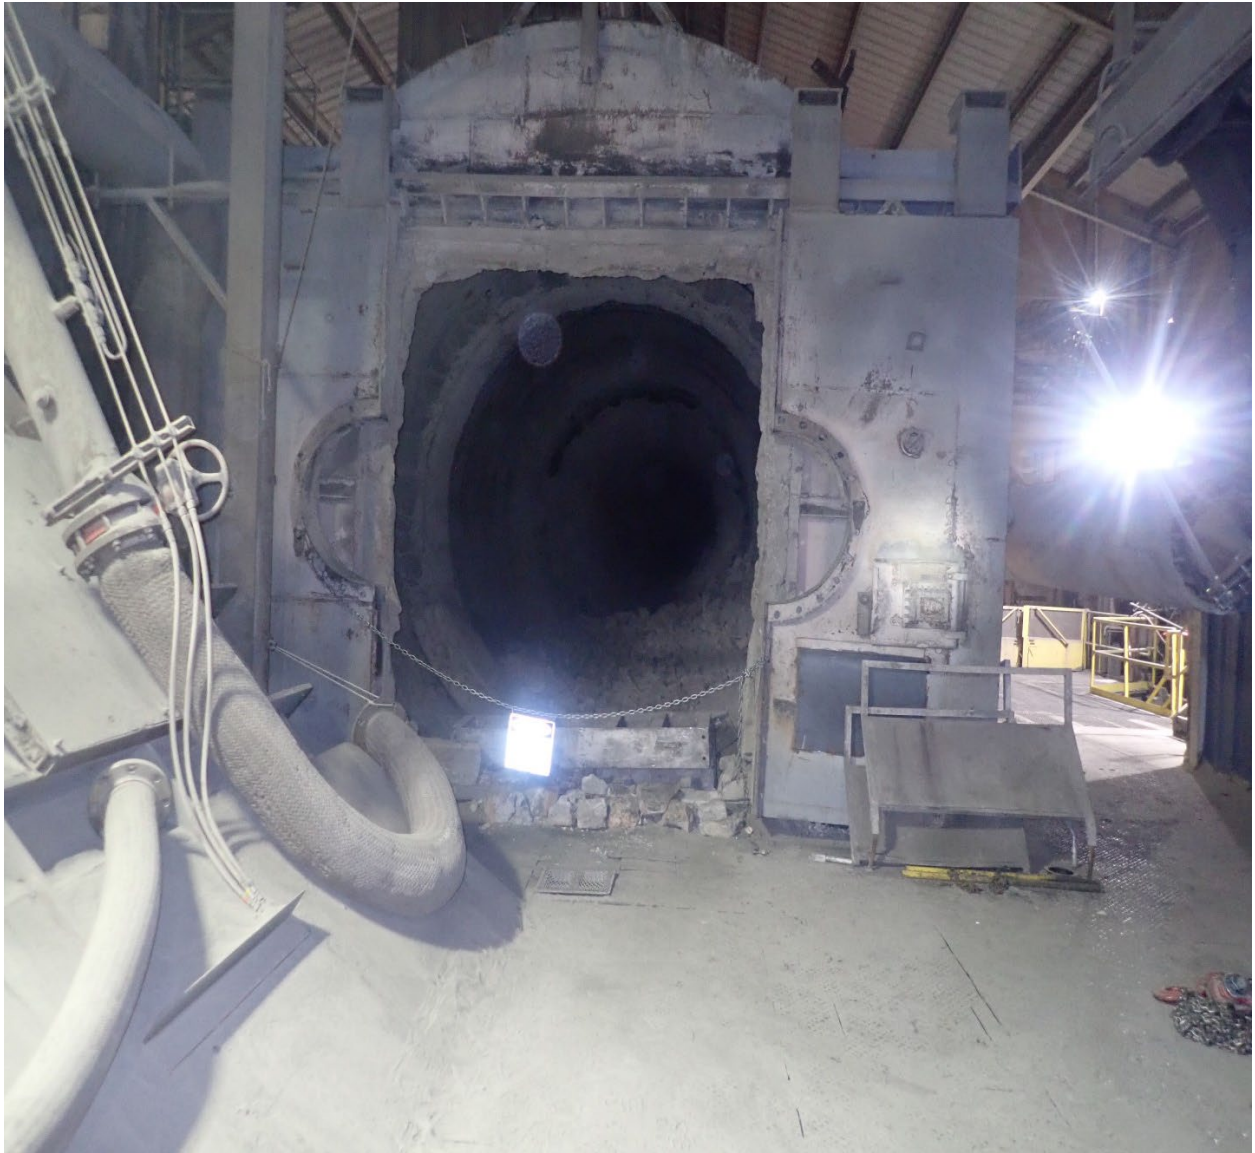
APPENDIX B – Kiln Entrance

According to interviews, at approximately 7:00 a.m., on February 20, 2025, Clifford Metzger Jr., Control Room Leader, asked Brandon Haslip, Control Room Operator, to take Jason Perry, Production Utility; Collin Murray, Utility; and Drew Anderson, Production Utility; to prepare the kiln for the rebricking work Elite was contracted to perform. This included opening the kiln doors, removing the burner pipe, and installing the ramp, bridge, and pedestal for the bridge assembly (see Appendix A), which provides access from the burner floor, across the cooler chute, and into the kiln (see Appendix B).

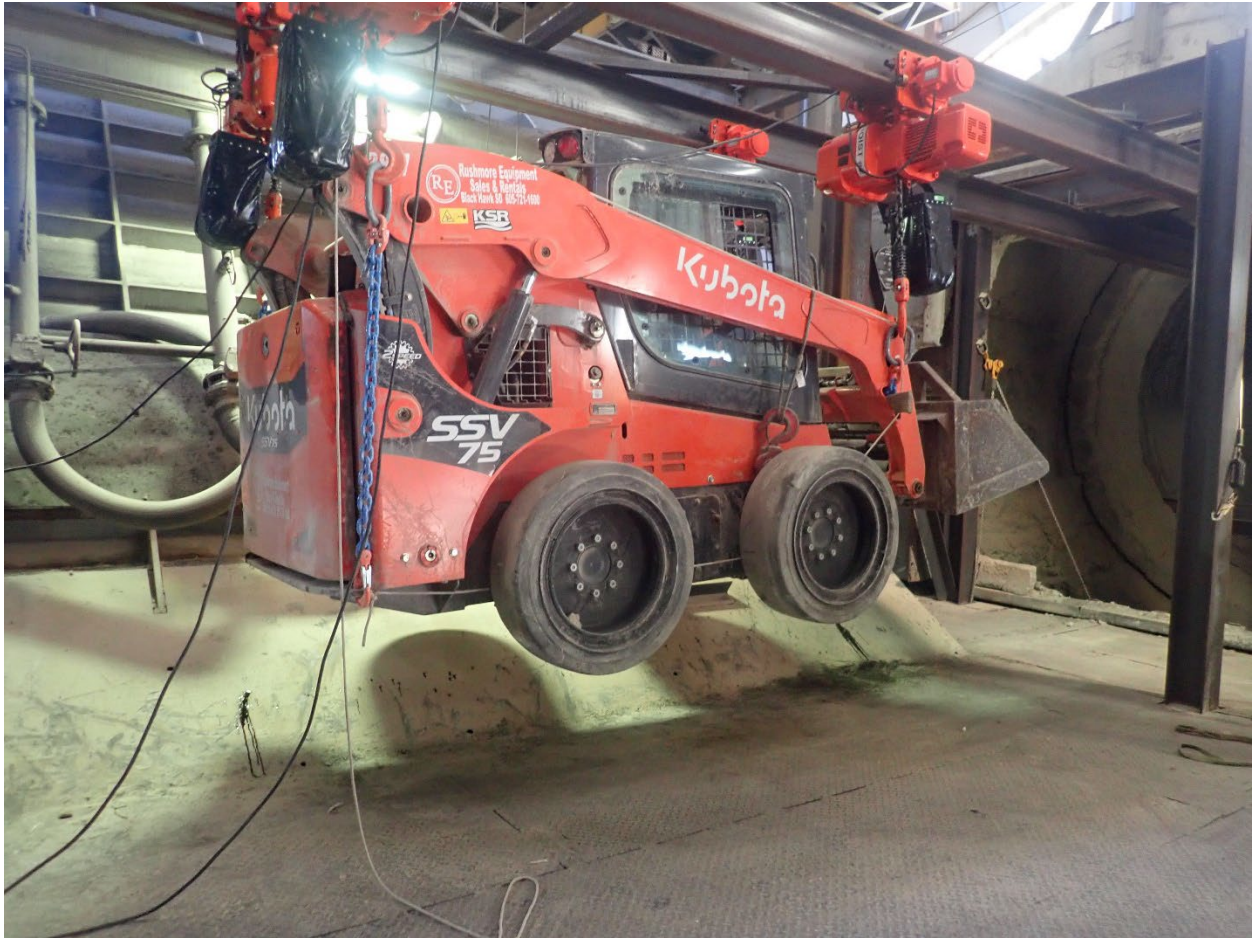
APPENDIX C – Kubota Skid Steer Loader

The skid steer loader was a model Kubota SSV75, rented by GCC from Rushmore Equipment, LLC. Clay Sabrowski, Mechanic for Rushmore Equipment, LCC performed a complete inspection of the skid steer loader and did not find any deficiencies.

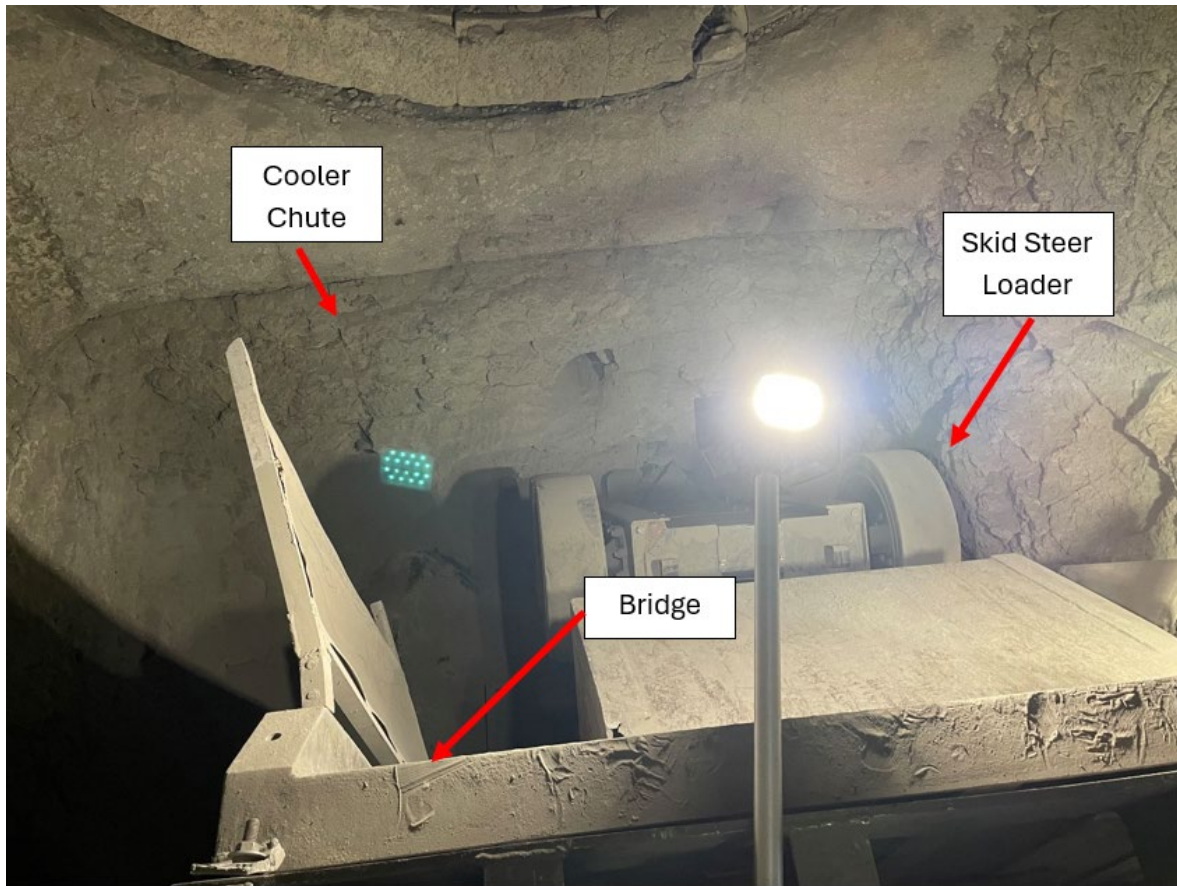
APPENDIX E – Cooler Chute with Fallen Skid Steer and Bridge

Burley finished demolishing the remaining brick and then left the plant to go back to his hotel. Perez-Perez continued operating the skid-steer loader to remove the remaining brick from the kiln. According to witness statements, Perez-Perez completed seven trips into the kiln and was in the process of backing out of the kiln on his eighth trip when the bridge and skid steer loader fell 18 feet into the cooler chute.

The accident occurred at the discharge/burner end of the kiln, in the cooler chute (see Appendix E).

On February 22, 2025, at approximately 2:00 a.m., a fatal accident occurred when the ramp and bridge assembly shifted and collapsed into the cooler chute as a contractor miner operating a skid steer loader traveled over it, landing approximately 18 feet below. The ramp and bridge assembly installed by the mine operator did not completely secure the pedestal nor was the nose section installed at the end of the bridge in accordance with manufacturers' installation instructions. The mine operator did not provide safe access to the inside of the kiln for the contracted work. The mine operator engaged in aggravated conduct constituting more than ordinary negligence. This violation is an unwarrantable failure to comply with a mandatory standard.

Corrective Action: The mine operator has developed a new task training procedure which includes assembly and securing the new assembly to the burner floor. Miners were trained on the new procedure.
