REPORT OF INVESTIGATION

Fatal Fall of Face, Rib, Side or Highwall Accident
February 28, 2025

Wright Concrete Underground LLC (P667)
Pikeville, Kentucky

Black Eagle
Marfork Coal Company, LLC
Pettus, Raleigh County, West Virginia
ID No. 46-09550

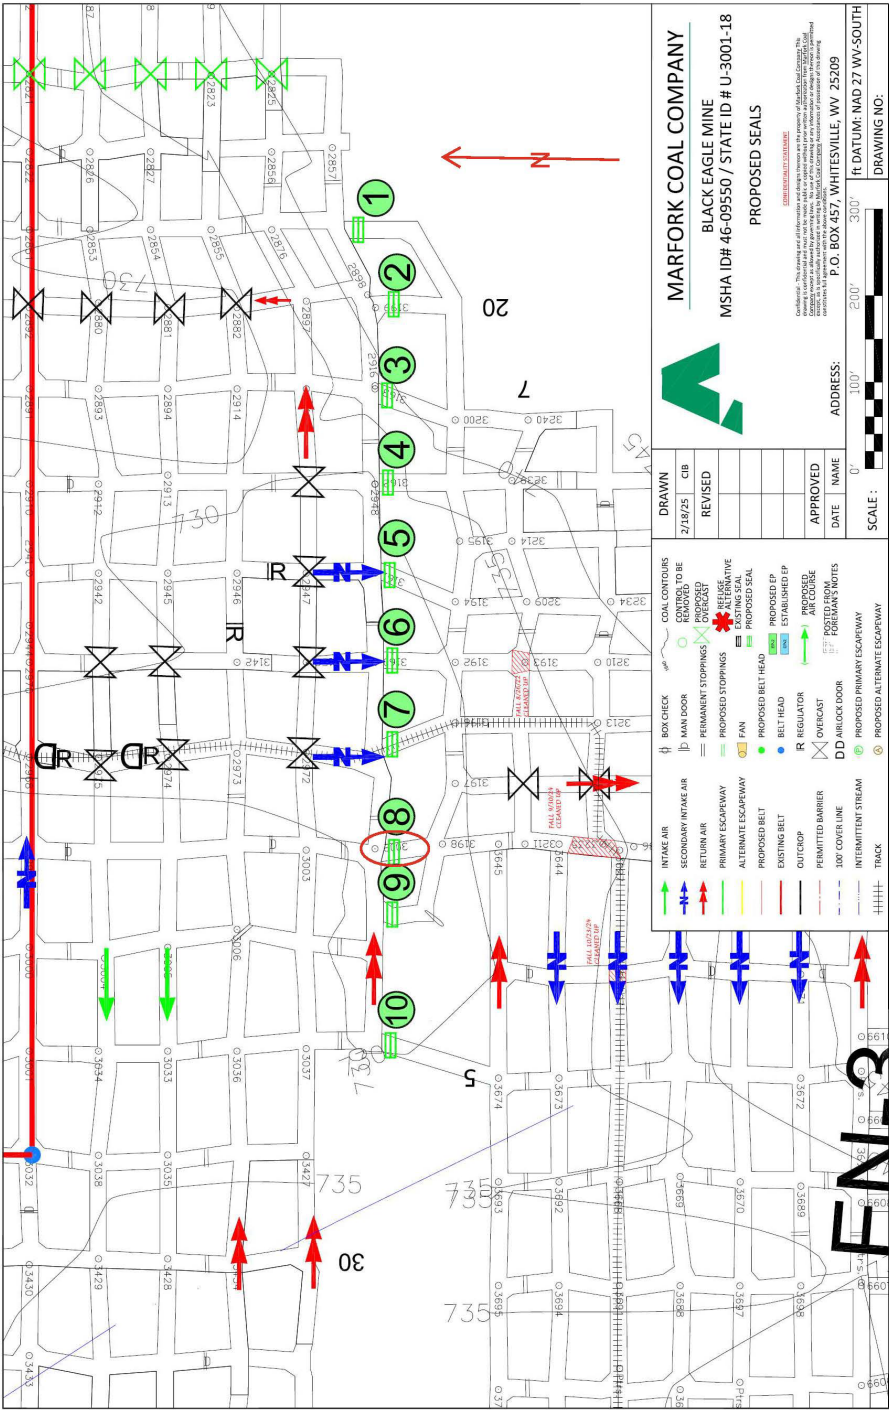
APPENDIX A – South Browns Branch Submains Seal Area Map

On February 28, 2025, at approximately 6:30 a.m., the construction crew entered the mine and traveled to the South Browns Branch Submains Seal Area (see Appendix A). The construction crew consisted of Stalker; David Bailey and Bradley Stiltner, Seal Construction Workers for Wright; Jerry Wills, General Laborer for Marfork; and Chad Vigilante, Block Foreman/Emergency Medical Technician - Mining (EMT-M) for Marfork.

○ - Accident site

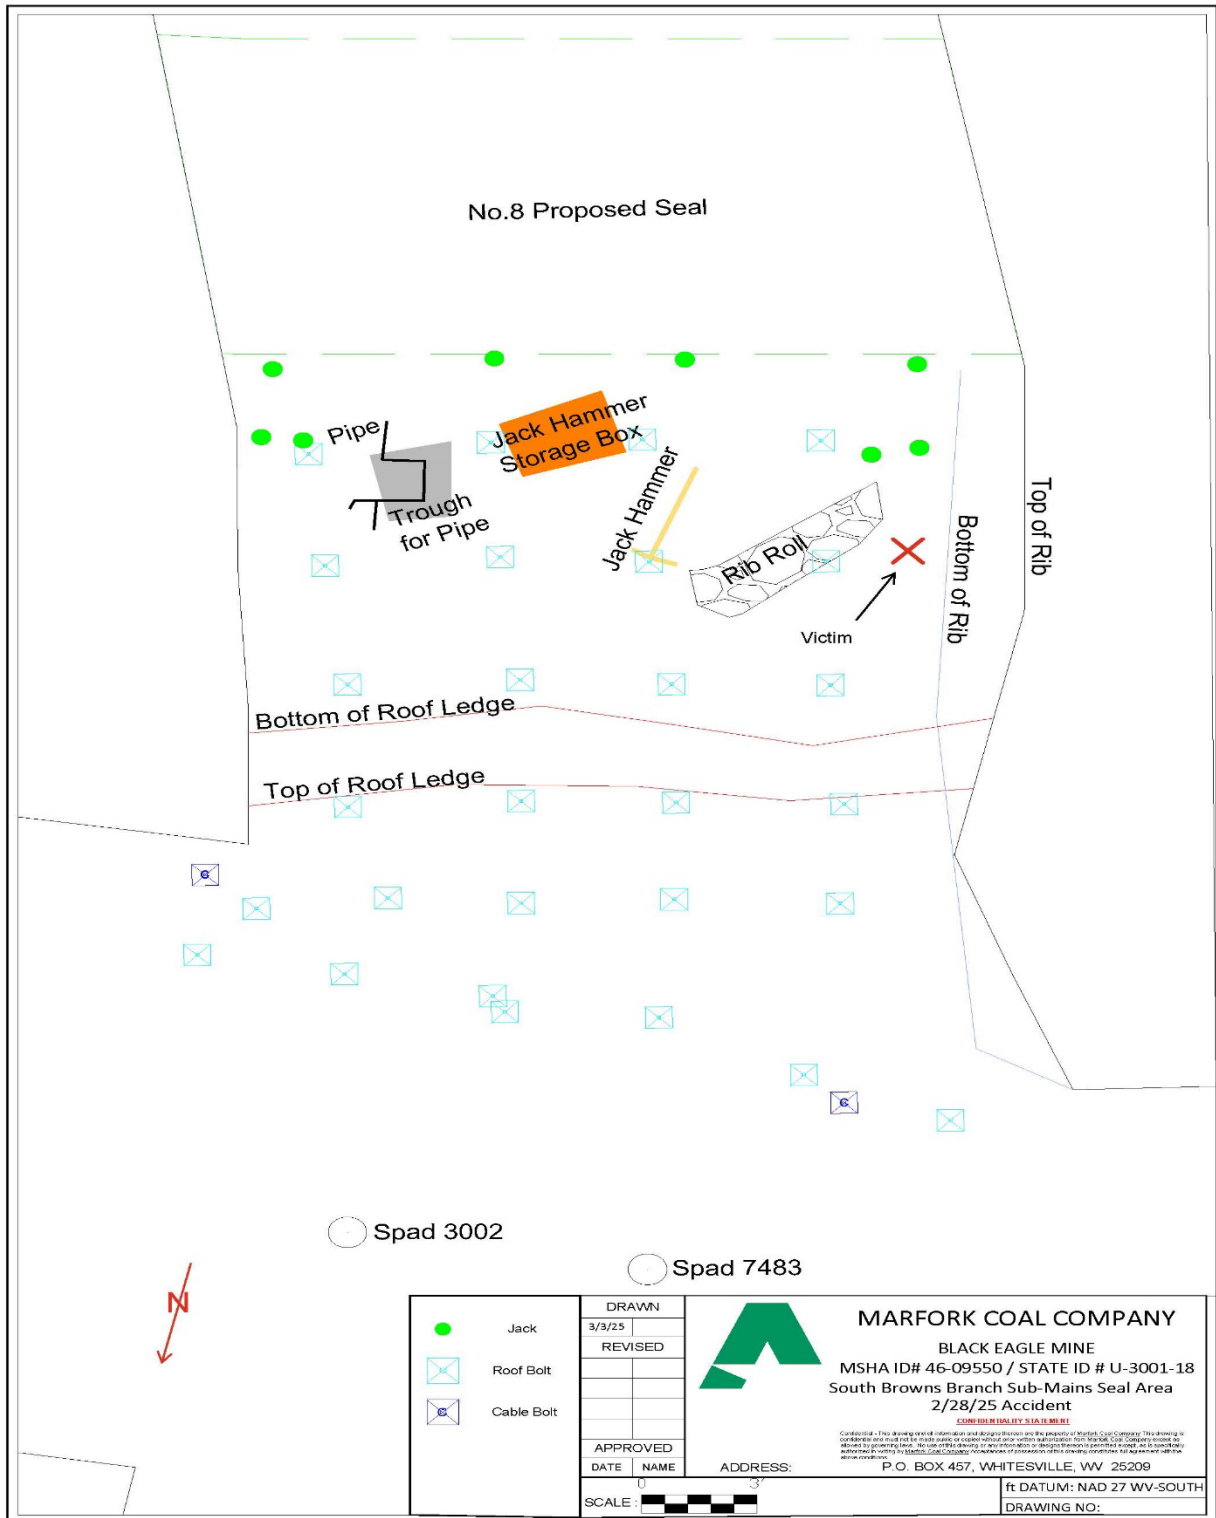
APPENDIX C – South Browns Branch Submains No. 8 Proposed Seal Map

The accident occurred at the No. 8 proposed seal, approximately eight feet from the proposed seal face along the right rib (see Appendix C). The construction crew was constructing ten, 120-psi Main Line J-Seals. The seals were being constructed to seal the South Browns Branch Submains.

Investigators observed a visible crack in the left rib brow showing evidence of separation and measured the brow to be approximately ten feet long, 20 inches wide and 12 inches thick. Loose roof existed along the right pillar rib approximately 20 feet from the proposed seal face.

Investigators measured the rock that struck Stalker to be 68 inches long, 23 inches wide, and eight inches thick. The rock weighed an estimated 1,155 pounds and fell from a height of 45 to 68 inches. Investigators determined that the mine operator did not support or otherwise control the rib to protect miners, which contributed to the accident.

- 1) The entry width measured 22 feet and eight inches, exceeding the required 20-foot maximum.
- 2) The right row roof bolts from approximately 12 feet to the face of the proposed seal were wide measuring over 64 inches from the pillar rib.
- 3) The cross-diagonal of the intersection at the No. 8 proposed seal measured 75.5 feet, exceeding the required 64-foot maximum.
- 4) Wide bolt spacing exposed an area of the loose roof measuring approximately six feet by seven and a half feet. This area measured at least 68 inches from the mine floor.

Corrective Action: The mine operator installed supplemental supports at the South Browns Branch Submains Seal Area in the form of fully grouted roof bolts, cable bolts, 560 (six by six) posts, nine cribs, five steel jacks, and a minimum of 50 rib bolts. The mine operator developed and implemented a revision to the approved RCP to require all construction sites to be rehabilitated in accordance with the approved plan. The mine operator trained miners on the revised RCP.
