REPORT OF INVESTIGATION

Fatal Fall of Face, Rib, Side or Highwall Accident
January 29, 2025

Twilight Mtr Surface Mine
Lexington Coal Company, LLC
Twilight, Boone County, West Virginia
ID No. 46-08645

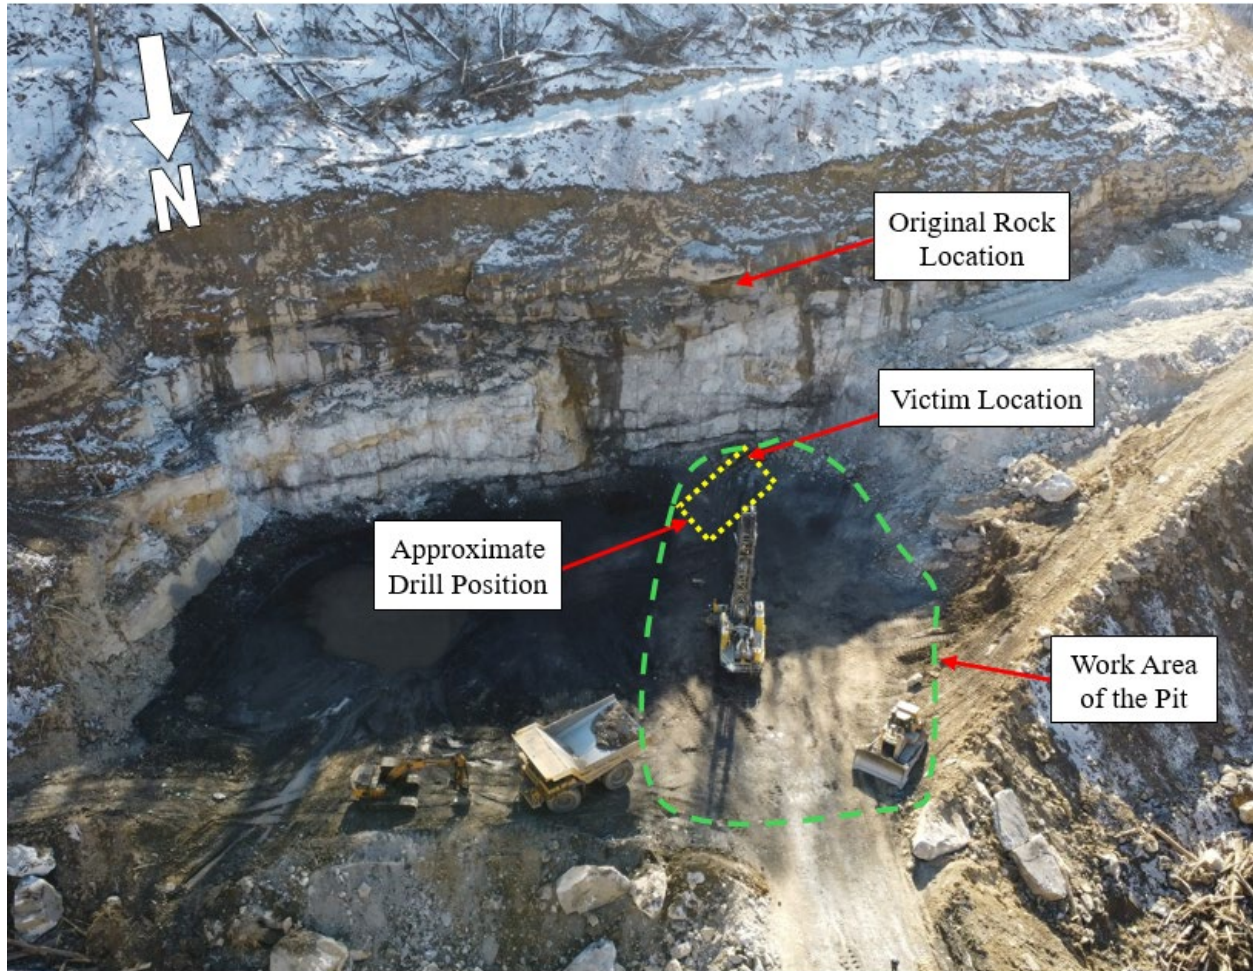
APPENDIX B – Aerial View of the Chilton A Pit

The accident occurred in the pit (see Appendix B). Investigators measured the work area of the pit to be 72 feet wide and 126 feet long. Two front-end loaders were loading haul trucks when the drill trammed into the pit and began drilling the test hole, causing the pit to become crowded. When the accident occurred, the drill was positioned at a slight angle to the highwall with the cab between the highwall and the drill's mast. The cab was three to five feet away from the highwall. Investigators determined the mine operator did not ensure the drill operator did not work under a dangerous highwall, which contributed to the accident.

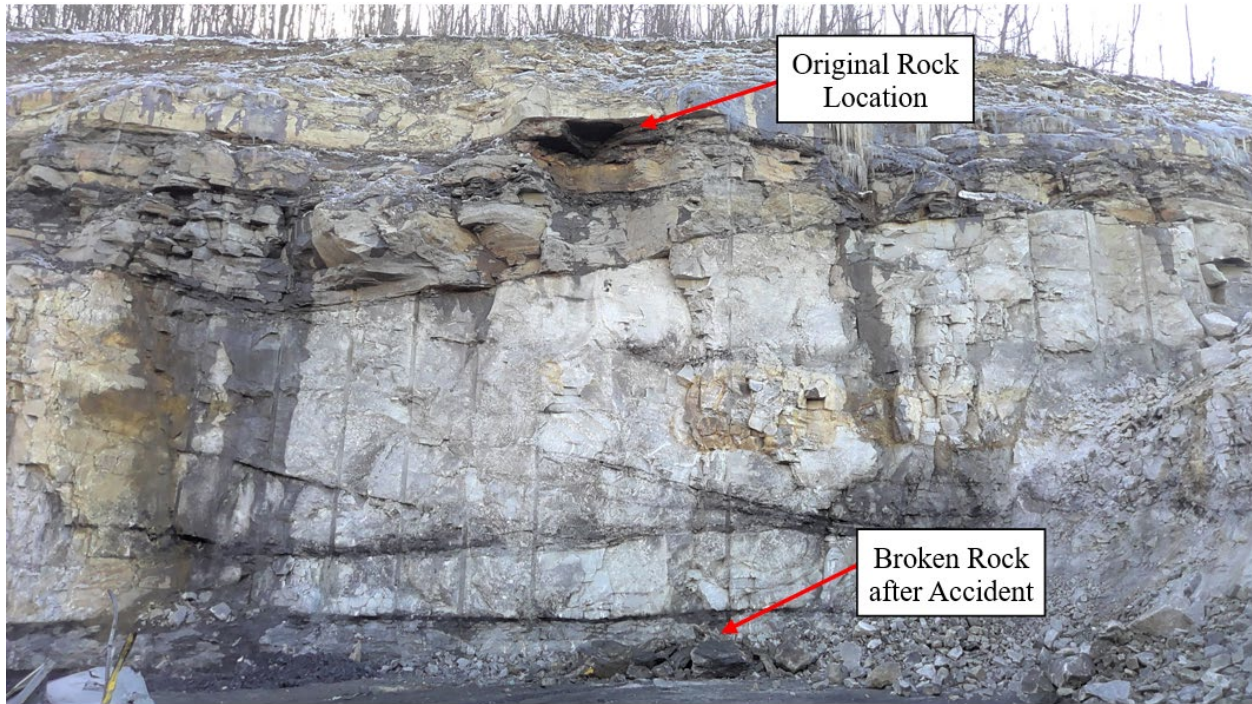
APPENDIX C – Highwall

The weather at the time of the accident was 37 degrees Fahrenheit with fair skies. According to the National Weather Service, the mine experienced severe freezing conditions starting on January 20, 2025. Average daily temperatures began to increase above freezing starting on January 26, 2025, causing thawing conditions. Investigators determined that the freezing and thawing conditions contributed to the accident due to the presence of mud seams and loose, unconsolidated rock in the highwall.

Development of the pit began on December 16, 2024. Austin Powder blasted the portion of the highwall involved in the accident on January 10, 2025. At the time of the accident, the highwall was 63 feet high. Investigators observed hazardous highwall conditions that were obvious and extensive, including mud seams, unconsolidated rock, and overhangs (see Appendix C). The mine operator did not have adequate equipment to scale the overhangs from a safe location, and did not install berms or signage to prevent miners from working under the hazardous highwall. Additionally, the mine operator assigned miners to work in the crowded pit, beside a highwall during a major freeze and thaw event. The mine operator did not ensure hazardous areas were scaled before work was performed in the pit, which contributed to the accident.

Corrective Action: The mine operator revised their Ground Control Plan to include procedures that ensure areas with hazardous highwall conditions are scaled prior to work being performed. The mine operator trained all miners on the revised Ground Control Plan.
