REPORT OF INVESTIGATION

Fatal Machinery Accident
January 30, 2025

Ellinger Sand & Gravel
Ellinger Sand & Gravel
Fayetteville, Fayette County, Texas
ID No. 41-04891

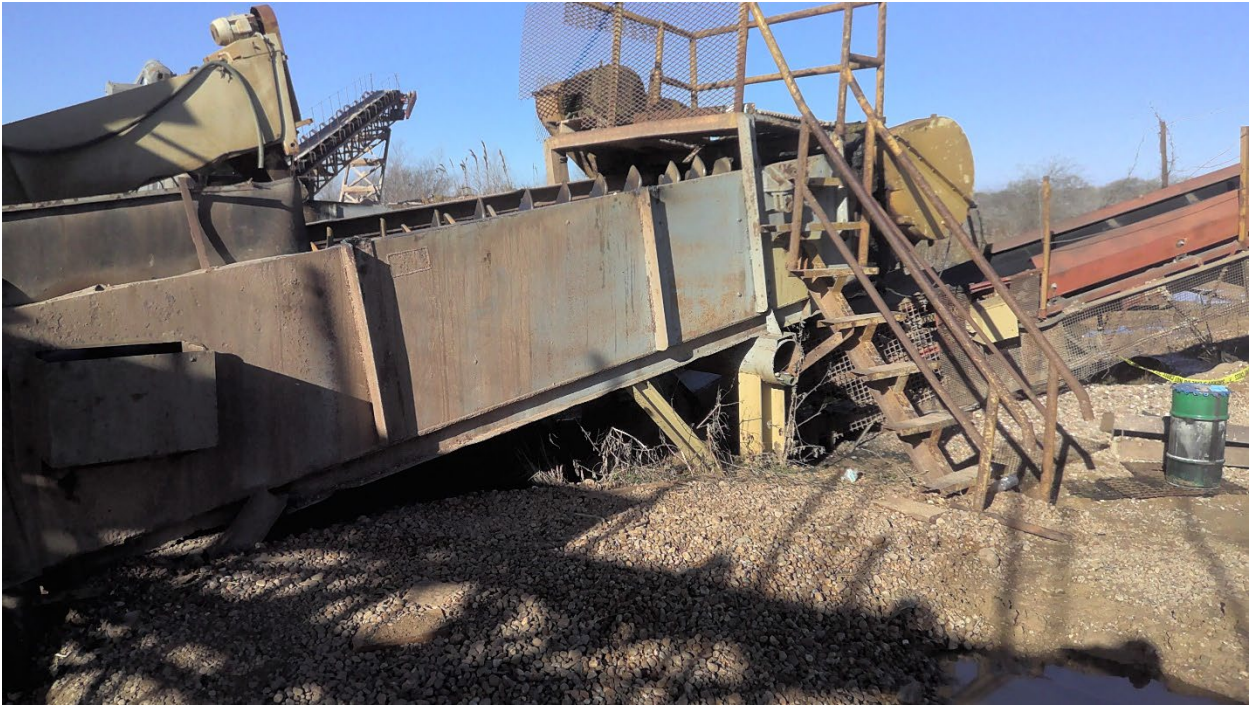
APPENDIX B – Eagle Sol-Clay Log Washer

Investigators learned the two paddle shaft bearings had completely failed, allowing the shafts to rotate inside of the bearing housing. This condition caused misalignment, allowing the paddle shafts to bind against one another, preventing them from rotating. Additionally, the keyway on the drive pulley for the unit was stripped out and would turn on the drive shaft when started. The mine operator made several failed attempts to weld a makeshift collar onto the shaft to stop the shaft from slipping in the drive pulley. The mine operator was aware of the mechanical defects and the unsafe work practices used to start the log washer.

The mine operator did not take the log washer out of service, tag, or use another effective method of marking the defective items to prohibit further use until the defects were corrected. Investigators determined that this contributed to the accident.

Corrective Action: The mine operator trained management and miners to recognize and identify defects on equipment, machinery, and tools that affect safety and take prompt corrective actions which includes immediately removing them from service. If the mine resumes production, the mine operator will submit a plan to MSHA to either repair or replace the log washer before operating the plant.
