REPORT OF INVESTIGATION

Fatal Powered Haulage Accident  
January 30, 2025

Salado Operations, Florence  
Salado Operations  
Florence, Williamson County, Texas  
ID No. 41-04216

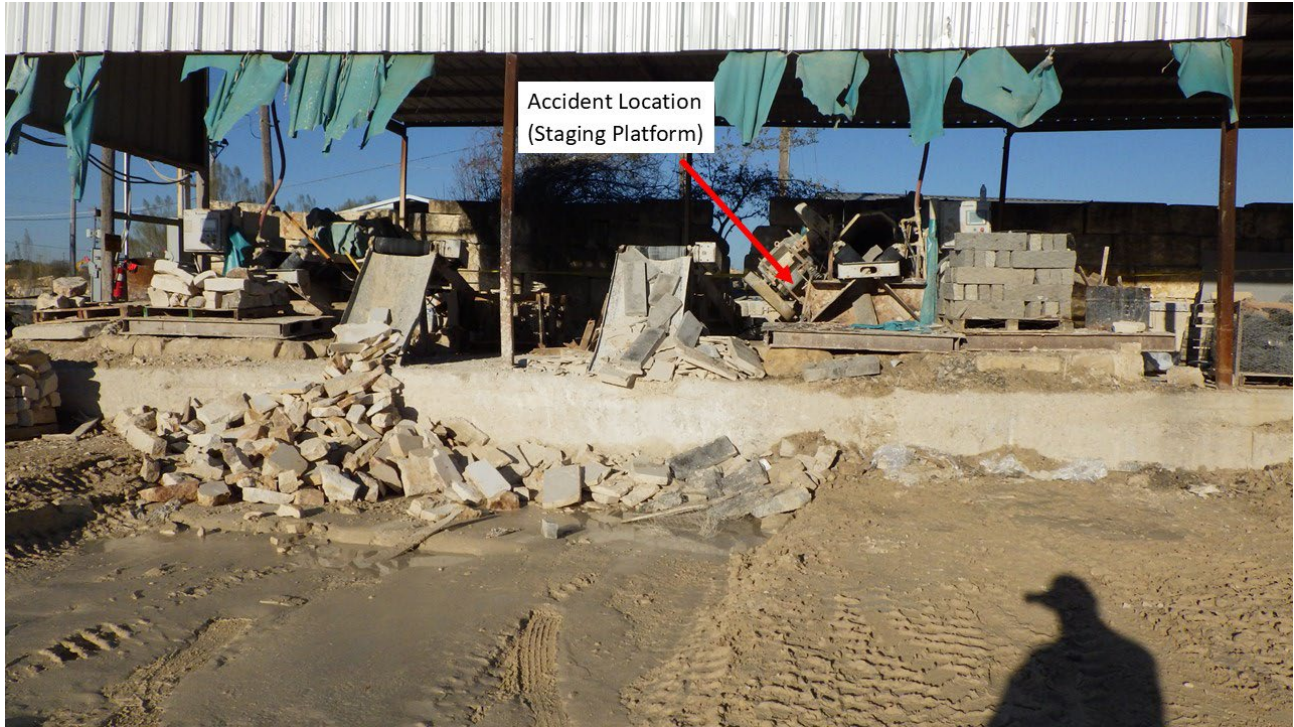
## APPENDIX B – Veneer Saw No. 2 Staging Platform

The accident occurred at the staging platform in thin-veneer saw No. 2 area (see Appendix B).

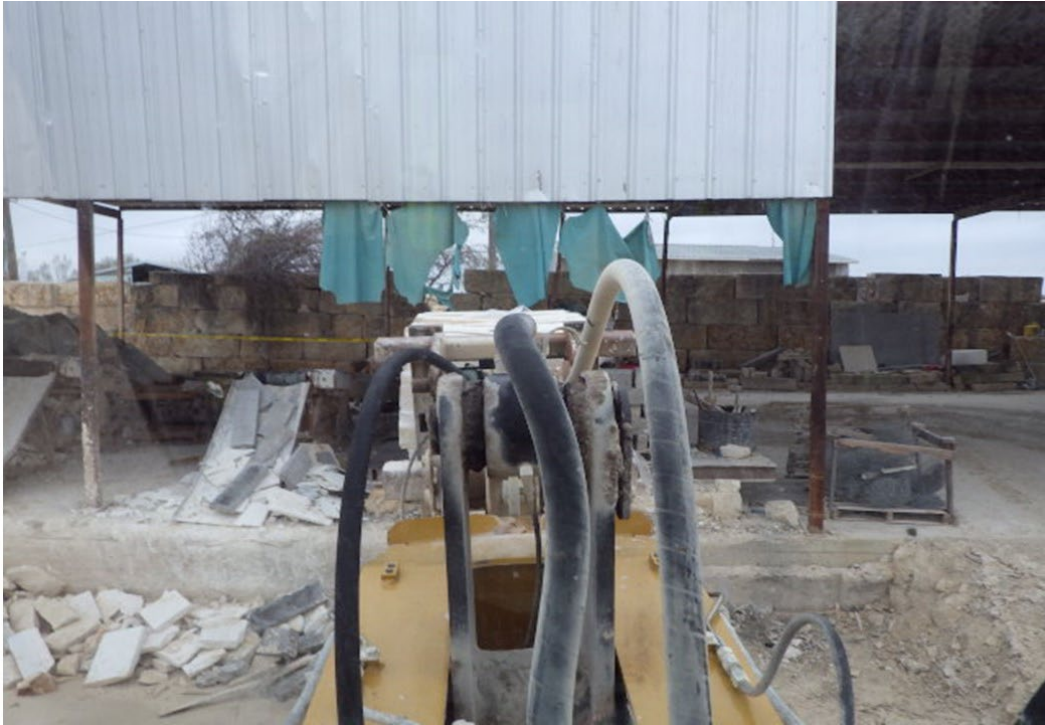
APPENDIX C – View from Front-end Loader Approaching the Staging Platform While Transporting a Loaded Pallet

At the time of the accident, the front-end loader was carrying a pallet of stone that was 39 ½ inches high, 50 inches long, 41 ½ inches wide, and weighed approximately 4,700 pounds. The forks of the loader were approximately four feet off the ground while the pallet of stone was being moved. As Gonzalez approached the staging platform, the pallet of stone was in his line of sight and blocked his visibility of the staging platform and Sanchez-Robles (see Appendix C). Investigators determined this contributed to the accident.

Root Cause: The accident occurred because the loader operator was moving the loader in a manner that caused the pallet of stone to block his visibility of the staging platform and the miner.

Corrective Action: The mine operator developed, implemented and trained miners on a procedure that would ensure that miners are not in the staging platform area when palletized stone is being loaded onto the staging platform of the thin-veneer saw area.
