REPORT OF INVESTIGATION

Underground  
(Lead-Zinc Ore)

Fatal Fall of Roof or Back Accident  
July 12, 2025

Young Mine  
Nyrstar Tennessee Mines, Strawberry Plains LLC  
New Market, Jefferson County, Tennessee  
ID No. 40-00168

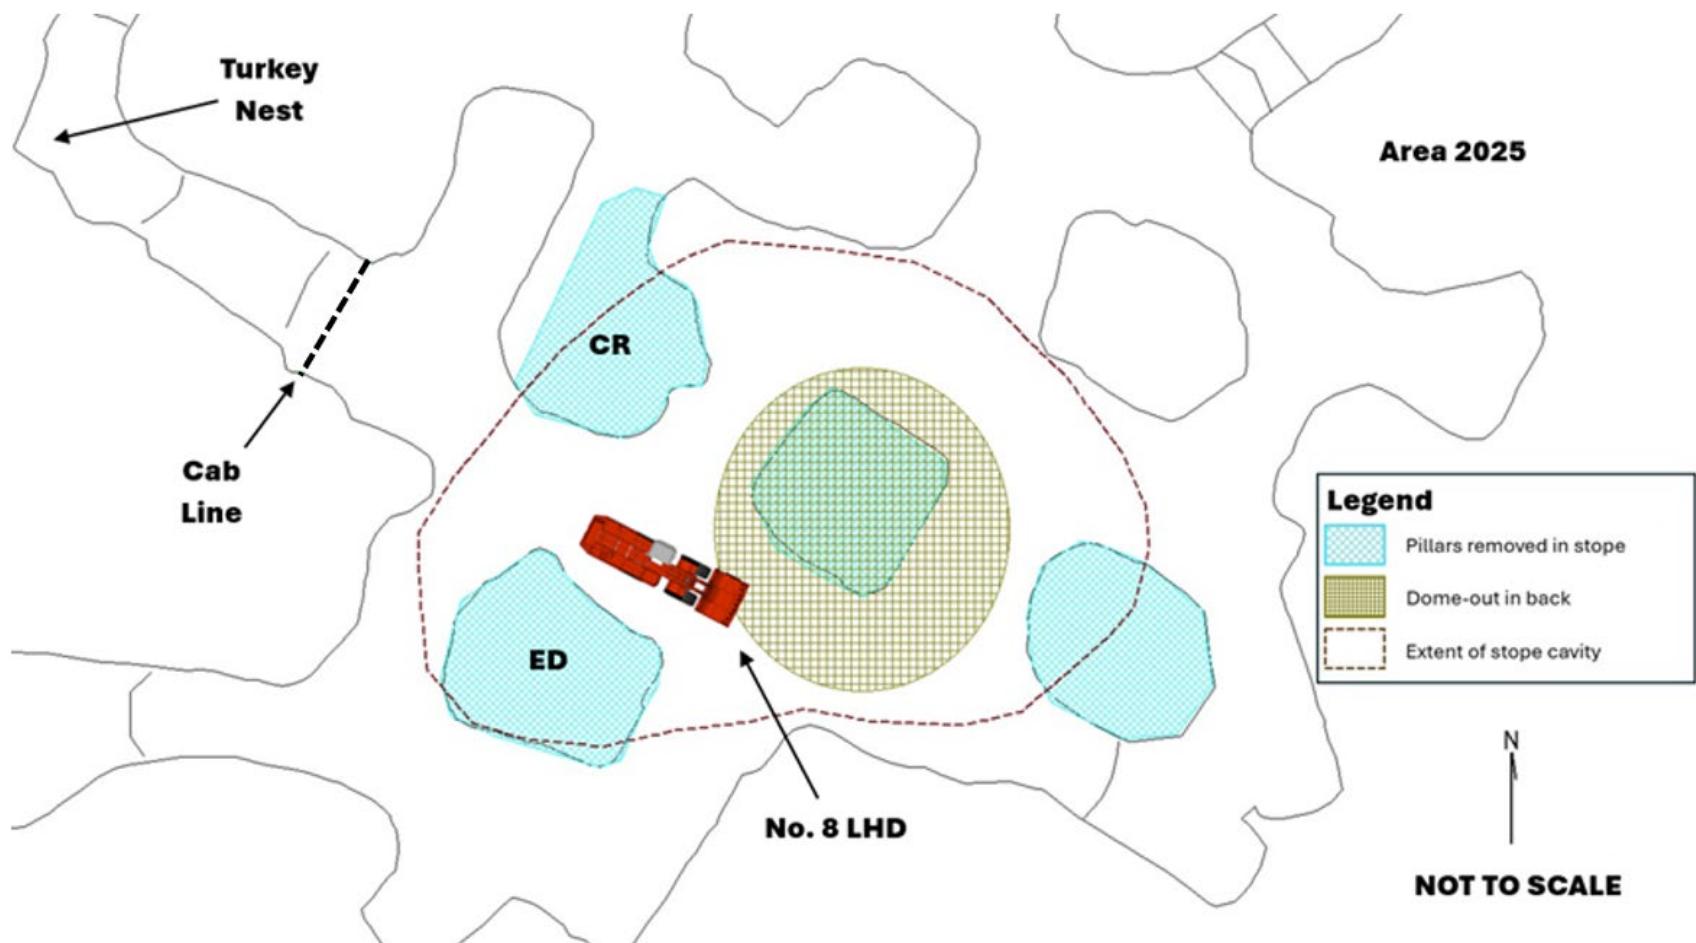
APPENDIX B – Post-Accident Sketch of Area 2025

The accident occurred in the stope of area 2025, under the area where the pillar just inby pillars CR and ED had been removed (Appendix B). Whitaker was in the cab of the LHD loader. The LHD loader was 68 feet beyond the cab line, which is described in depth in the Mining Methods section.

Root Cause: The mine operator did not take down or support the hazardous ground conditions before work and travel occurred in the affected area. The LHD loader was operated manually beyond the established cab line.

1. All remote LHD loader operators will be retrained in line-of-sight remote loading operations.
2. All employees will be retrained on precautions and limitations in open stope areas.
3. In addition to cab line markings, signage was posted at all entries to open stopes reiterating no personnel permitted beyond this point. Additionally, cab line markings will be made with reflective paint.
4. Cameras were installed in all open stope areas during remoting operations as an additional control to monitor operations and conditions within the stope.
5. Updated the remote permit to work procedure to include monitoring the dangers beyond the cab line.
