REPORT OF INVESTIGATION

Electrical Accident Fatality Report
July 26, 2025

Stillwater Mine
Stillwater Mining Company
Columbus, Stillwater County, Montana
ID No. 24-01490

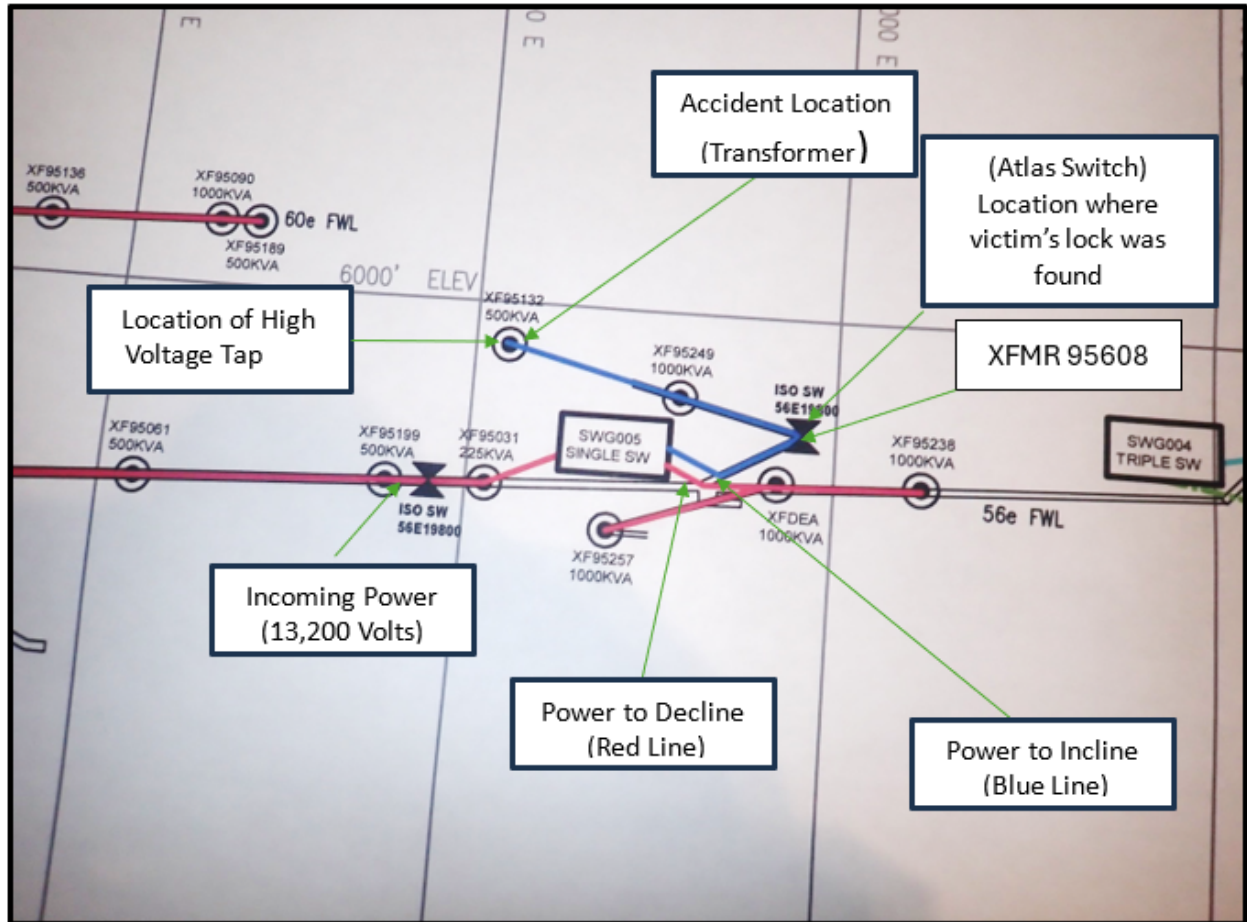
APPENDIX A – Electrical Diagram

On July 26, 2025, at approximately 7:00 a.m., Hanson started his shift. He was assigned the task of conducting electrical preventive maintenance (PM) on two transformers, #95132 and #95249, located on the 5600 Level East 21,000 inclined ramp underground. Lisa Williams, E&I technician, was assigned to assist with the PM. Prior to this, Garrett Pederson, electrical supervisor, attended the morning management meeting to discuss the need to de-energize electrical power to the 21,000 ramp. This would allow the electrical department to conduct the PMs but would shut down mine ventilation to the headings. Mining activities would cease in the 21,000 incline until the electrical power was restored (Appendix A).

Hanson told Nieto and Williams that he was going to go lock out and drove off in the personnel carrier down the incline. Investigators found Hanson's lock on the Atlas switch in the 5700 Level East, 21,700 location, which was determined not to be the appropriate location to properly de-energize power to transformer #95132 and #95249. Nieto and Williams started opening circuit breakers and removing side covers on the 480-volt side of the transformer. Approximately four minutes later, Hanson returned and removed the top cover from the 13,200-volt side of transformer #95132. Nieto observed Hanson climbing into the 480-volt side of the transformer #95132 metal housing. Hanson then climbed into the 13,200-volt side to clean the individual phases. When he touched one of the three phases, it was still energized and he received a phase-to-ground electrical shock of 7,600 volts.

The equipment involved in the accident was an Intermountain Electronics Transformer, Model Number: 500/PC, Company #95132. This was the last transformer located up the 21,000 ramp. The area where the victim placed his lock was located at 5700 East, 21,700 location. This was a vertical Atlas Switch that did not control power to transformer #95132.

A fatal accident occurred on July 26, 2025, when an E&I technician came into contact with one phase of a 13,200 high voltage power circuit in transformer #95132. The SWG005 switch controlling the 13,200 high voltage power circuit was not labeled to show which unit it controlled, and this could not be readily determined by its location. Due to the absence of

labels, the electrician placed his lock on a different switch that was not intended to de-energize transformer #95132. This lack of labels posed a high degree of danger to miners and exposed any miner working on the circuit to the risk of electrocution and death. The mine operator engaged in aggravated conduct constituting more than ordinary negligence. This is an unwarrantable failure to comply with a mandatory standard.

Corrective Action: The mine has revised existing preventive maintenance procedure and developed an additional practice of labeling power systems to make them easily identified.

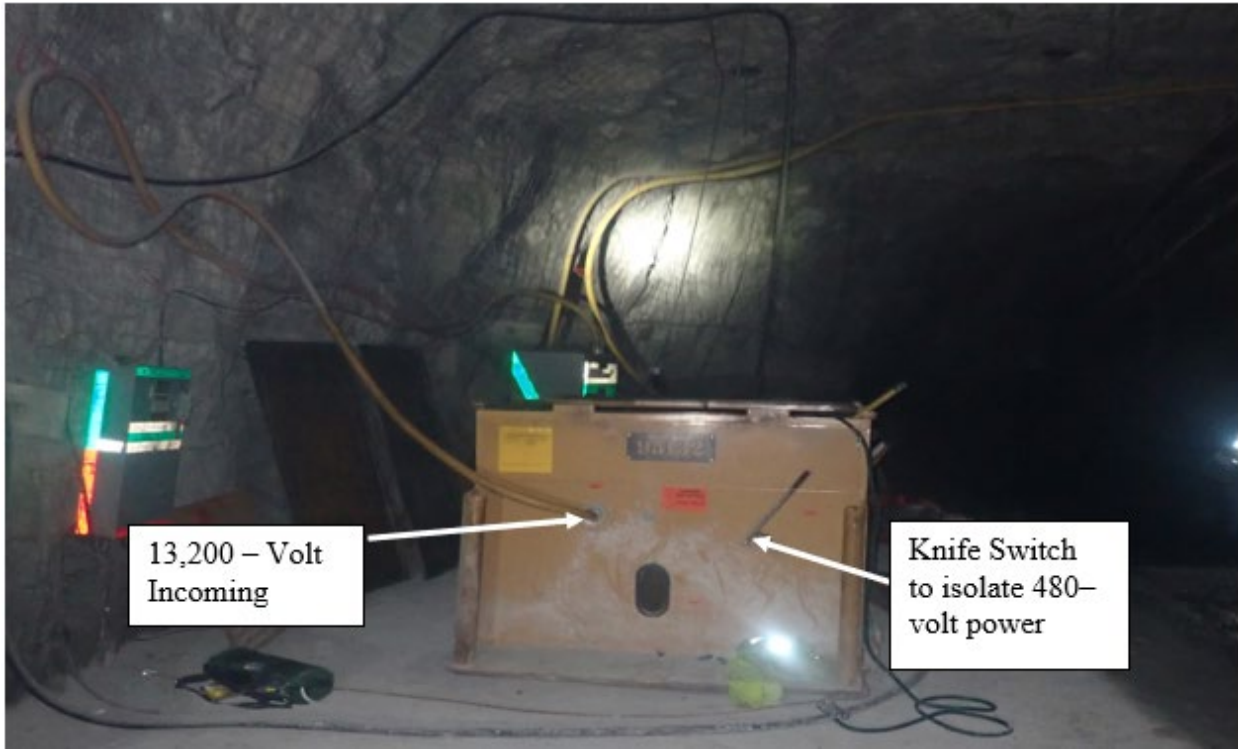
APPENDIX B – Transformer #95132

At 10:40 a.m., Williams called dispatch in accordance with the protocol to notify them that electrical power was being de-energized at the 21,000 ramp. Hanson opened the knife switch on transformer #95132; this only de-energized the 480-volt side of the transformer, de-energizing

power to the lights and the ventilation fan for the 21,000 ramp development section, but the 13,200-volt incoming feed remained energized at the transformer.

The accident occurred underground at transformer #95132 located on the 5600 Level East 21,000 inclined ramp underground.

Corrective Action: The company has established new policies and procedures for locking equipment out when doing preventive maintenance.

Corrective Action: The company updated the SOP and trained miners on the new procedure.
