REPORT OF INVESTIGATION

Surface
(Crushed and Broken Granite)

Fatal Power Haulage Accident
March 5, 2025

Arrowood
Martin Marietta Materials, Inc.
Charlotte, Mecklenburg County, North Carolina
ID No. 31-00059

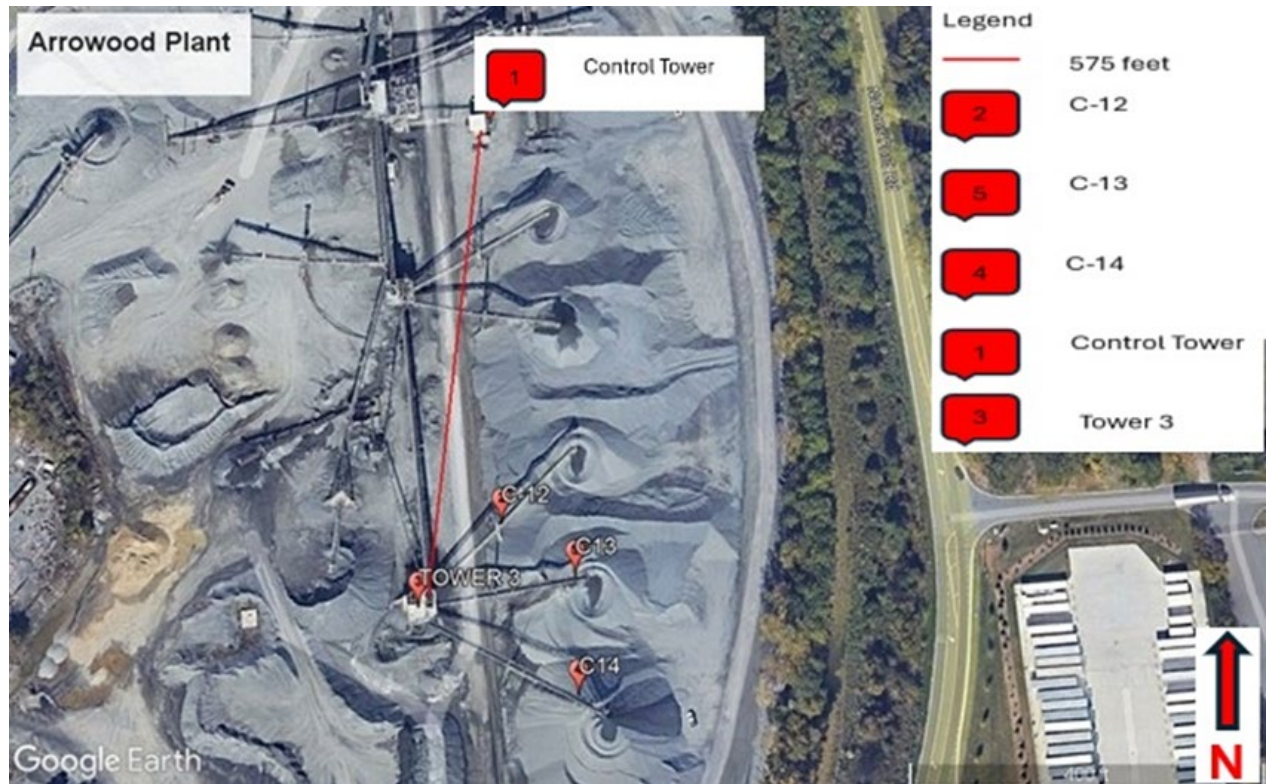
APPENDIX B – Aerial View of Plant

The accident occurred in the Tower 3 on the No. 12 belt conveyor tail roller (see Appendix B). The No. 14 belt conveyor where Maciel adjusted the belt skirt rubber was also located in Tower 3, approximately six and one-half feet away from the No. 12 belt conveyor tail roller (see Appendix C).

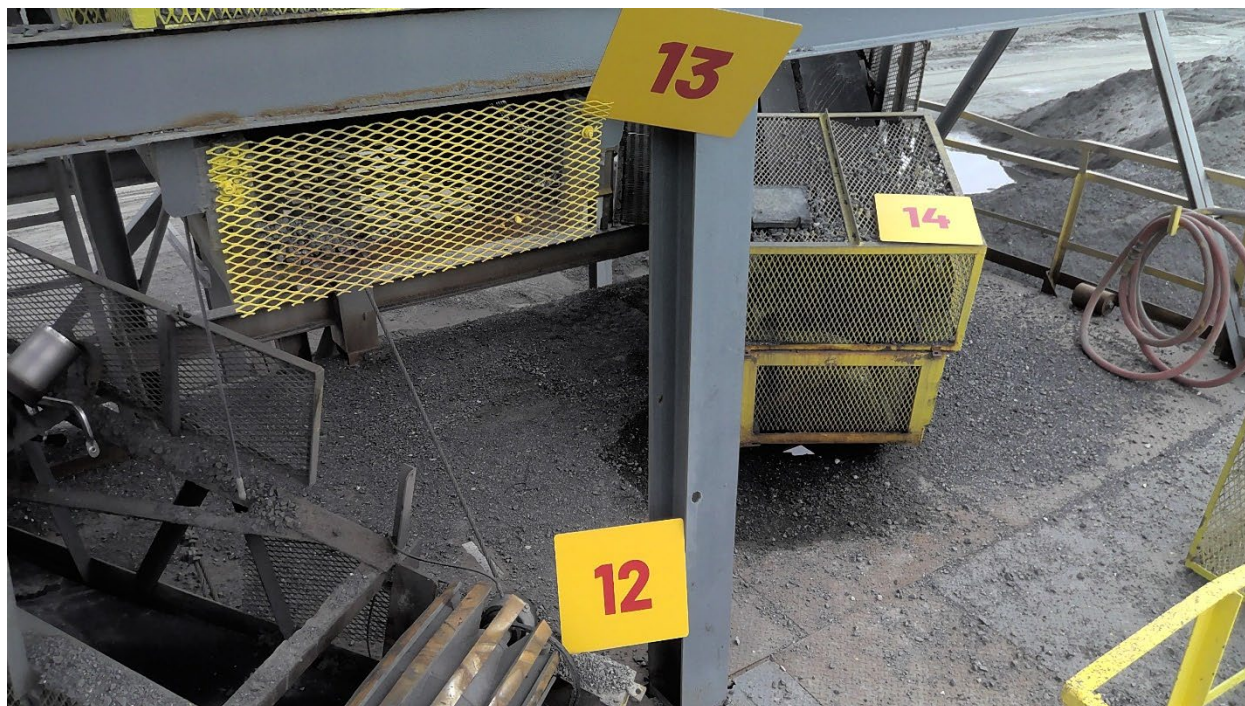
APPENDIX C – Belt Conveyors on Tower 3

The No. 12 belt conveyor had a 24-inch-wide belt and was 254 feet long. A 460-volt Toshiba 25 HP electric motor powered the belt conveyor. The self-cleaning tail roller was 16 inches in diameter, and the area that Maciel accessed had less than 6 inches of clearance from the edges of the belt and the guards he did not remove. While the plant was down, Maciel locked out and tagged out the No. 14 belt conveyor but not the No. 12 belt conveyor. The circuit breakers for both belt conveyors were located in the MCC. Maciel informed Cafaro that he was going to perform maintenance on the No. 14 belt conveyor but did not inform Cafaro of his intention to perform work on the No. 12 belt conveyor. The mine operator did not de-energize and block the No. 12 belt conveyor against hazardous motion, which contributed to the accident.

Root Cause: The mine operator did not de-energize and block the No. 12 belt conveyor against hazardous motion.

Corrective Action: The mine operator developed and implemented a revision to the Lock and Tag-out procedure. This revision includes labeling all belt conveyors and tailpieces, and visual confirmation of miners working in the areas prior to starting the equipment. The mine operator trained all miners on the revision, which emphasizes verification prior to starting the equipment.
