REPORT OF INVESTIGATION

Fatal Explosives and Breaking Agents Accident  
March 5, 2025

Calhoun Quarry #1  
Calhoun Quarry Inc  
Fieldon, Jersey County, Illinois  
ID No. 11-00111

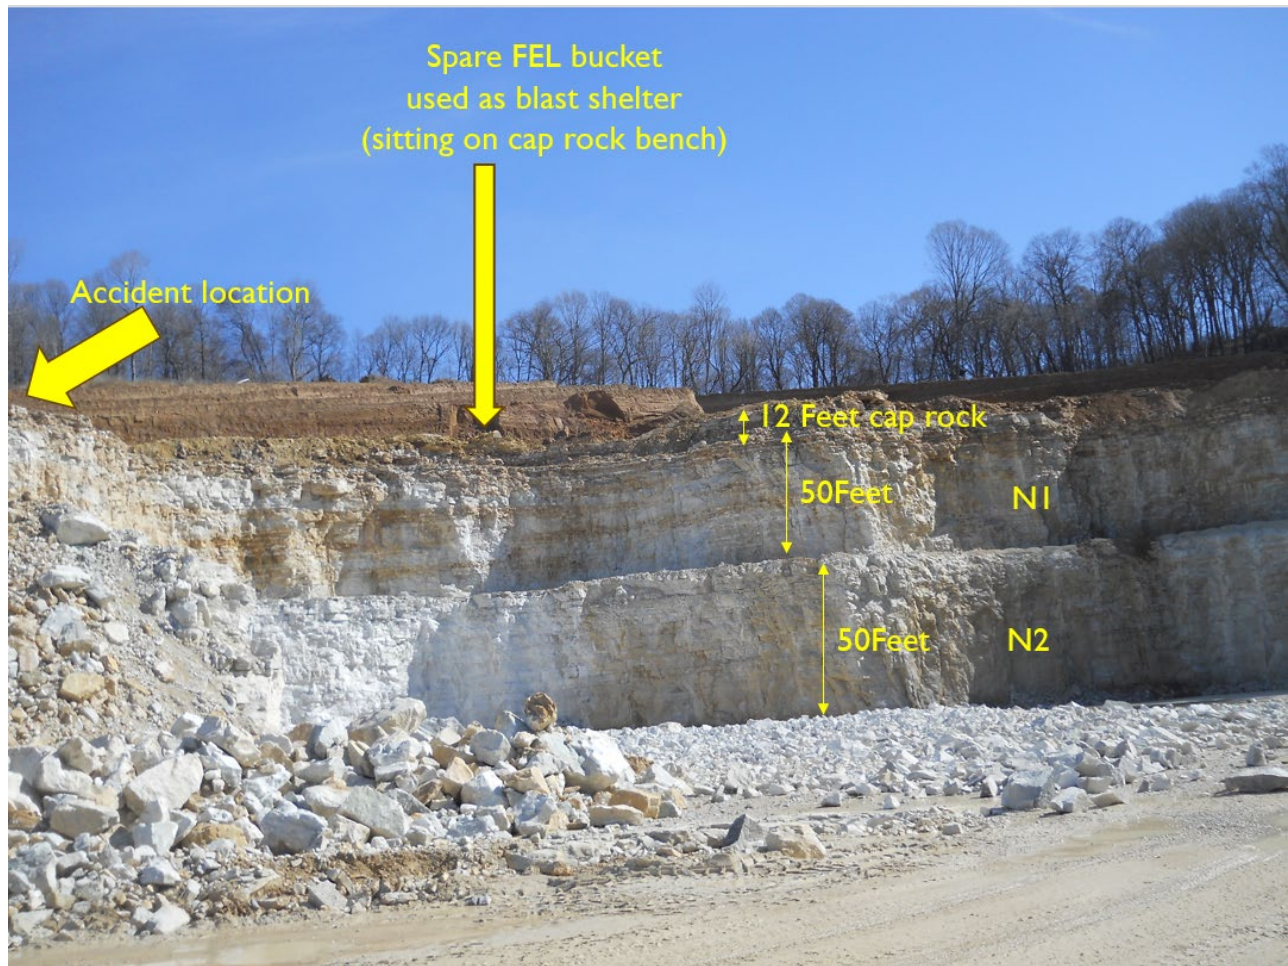
APPENDIX A – Front-End Loader on Cap Rock Bench with Blast Shelter 224 feet away

On March 5, 2025, A. Sievers arrived at the scale house to start his shift at approximately 8:00 a.m. A. Sievers planned on initiating a blast on the lower bench (N2) in the open pit (see Appendix A). The weather early in the day was wet and windy. A. Sievers talked to Jerry Sievers, Equipment Operator/Co-owner, who recommended that they wait until later in the day hoping weather conditions would improve. A. Sievers agreed, and the miners started their shift performing their normal duties. A. Sievers sent Kevin Slone, Blaster Helper, to finish drilling the holes for the planned blast on the N2 Bench.

The accident occurred along the North Road on the cap rock bench where the FEL was parked. The shot consisted of 29 holes in three rows. The FEL was parked approximately 140 feet from the shot site (see Appendices A and D). Investigators determined that A. Sievers was struck by a piece of fly rock from the blast after exiting the cab of the FEL. Neither A. Sievers nor Slone were in a safe location or adequately protected from fly rock when the shot was initiated. The blast shelter that Slone originally tried to detonate from was located approximately 105 feet from the blast site. Investigators determined the close proximity to the blast contributed to the accident.

1. Root Cause: The mine operator did not ensure miners were in a blast shelter while initiating a shot in the blast area.

Corrective Action: The mine operator removed all explosives from mine property. All future blasting will be performed by a company who specializes in blasting. This blasting company will ensure compliance with all drilling and blasting regulations and miners' safety.

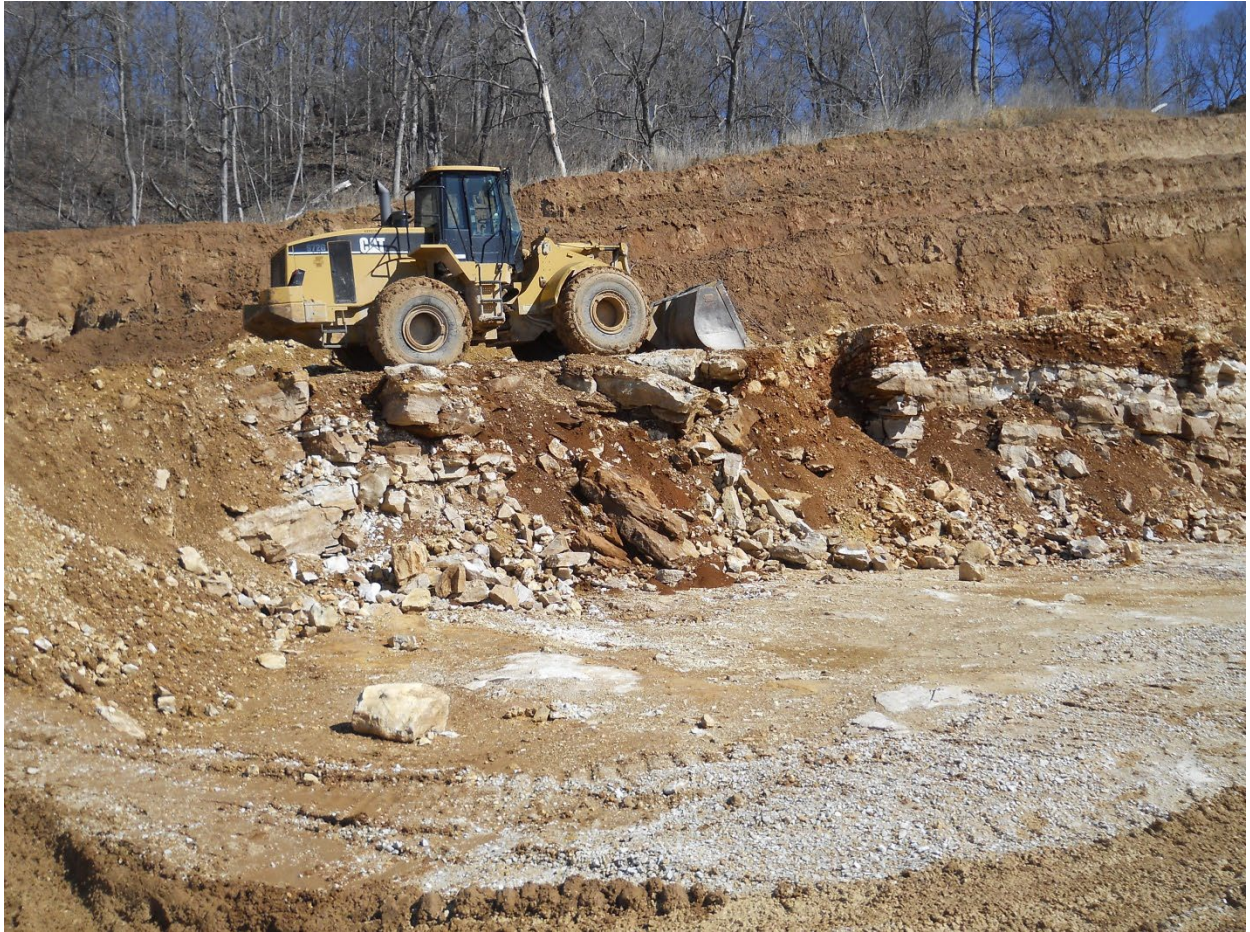
## APPENDIX B – Front-End Loader Parked on Cap Rock Bench

When Slone attempted to use the detonator box it would not set off the blast. Slone believed the battery in the detonator box was dead and called A. Sievers to bring him another nine-volt battery. A. Seivers could not find a nine-volt battery and told Slone he would bring the FEL to use its battery. Because the roadway leading to the blast shelter was too muddy and narrow for the FEL to travel safely, he instructed Slone to move the blasting line to the North Road. A. Seivers drove the FEL to the North Road so Sloan could use the electrical system batteries on the FEL to initiate the blast (see Appendix B).

On March 5, 2025, a fatality occurred at this mine when a miner parked the Front-End Loader (FEL) approximately 140 feet from a 29-hole shot in order to use the electrical system of the FEL as the power source to detonate the shot. The miner was outside the cab of the FEL when the shot was detonated by another certified blaster who was standing at the back of the FEL. This resulted in the miner being struck by a piece of fly rock, causing fatal injuries. The mine operator engaged in aggravated conduct constituting more than ordinary negligence in that all miners located in the blasting radius were not protected by a blast shelter. This violation is an unwarrantable failure to comply with a mandatory standard.
