REPORT OF INVESTIGATION

Fatal Falling, Rolling or Sliding Rock or Material of Any Kind Accident  
May 1, 2025

Stout Excavating Group LLC (B7441)  
San Antonio, Texas

Signal Peak Silica of Atascosa  
SP Silica of Atascosa, LLC  
Poteet, Atascosa County, Texas  
ID No. 41-05317

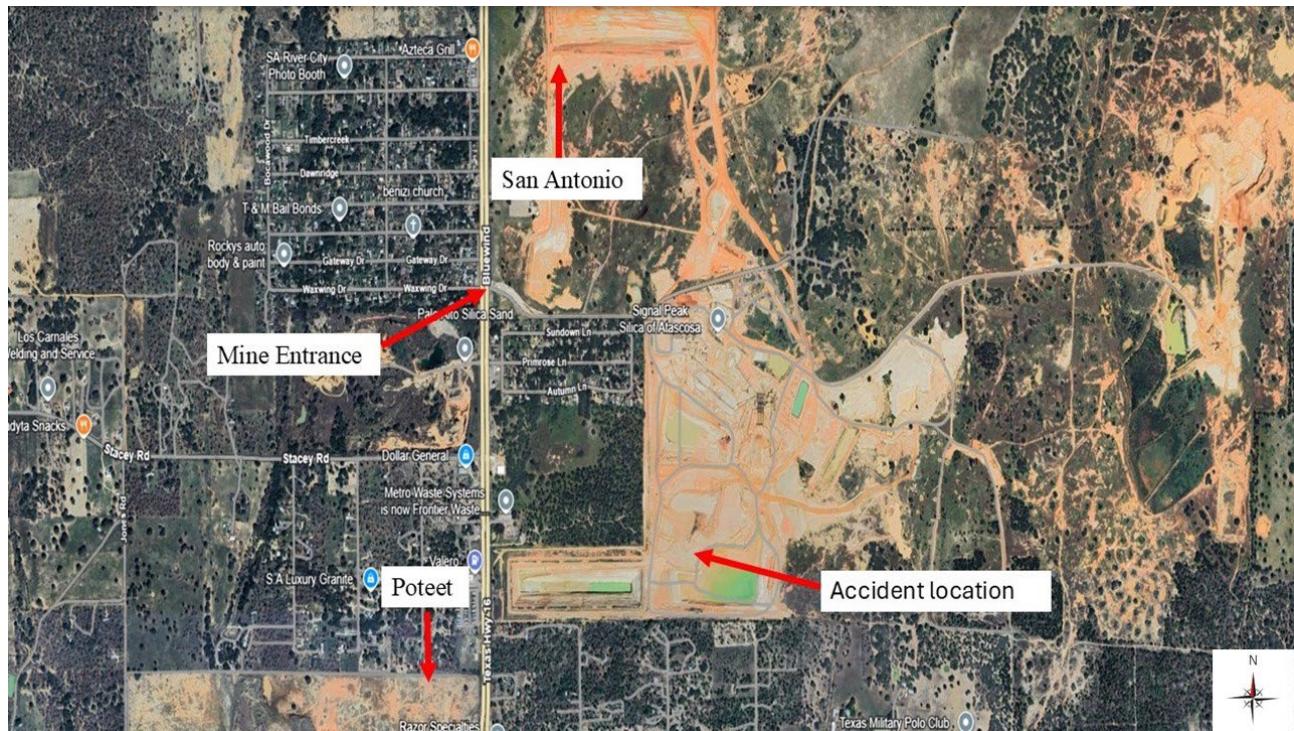
## APPENDIX B – Mine Map

At the time of the incident, the excavator was positioned on a bench in Pit 2C and was being used to load haul trucks with material from the ramp (see Appendices B and C). The bench Herrarte was working off was approximately eight feet high.

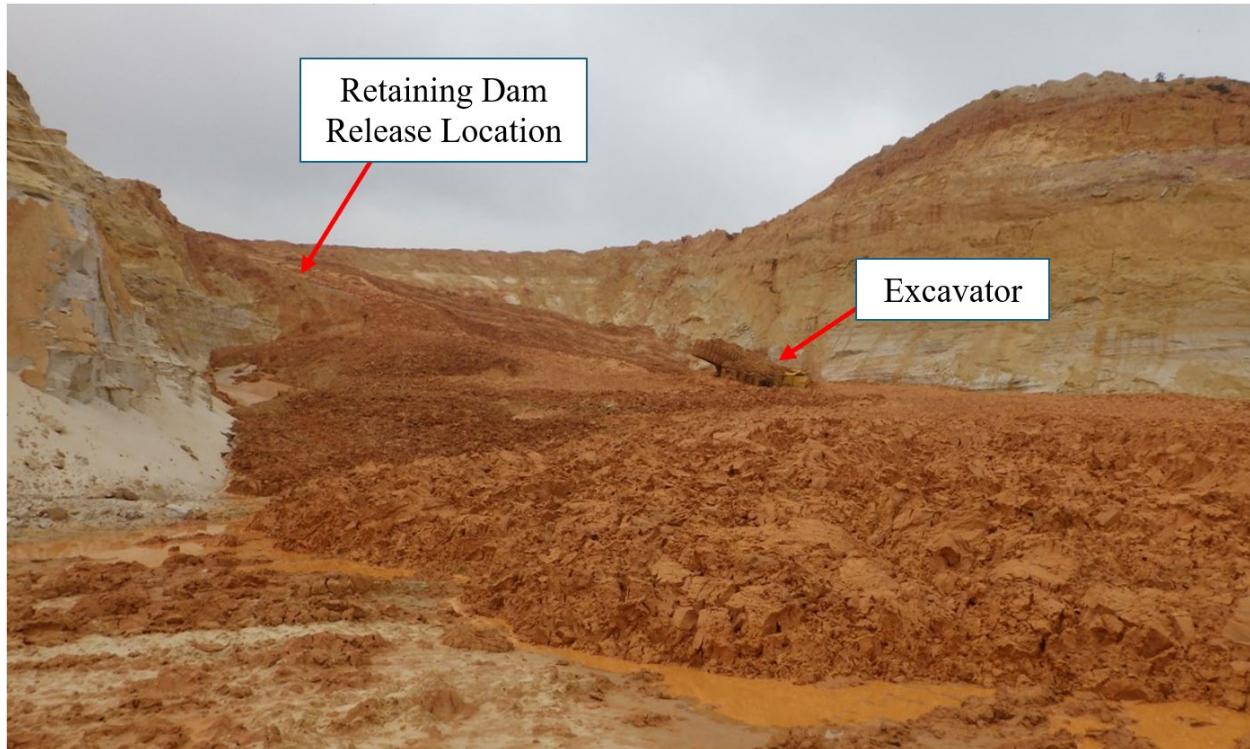
APPENDIX C – Photo of Accident Area

Fritz stated the cap was approximately 25 feet thick. The center of the waste tailings pond reached an elevation of 730 feet. The cap surface slopes down towards the north, west, and south highwalls with elevations ranging between 700 to 705 feet along the edge of each of these highwalls. The tailings flowed out of the south end of the waste tailings pond, and the retaining dam release location had an elevation of 684 feet. This appears to be directly over top of the southern end of the waste tailings pond. The excavator’s final position in Pit 2C was 257 feet southwest of the release location.

Using the surface area and these estimated flow depths, the corresponding volume of tailings that was released ranged between 2.2 and 3.3 million gallons. A portion of the cap subsided behind the release location (immediately to the north). This formed a depression in the cap that was approximately 200 feet wide (east-west) by 400 feet long (north-south) and had a bottom elevation of 700 feet.

The mining method utilized by the mine operator and contractor resulted in a retaining dam being constructed insufficient to support the contents of the adjacent tailings pond. Indicators of seepage were present two days prior to the failure. Neither the mine operator nor contractor conducted examinations of the area. Investigators determined that the mine operator and the contractor did not substantially construct and inspect the retaining dam at regular intervals, which contributed to the accident.

implemented, and trained miners on a robust procedure for mining methods that incorporates geotechnical and engineering recommendations for the construction of retaining dams. Furthermore, the mine operator will construct a buttress based on current geotechnical and engineering recommendations to stabilize the area where the dam failure occurred.

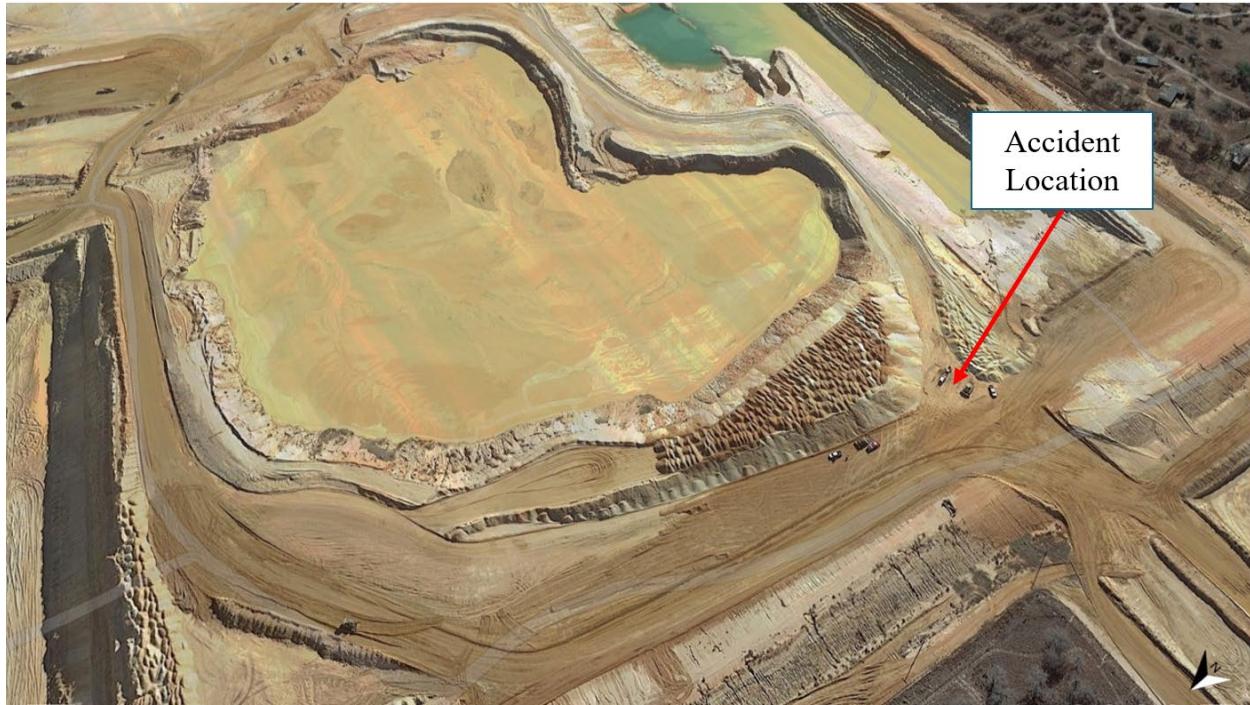
#### APPENDIX D – Historical Photo Tailings Pond Prior to Accident

MSHA Technical Support conducted an investigation at the Signal Peak mine to examine the ground conditions at the south end of the mine property near the release location in the retaining dam. Pit 1 (waste tailings pond) was developed near the south end of the mine property during 2018. Fritz indicated Pit 1 was approximately 60 feet deep. There is no survey data or other information available for Pit 1 development. Based on the historical Google Earth Photo (GEP) images, Pit 1 appeared deeper along the southern end given the highwall that was evident in the images (see Appendix D). After Pit 1 excavation was completed, it was used for tailings disposal. The waste tailings pond had an approximate surface area of 18 acres. Haul roads

The mine operator initiated capping of the waste tailings pond sometime in 2021, as evident by the GEP image dated October 29, 2021, showing the capping in progress with approximately seven acres of exposed tailings remaining. While examining the cap, MSHA Technical Support observed an uncapped area of exposed tailings near the center of the cap, approximately 20 feet wide by 80 feet long, surrounded by berms of material.

Google Earth historical photo year 2020
