REPORT OF INVESTIGATION

Handling Material Accident Fatality Report
November 22, 2025

Carlsbad Plant
United Salt Carlsbad LLC
Carlsbad, Eddy County, New Mexico
Mine ID: 29-01043

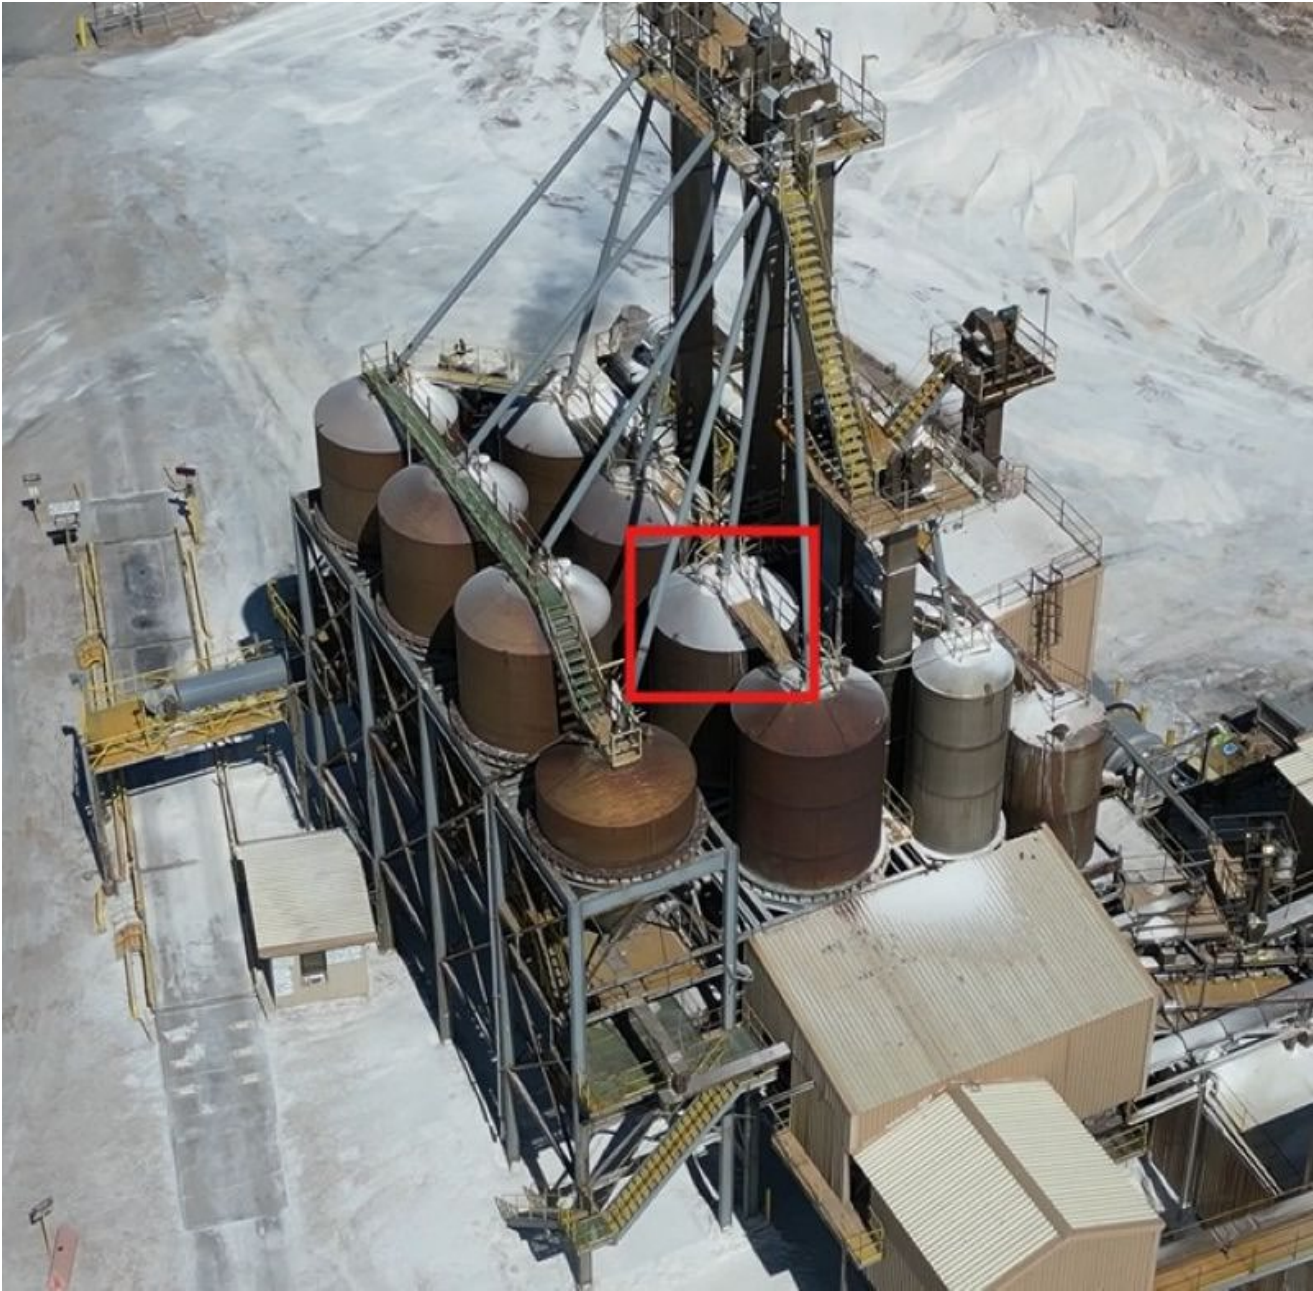
APPENDIX B – Bulk Processing Plant

The accident occurred at Silo No. 6 on the silo deck floor of the Bulk Processing Plant (Appendix B).

Note: The red square shows the location of Silo No. 6.

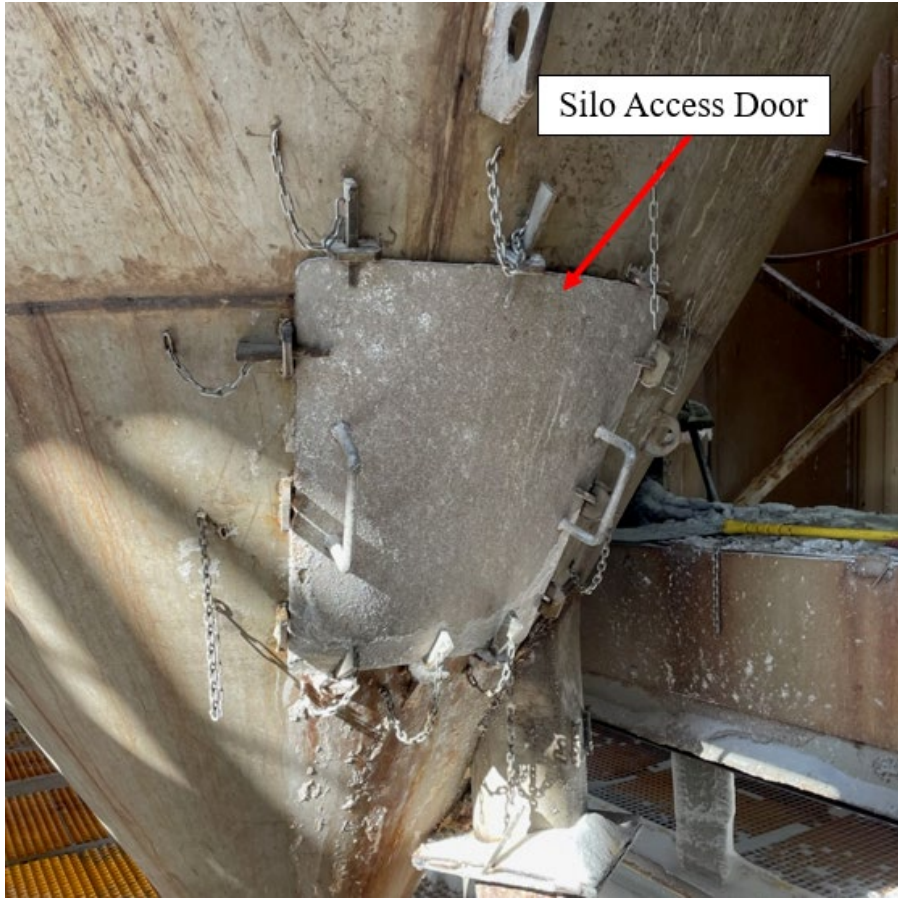
APPENDIX C – Silo Access Door

The access door is located on the east side of the silo cone, opposite the swing hammer (Appendix C). The access door is tapered to match the cone, with a top opening of 29 inches, a lower opening of 22 inches, and a vertical height of 30 inches. The bottom edge of the access door opening is 49 inches above the silo deck floor.

Other tools used to break up salt buildup inside the silo included eight- and ten-pound long-handled sledgehammers, an air chisel with 16-inch and 36-inch bits, swing hammers, and two hand-cart-mounted gas-powered pressure washers. The swing hammers were attached to chains on only one side of the silos and required miners to continuously use them to prevent material buildup on that side. The access door opening was located on the opposite side of the swing hammers, and no means existed to reduce salt buildup at or above the access door.

Root Cause: The mine operator did not equip Silo No. 6 with effective means of handling material to prevent the plant operator from being required to enter or work where he was exposed to entrapment by caving or sliding materials.

Corrective Action: The mine operator sealed all silo access doors by welding and cut vents in the tops of the silos to wash out remaining salt with water hoses. The mine operator developed and implemented a written procedure to use the vents when cleaning and clearing blockages from the silos.
