REPORT OF INVESTIGATION

Fatal Powered Haulage Accident  
November 6, 2025

Mountain View Mine  
Mettiki Coal WV, LLC  
Davis, Tucker County, West Virginia  
ID No. 46-09028

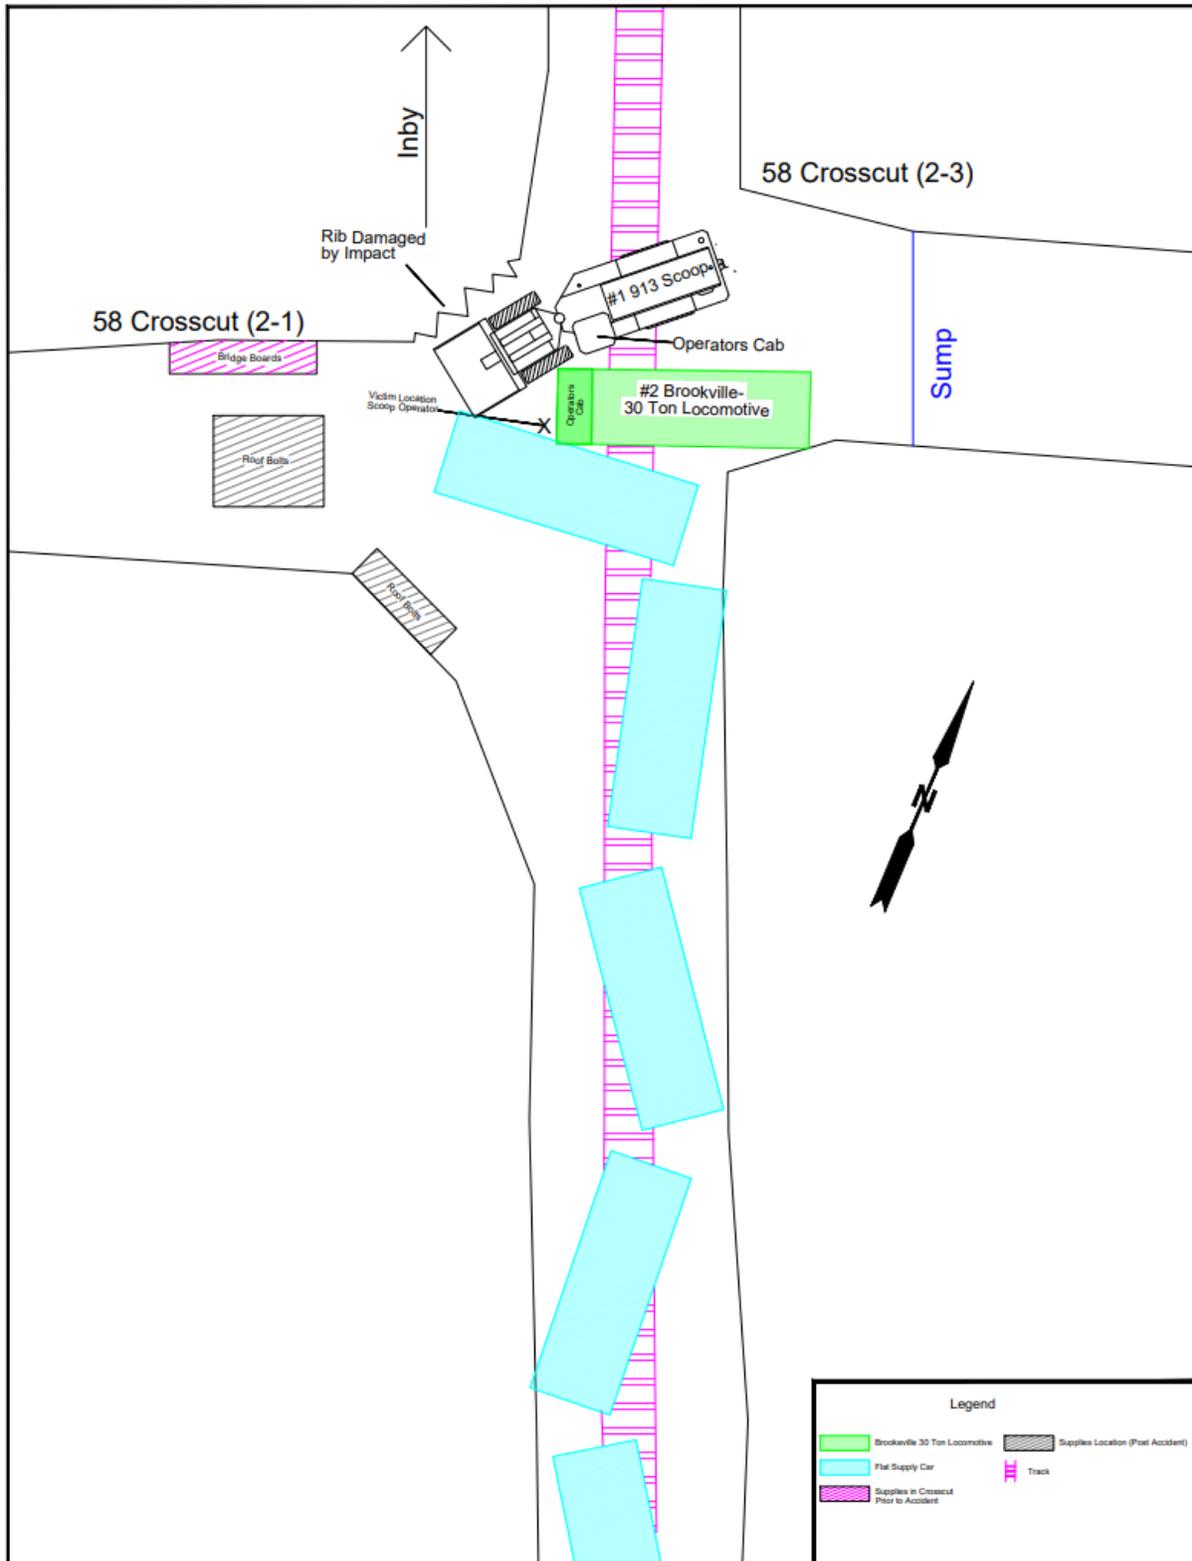
APPENDIX A – Sketch of Accident Scene

collision pushed the scoop into the inby corner in the 58 block intersection, causing the No. 2 locomotive and five of the six supply cars to derail. The No. 1 locomotive and the sixth supply car remained on the track.

Ahern radioed Duckworth, and when he did not receive an answer he made his way to the locomotive. Duckworth had been knocked to the locomotive floor, suffering head and leg injuries. Ahern helped Duckworth break one of the locomotive's windows and climb out so they could look for Mitchell. Mitchell was found unresponsive under the first derailed supply car (Appendix A). Ahern radioed for help. High heard the call for help and called 911 at 1:32 a.m.

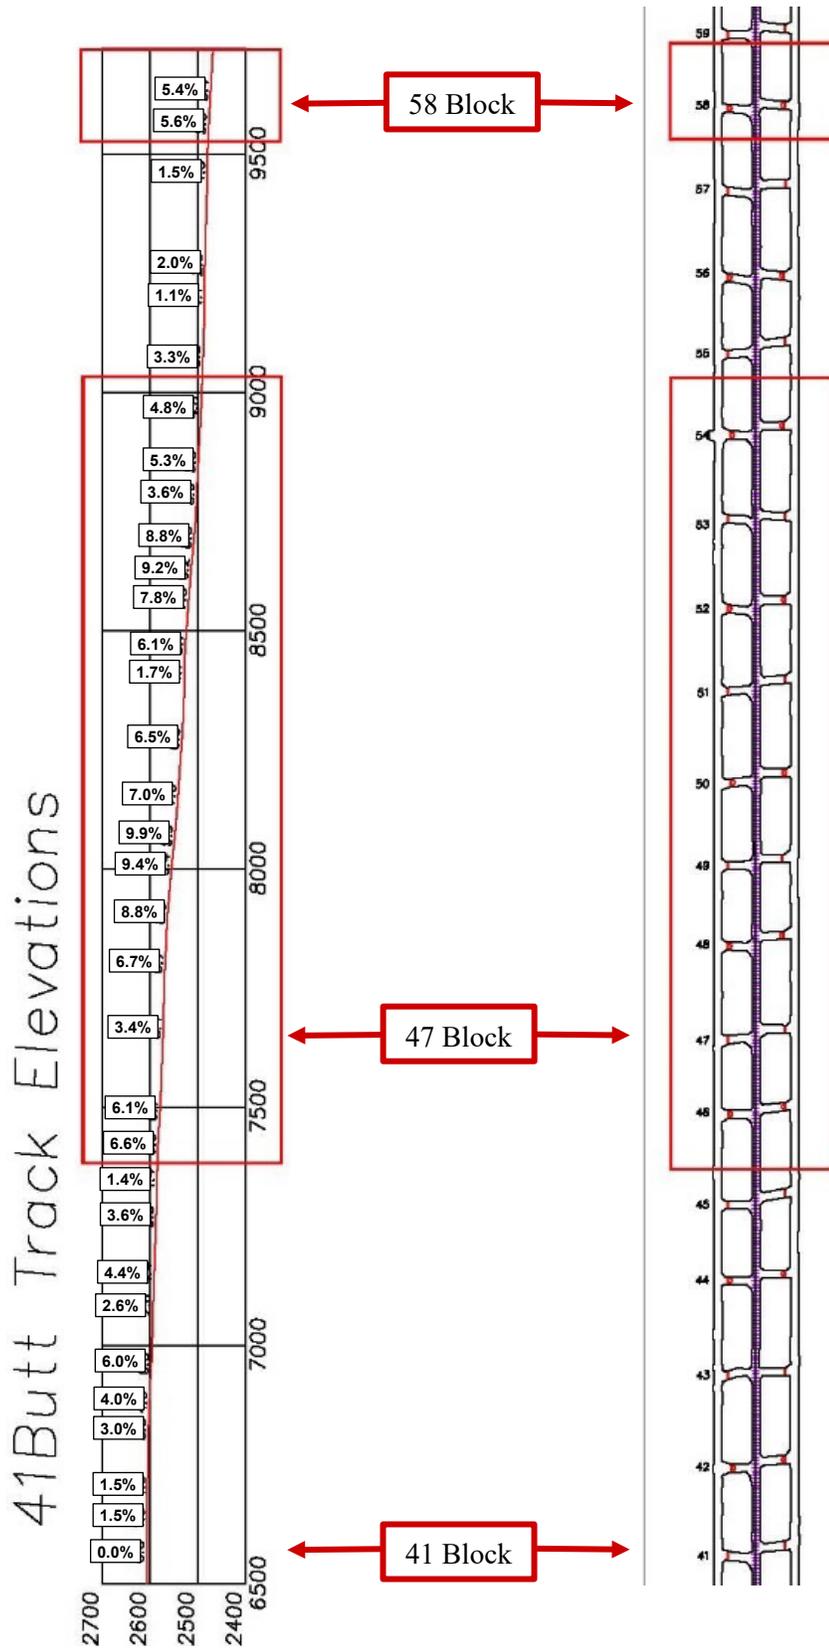
APPENDIX C – Grade Profile of 41 Butt Section Track Haulage

The accident occurred on the 41 Butt miner section track haulage at the 58 block crosscut. The track haulage from approximately 45 to 55 blocks averaged a down grade of 5.9% inby with a maximum grade of 9.9%. The track was also wet and muddy in this area. There was no water over the rails and muddy conditions existed where rubber-tired mobile equipment drove over the rails. Investigators determined that the grade and conditions of the track affected the locomotive operator's ability to control the diesel locomotives and contributed to the accident. See Appendix C for a map showing the track haulage grade.

Corrective Action: The mine operator has installed derails, warning signs, and a block light system at the beginning of all steep grades and developed procedures in their use. All miners were trained in the procedures.
