REPORT OF INVESTIGATION

Inundation Accident Fatality Report
November 8, 2025

Rolling Thunder Mine
Nicholas-Contura, LLC
Swiss, Nicholas County, West Virginia
Mine ID: 46-09111

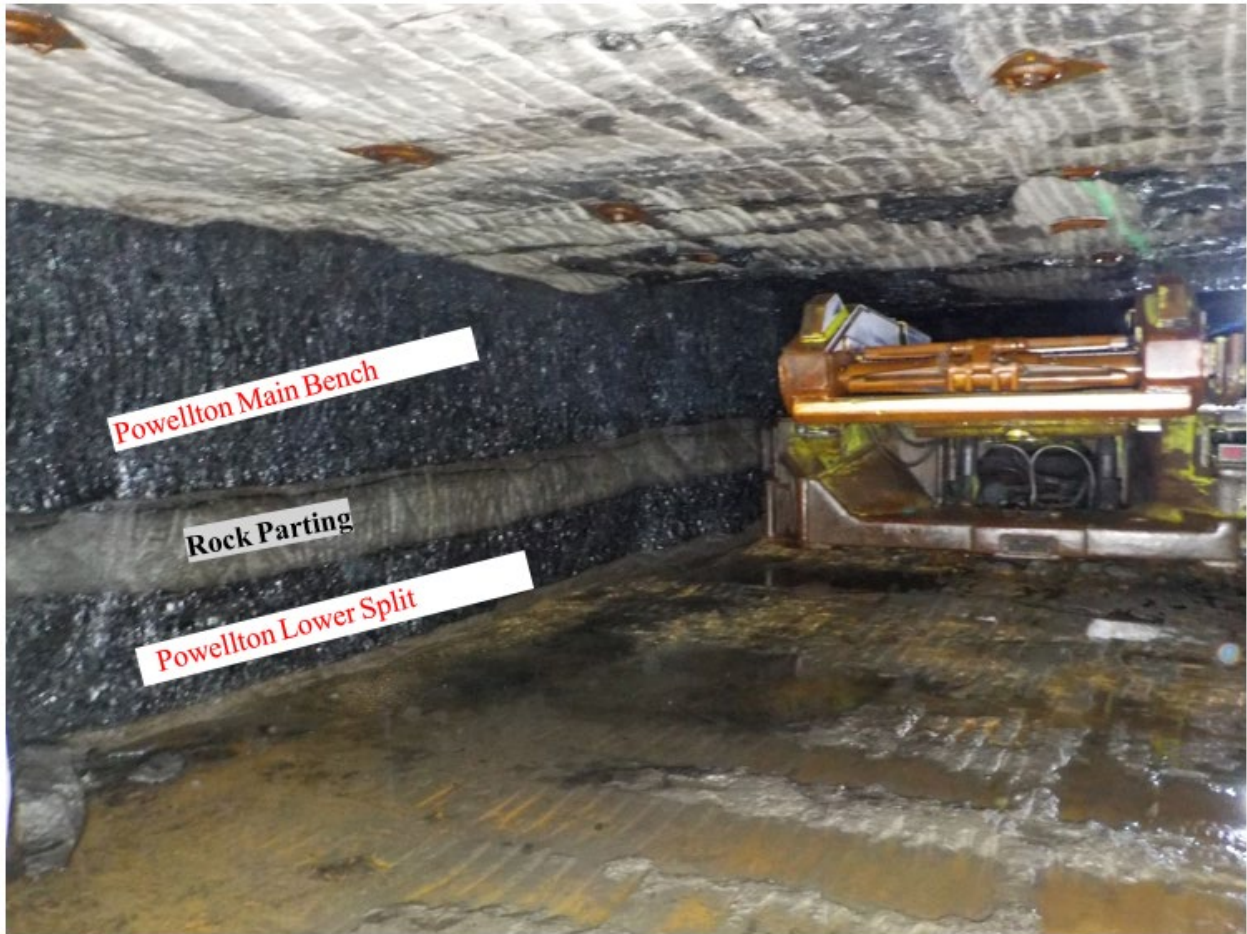
APPENDIX C –No.1 Section Face

At approximately 6:45 a.m., the production crew arrived on the No. 1 section. During the regular mining cycle, Hicks mined into the upper half of the coal seam on the left side of the No. 1 face and encountered water at 12:05 p.m. Hicks evacuated the No. 1 face and traveled to the No. 2 entry where he met Belt and Neil. Belt called Lipscomb on the radio to tell him about the water. Lipscomb arrived in the No. 2 entry where he met with Belt to discuss the inundation. Belt began alerting the remainder of the production crew before he and Lipscomb traveled to the power center in the No. 4 entry. Keyes, already at the power center, pushed the emergency stop button to deenergize the No. 1 section. Belt told Lipscomb that everyone was accounted for, and that they needed to travel outby because the water level was rising quickly. All miners except Lipscomb traveled outby through water to get to higher ground. The section rail-mounted mantrip could not be used because the water level was too high. John Winthrow, fireboss; Steve Johnson, outby foreman; and Neil operated three rubber-tired personnel carriers (located one crosscut outby the rail-mounted personnel carrier) to transport the crew to the surface.

When the CMM cut into the abandoned mine works in the No. 1 face, the initial inrush of water filled localized dips from the active No. 1 section extending outby to the No. 5 Belt Head. The section was mining slightly upgrade with an elevation change of approximately 38 feet over the 4,400-foot distance from the No. 5 Belt Head to the active section. The inflowing water settled in the low-lying entries surrounding the No. 5 Belt Head, flooding all entries and crosscuts for approximately 3,300 feet and reaching the mine roof. The flooded area prohibited any travel inby the No. 5 Belt Head area (Appendix A).

The accident occurred in the No. 1 section in the No. 1 entry. The miners evacuated the mine in accordance with the Mine Emergency Evacuation and Firefighting Program of Instruction.

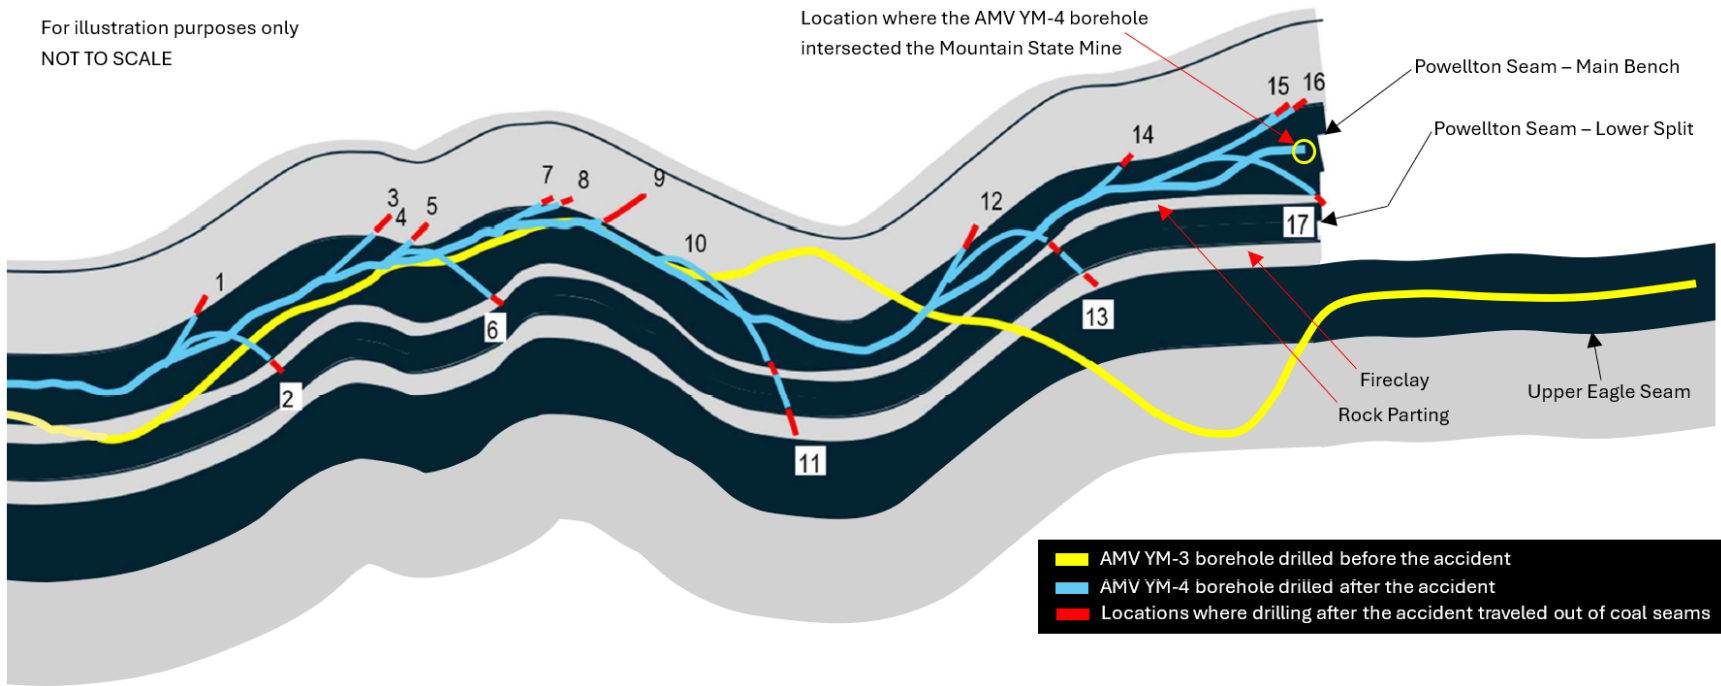
APPENDIX F – Vertical Comparison of Drill Paths and Seams

barrier between the Mountain State Mine and the Yankee Mains. The YM-4 directional hole verified the 50 feet barrier and intersected Mountain State Mine. Target completed their survey, which included 17 short “sidetracks” to “tag” or locate the top and bottom of the coal seam. A comparison of the drill paths and seams encountered for YM-3 and YM-4 are illustrated in Appendix F.

In addition to drilling the YM-3 directional hole into the wrong coal seam, the survey crew established the YM-3 directional hole using an incorrect azimuth (horizontal angle) 8 degrees off from the projected azimuth plotted on the mine maps. These maps were intended to show the progress of drilling. According to interviews with the engineers, the incorrect azimuth was the result of a notation error. Aracoma used the projected directional hole to plot the progress of the YM-3 directional hole, rather than the actual drill line. The change in azimuth resulted in the directional hole deviating from the projected drill line. Although the azimuth for the YM-3 directional hole was set incorrectly, it would have intersected the Mountain State Mine if the directional hole remained in the Powellton Main Bench rather than drifting down into the Upper Eagle Seam. If the engineers had plotted the actual drill path for the YM-3 directional hole on the map rather than the projected drill path, the mine operator would have had the opportunity to see that the YM-3 directional hole did not intercept the abandoned Mountain State Mine. This would have revealed the drill line was not in the Powellton Main Bench as planned.

Corrective Action: The mine operator and contractor developed enhanced written procedures for effectively drilling in the minable reserve and to accurately verify the absence of adjacent mine works. The new procedures require that drillers:

- (a) "Sidetrack" to "tag" or locate the top and bottom of the targeted coal seam at 200-foot intervals,
- (b) Complete the entire directional hole and have it certified by an engineer before advancing

- the mine,
- (c) Perform vertical core drilling to determine the location of the coal seam, and
 - (d) Drill into the abandoned mine while using a blowout device to ensure that miners are protected.
